# Popping Noise When the Engine is Running

**Service Category** Engine/Hybrid System

**Section** Engine Mechanical

| YEAR(S) | MODEL(S) | ADDITIONAL INFORMATION |
|---|---|---|
| 2023 | ES250 | |

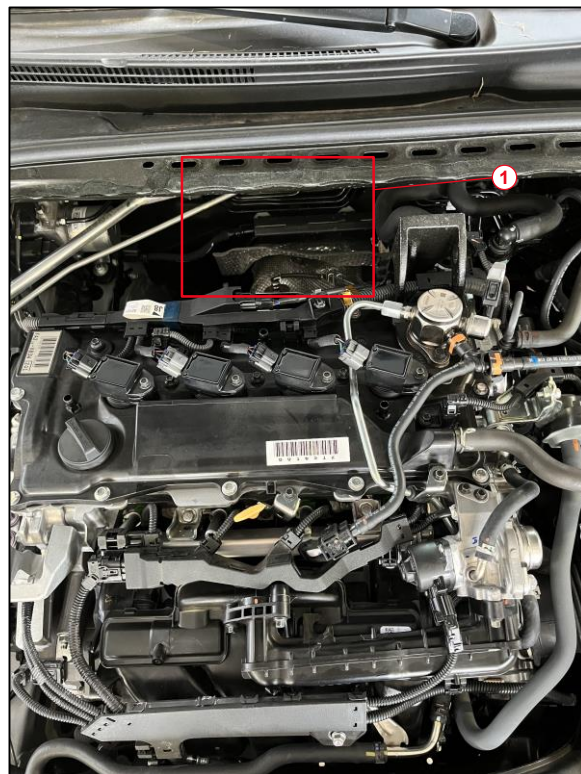
**Figure 1. Engine Bay**

Focus on the middle of the head casting, just above the exhaust manifold.

The water-jacket plug is located on the middle of the head casting, just above the exhaust manifold.

Area of Focus (for Phone or Borescope)

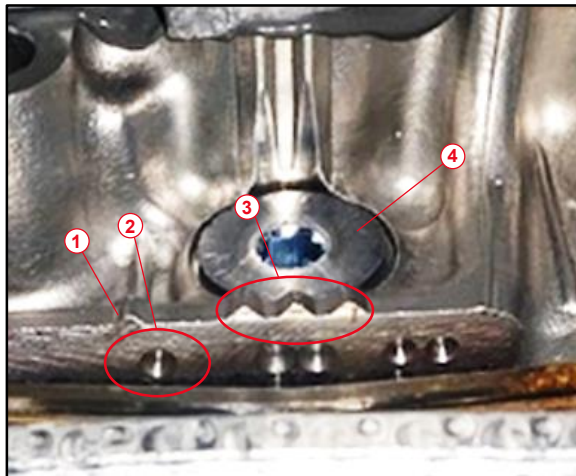
**Figure 2. Indications of a Suspect Cylinder Head**

- D. Locate the leftmost casting rib as shown in Figures 2 and 3.  
Is there more than one dot located to the left of the leftmost casting rib?
- **YES** — This bulletin does NOT apply.  
Continue diagnosis using the applicable Repair Manual.
  - **NO** — Continue to step 3.

| 1 | Left Side: One Casting Rib |
| 2 | One Marking Present |
| 3 | Right Side: Three Casting Ribs |
| 4 | Water-jacket Plug |

3. Replace the cylinder head sub assembly.
  - A. Remove the cylinder head sub assembly.

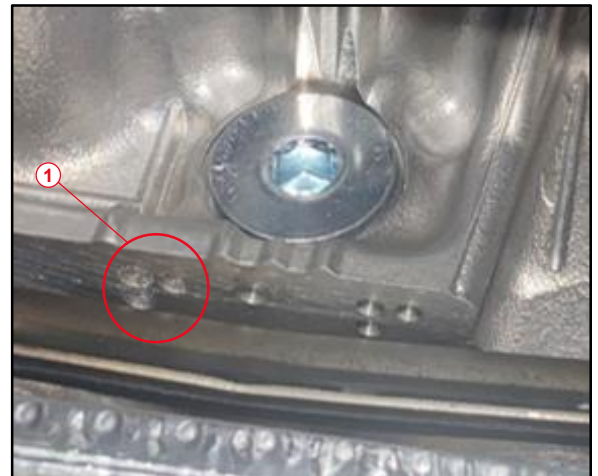
**Figure 3. Indication of Non-suspect Cylinder Head**

| 1 | More Than One Marking Present |
