Whine Noise from Rear of Vehicle

Service
Category Drivetrain

Section Axle/Differential

YEAR(S)	MODEL(S)	ADDITIONAL INFORMATION
2019 - 2023	Tacoma	Body Type(s): Double Cab

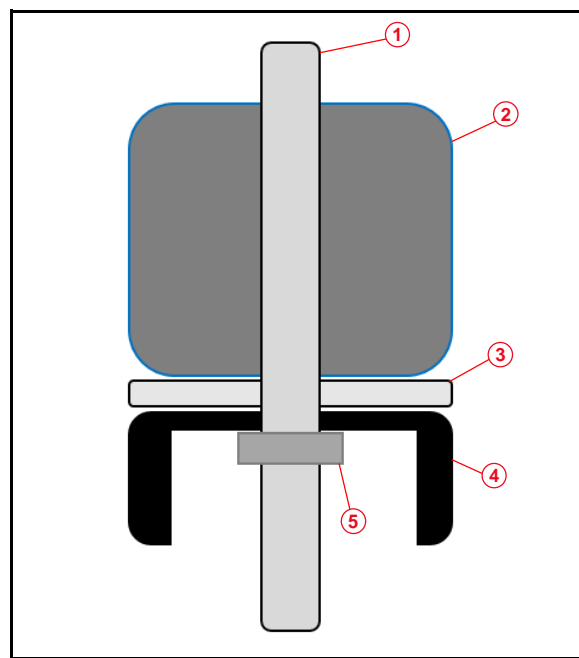
Figure 7.

Some 2019 – 2023 model year Tacoma Double Cab vehicles may exhibit a whine noise from the rear of the vehicle. This condition may occur while driving around 50 mph (80 kph) at constant speed, slight acceleration, or slight deceleration. This condition may be caused by rear differential vibration transferring through the chassis and body. Follow the Repair Procedure in this bulletin to address this condition.

- B. Install the NEW cab mounting cushion stopper and the NEW frame dynamic damper to the right-hand and left-hand cab mount.
- C. Retighten the cab mount nut.
Torque: 45 N*m (459 kgf*cm, 33 ft*lbf)

1	Body Mounting Bolt
2	No. 3 Cushion Sub-assy Cab Mounting
3	Cab Mounting Cushion Stopper
4	Frame Dynamic Damper
5	Lock Nut
