T-SB-0046-23 July 21, 2023

MIL On With DTC(s) P060649 and/or P060647

YEAR(S)	MODEL(S)	ADDITIONAL INFORMATION
2023	Sequoia HV	
2022 - 2023	Tundra HV

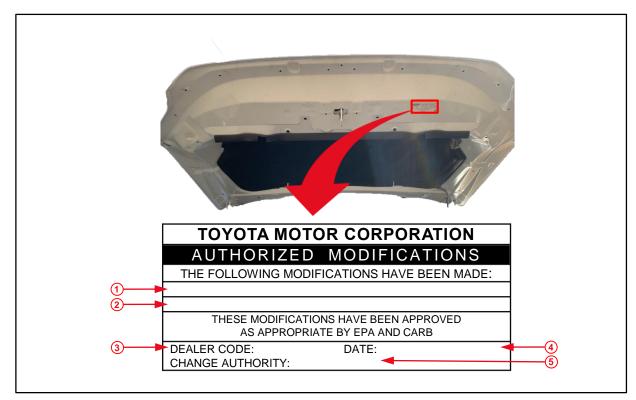
Figure 1. Location of Authorized Modifications Label on 2022 – 2023 Tundra HV and 2023 Sequoia HV

2. Use Techstream to confirm if the ECM (PCM) calibration has been updated and check for the Authorized Modifications Label affixed to the vehicle in the location shown below.

1	Replacement Skid Control Computer Part Number e.g., 896610CU71
2	New Calibration ID e.g., 896630CS1200
3	Dealer Code

4	Date Completed
5	This SB Number

- 4. Prepare and install the Authorized Modifications Label.
 - A. Using a permanent marker, enter the following information on the label:
 - ECM (PCM) part number [Refer to the Parts Information section for the NEW PART NUMBER]
 - Calibration ID(s) [Refer to the Calibration Information section for the NEW CALIBRATION ID]
 - Dealer Code
 - Repair Date
 - Change Authority [This bulletin number]
 - B. Install the Authorized Modifications Label onto the vehicle at the location shown in Figure 1. The Authorized Modifications Label is available through the MDC, P/N 00451-00001-LBL.
- 5. Test-drive the vehicle to confirm proper operation.
