TECHNICAL INSTRUCTIONS

Software Update 23TC05

EV Charging Performance + Display Software Update

CERTAIN 2023 bZ4X

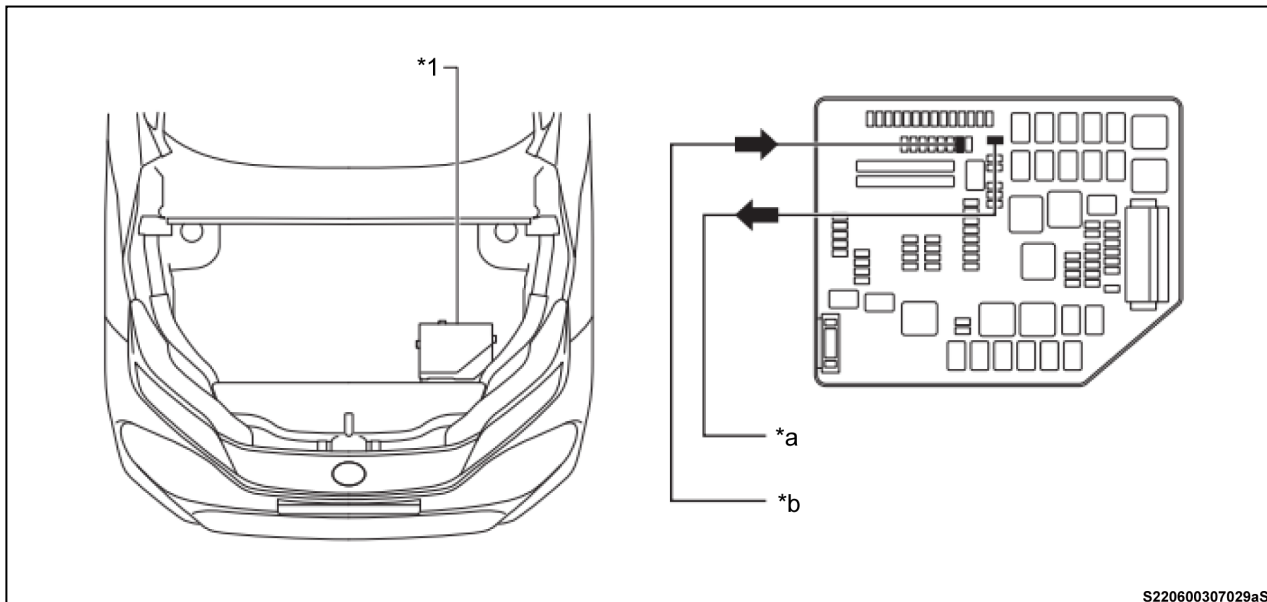
*1	Relay Block	-	-
*a	Remove D/C CUT FUSE (30A)	*b	Install D/C CUT FUSE (30A) here (Original Location)

- a. To perform the ECU reprogramming, it is necessary to reinstall the D/C CUT FUSE (30A) stored in the blank space of Relay Block in the original location as shown in the illustration. This operation is only applicable if the vehicle has not been Pre-Delivery Serviced.

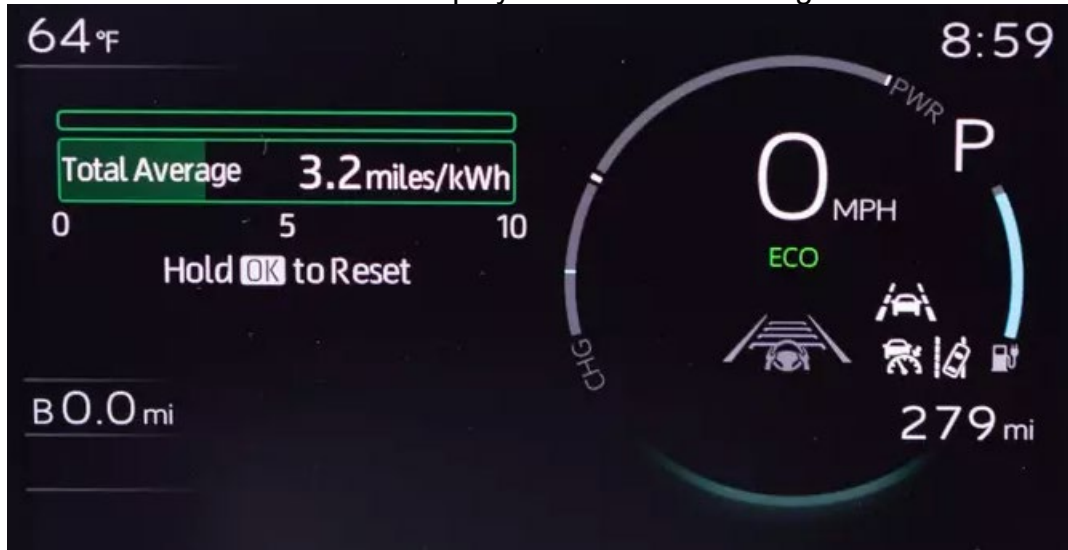
Note the before condition of the digital display.
There is no display for the state of charge.

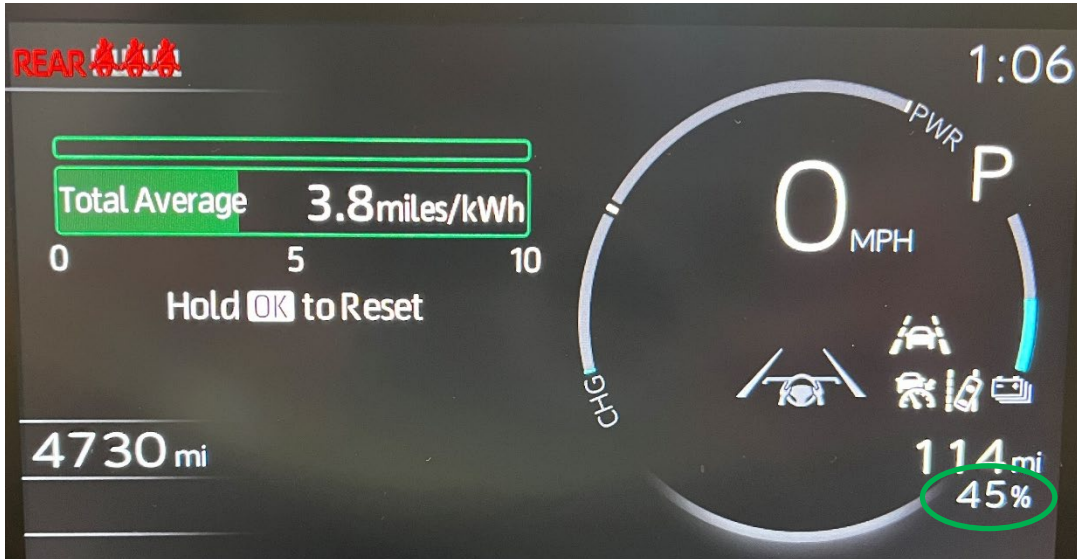
- a. When the update is successful, you will see a visible change in the digital gage showing the state of charge, as a percentage.
