Technical Service Bulletin

87 Noise from the air conditioning compressor when the AC is active

87 23 49 2063467/5 August 9, 2023. Supersedes Technical Service Bulletin Group 87 number 22-31 dated August 11, 2022, for reasons listed below.

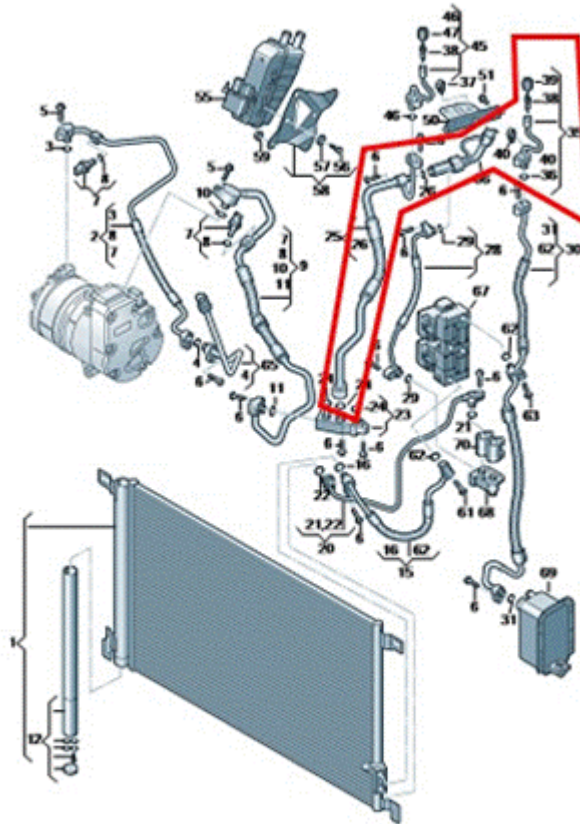
The source of this noise may be due to direct contact between adjacent refrigerant lines (Figure 1) or between a refrigerant line and the Bowden cable clip for the front hood release in the front motor compartment (Figure 2). When the air conditioning compressor is operating the noise created by the vibration is transferred from this point of contact and into the cabin.

Figure 1. The refrigerant lines possibly make contact.

3. These refrigerant lines must be separated and, if necessary, retained in a separated position using a hose holder, clip, or tie-wrap (Figure 5).

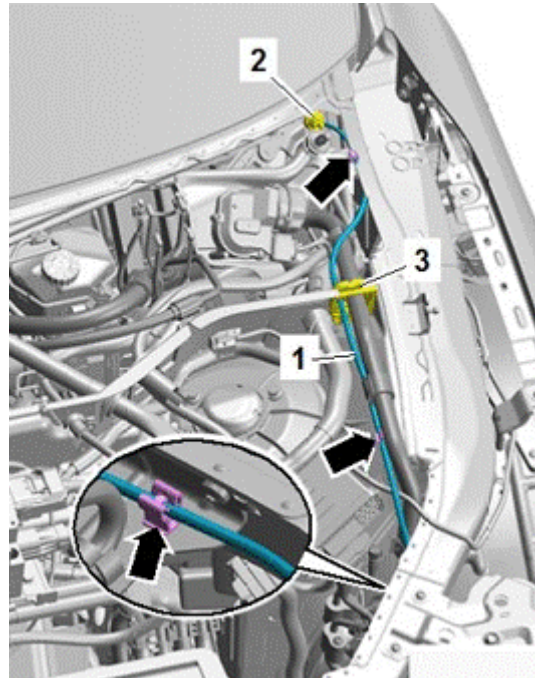
Figure 2. Location of the Bowden cable clip for the front hood release.

5. An additional point of contact may be found between the refrigerant line containing the service port and the clip that retains the Bowden cable for the front hood release. If contact is found here these components must be separated and secured in a separated position. The retaining clip for the refrigerant line allows the line to slide within it. This is to be considered when securing the line away from the clip for the Bowden cable.

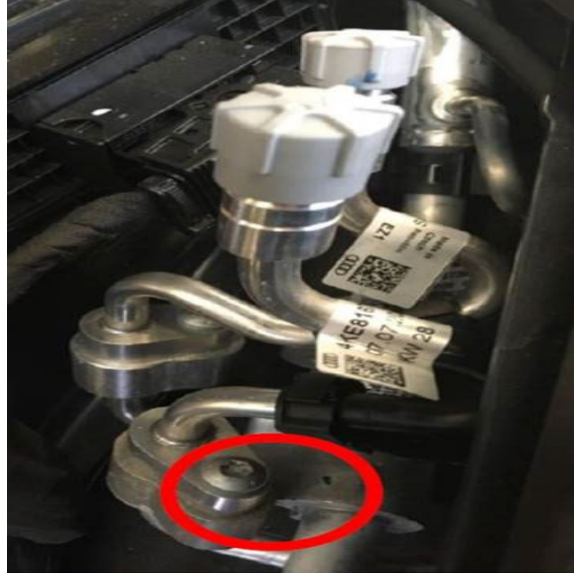
1. Figure 3 shows refrigerant lines close enough to make contact and elicit vibration transfer and noise.

Figure 3. The refrigerant lines are making contact.

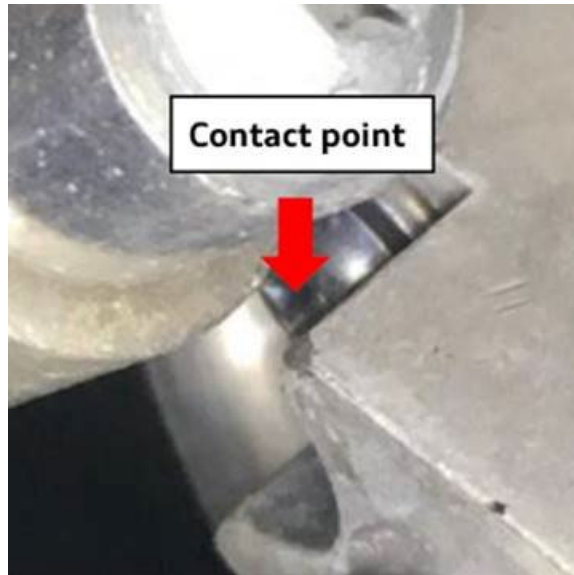
2. Figure 4 shows a close-up view of the point of contact.

Figure 4. Point of contact.

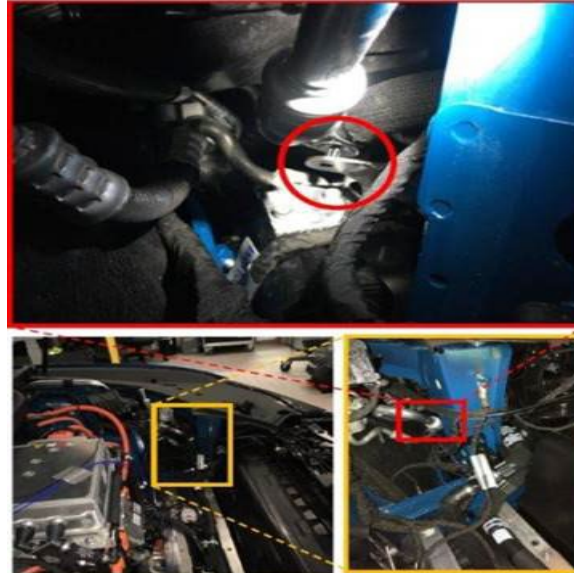
Figure 5. The area in the motor bay where contacting lines are located.

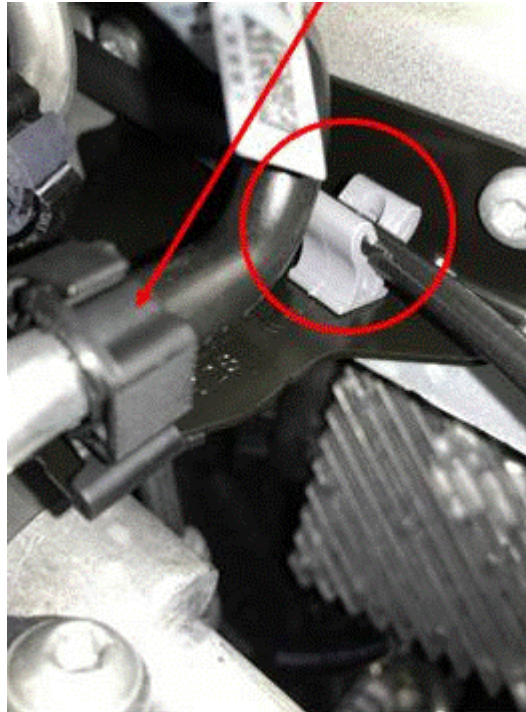
Figure 7. Point of contact between refrigerant line and Bowden cable clip.

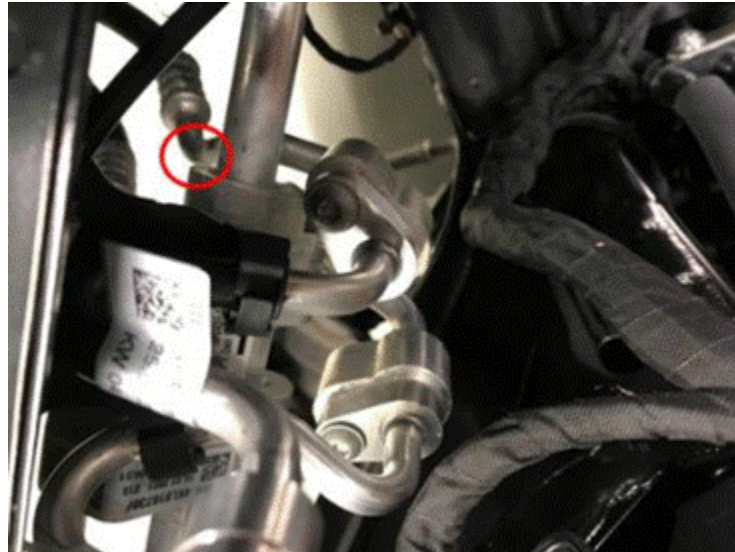
Figure 8. Point of contact between coaxial refrigerant line and the refrigerant line containing the service port.

6. Figure 8 shows an additional point of contact possible at the coaxial refrigerant line where it crosses the refrigerant line containing the service port. Again, separate and secure these lines in a separated position.

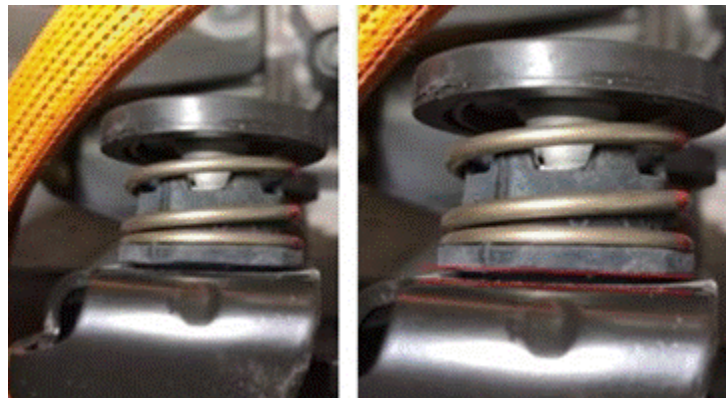
7. In some cases the compressor isolator spring is not indexed correctly in the rubber mounting causing an incorrectly seated compressor isolator assembly. Inspect the isolator / spring assembly for proper fit of the spring to the isolator at the top and bottom seating areas. Figure 9 shows a poorly seated isolator showing a gap between the rubber isolator and the mounting bracket.

Figure 9. Poorly seated compressor isolator / spring assembly.

8. The spring and / or rubber mount may need to be twisted to correct the spring to rubber mount index allowing the isolator assembly to lie flat against the bracket. Figure 10 shows a properly seated isolator / spring assembly.

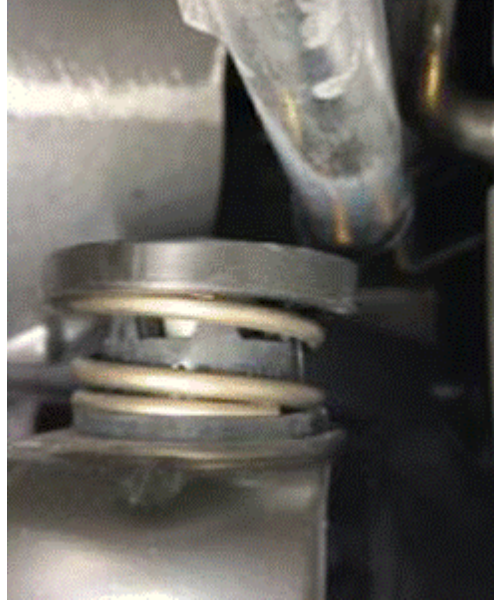
Figure 10. Correctly seated compressor isolator / spring assembly.

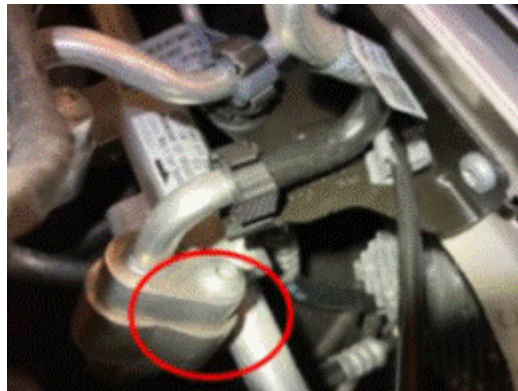
9. An additional possible point of line contact is the service port mounting block in Figure 11.

Figure 11. Service port mounting interference with adjacent line.

- 10 Correct this by pushing the service port in the direction of the arrow with just enough force to create a permanent clearance as shown in Figure 12.

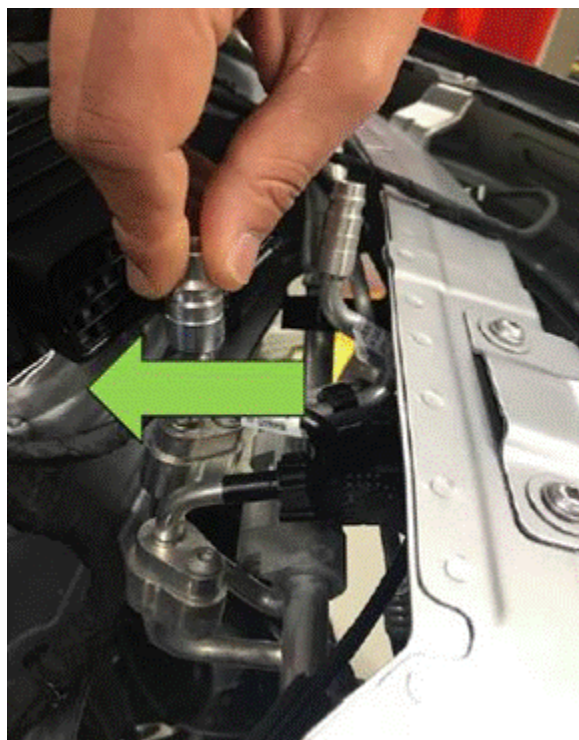
Figure 12. Creating a permanent gap between the service port mounting and the adjacent line.
