# Technical Service Bulletin

## 90 Instrument cluster driver information system display is blank

90 23 35 2063913/6 August 8, 2023. Supersedes Technical Service Bulletin Group 90 number 23-33 dated July 25, 2023, for reasons listed below.

Model(s)	Year	VIN Range	Vehicle-Specific Equipment
A4, A4 allroad, and S4	2021	A000001 – A062322 N000001 - N012657	Not Applicable
A5, A5 Cabriolet, A5 Sportback, S5, S5 Cabriolet, S5 Sportback	2021	A000001 – A045240 N000001 – N 005166

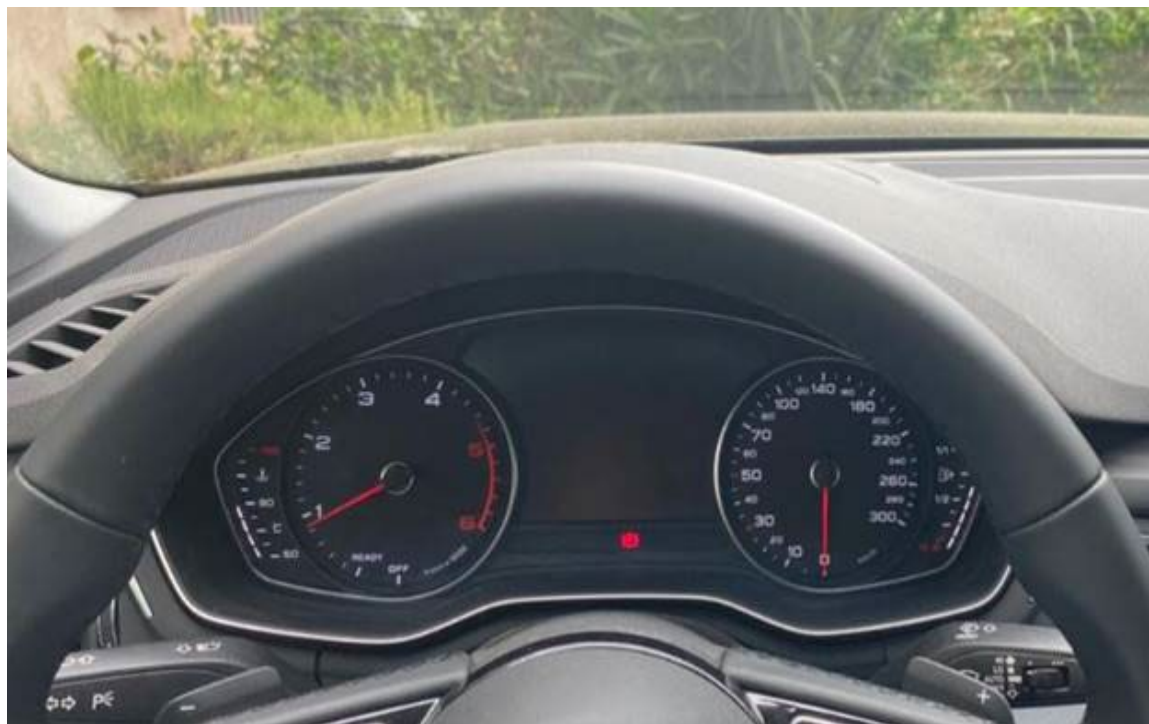
- The driver information system (DIS) in the instrument cluster (PR Code 9S7) is blank.
- The speedometer, tachometer, and bar graphs showing the fuel level and coolant temperature work normally (Figure 1).

**Figure 1.** Instrument cluster display is blank.

There is a hardware defect in the instrument cluster.

1. Follow all instructions in TSB 2011732: *00 Software Version Management (SVM), operating instructions*.
2. Update the instrument cluster, J285 (address word 0017) using the SVM action code as listed in the table below, if necessary:

The update can take multiple attempts. Please attempt the update **up to 12 times** before replacing parts. If an improvement to the update is available, this TSB will be updated.
