ServiceNews Article

August 2023

Front Brake Pads Wearing Unevenly

Year	Model	Trim Level
2022	MDX	ALL

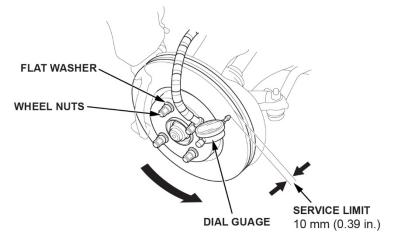
- If the inner and outer edges of the rotors are raised, indicating significant wear, replace the brake rotors.
- If the inner and outer edges of the rotors are not raised, go to step 2.
- 2. Clean the brake rotor thoroughly and remove all rust.
- 3. Install suitable flat washers and wheel nuts.
- 4. Tighten the wheel nuts to the specified torque to hold the brake rotor securely against the hub.
- 5. Measure the brake rotor runout. If the runout is within spec, proceed to step 6.
- 6. If runout is not within spec, replace brake rotors.

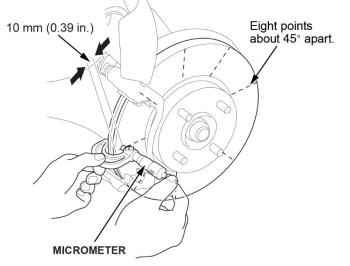
7. Measure the brake rotor thickness. If the thickness is not within spec at any of the eight points measured, replace brake rotor. If thickness is within spec at the eight points measured, rotors are deemed good.

Item	Standard Value (New)	Service Limit
Brake Rotor Thickness	30.0 mm (1.181 in)	28.0 mm (1.102 in)
Brake Rotor Parallelism*	-	0.015 mm (0.00059 in) max
