# 46-003: T680E and T880E Battery Electric Vehicle - R5 Software Power Gauge Incorrect

8/1/2023

46-003

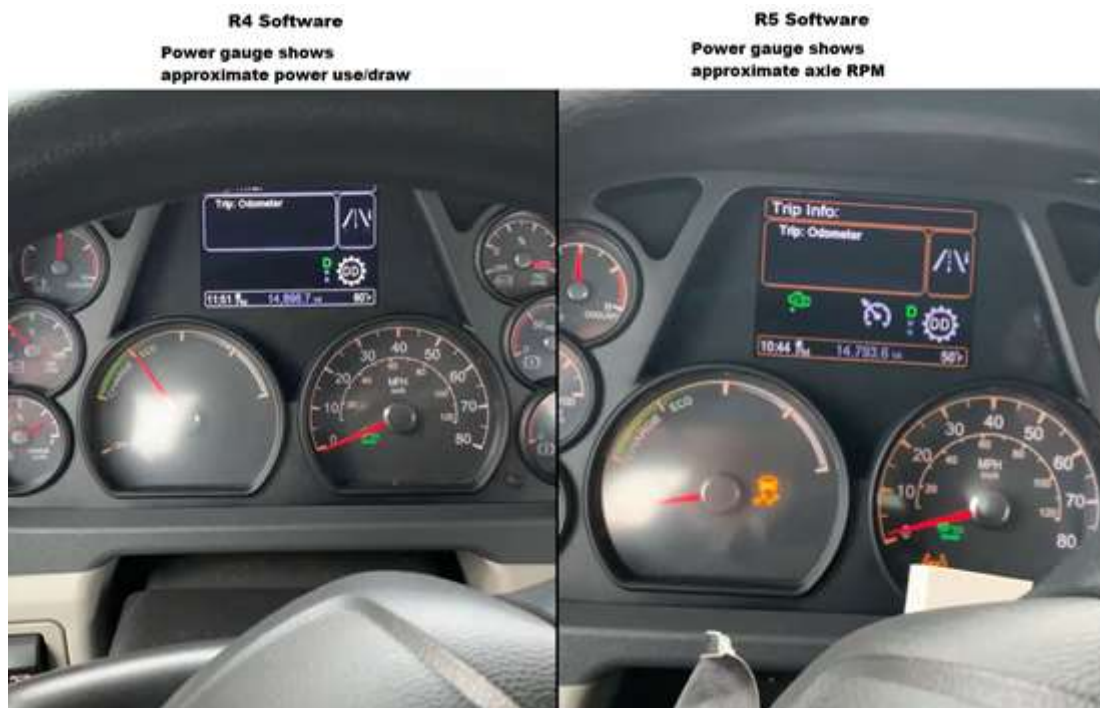
1. The power gauge displays axle RPM instead of power draw. This is not an accurate representation of power draw and could lead to incorrect estimations of power usage. All other gauges will continue to

operate normally.

There is currently a repair procedure available for T680E and T880E chassis that will address issues caused by the previous BEV2 R5.00\_002 software update. This repair involves replacement of the Bendix ABS control module with an updated version and a software update to R5.00\_003.
