GLOBAL SAFETY FIELD INVESTIGATIONS
DCS6633
URGENT - DISTRIBUTE IMMEDIATELY

Subject: N222375791-07 - Customer Satisfaction Program
Park Assist Retrofit
Population Update

N222375791 Park Assist Retrofit

Condition	Due to the industry-wide semiconductor shortage, the park assist feature is not functional on certain 2022 and 2023 model year vehicles listed above, built beginning December 2, 2021. The affected vehicle owners should have been made aware of the condition at sale, and notified, that once parts are available, they would be eligible for a no additional cost retrofit to enable the feature.
Correction	Dealers are to replace the park assist control module to restore the Park Assist feature. Note: some vehicles may also require reprogramming of the instrument cluster or the active safety control module.

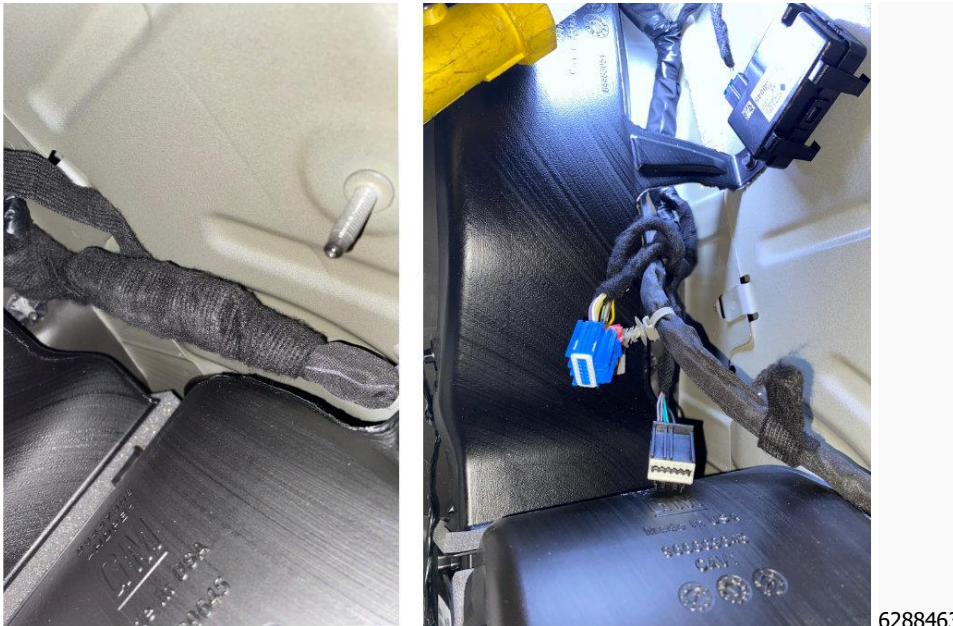
Camaro

Note: The wiring harness for the Parking Assist Control Module may be wrapped around an adjacent wiring harness as shown above. Remove the attaching tape by unwrapping. Do NOT cut the tape as it could damage the wiring harness.

1. Install the new Parking Assist Control Module. Refer to *Parking Assist Control Module Replacement* in SI.

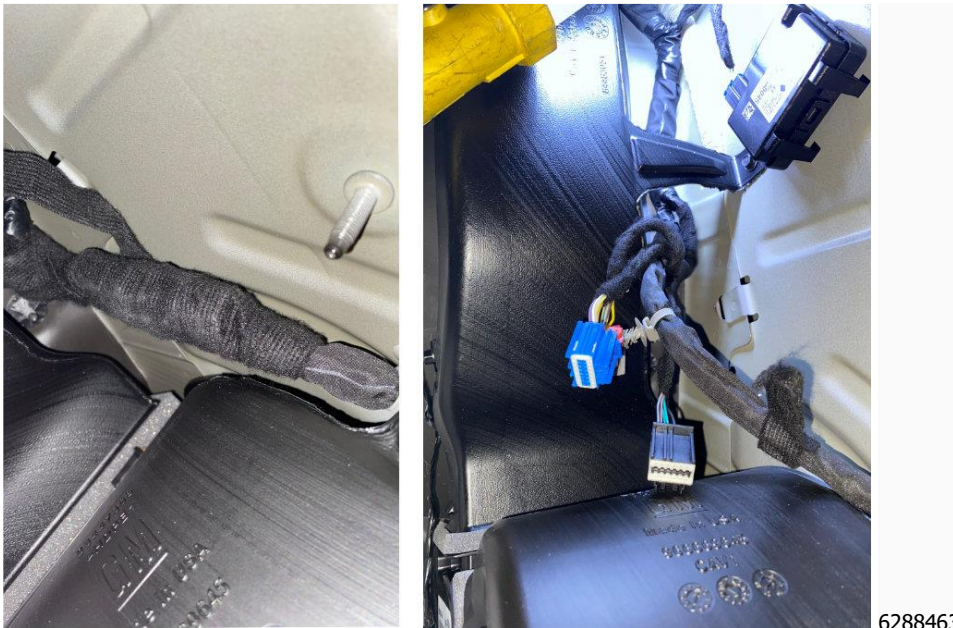
XT6

Note: The wiring harness for the Parking Assist Control Module may be wrapped around an adjacent wiring harness as shown above. Remove the attaching tape by unwrapping. Do NOT cut the tape as it could damage the wiring harness.

1. Install the new Parking Assist Control Module. Refer to *Parking Assist Control Module Replacement* in SI.

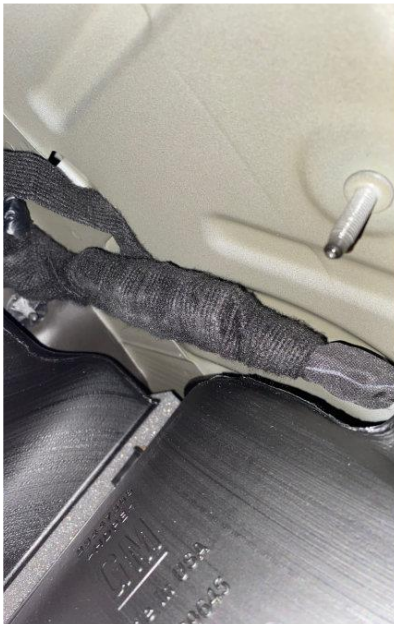
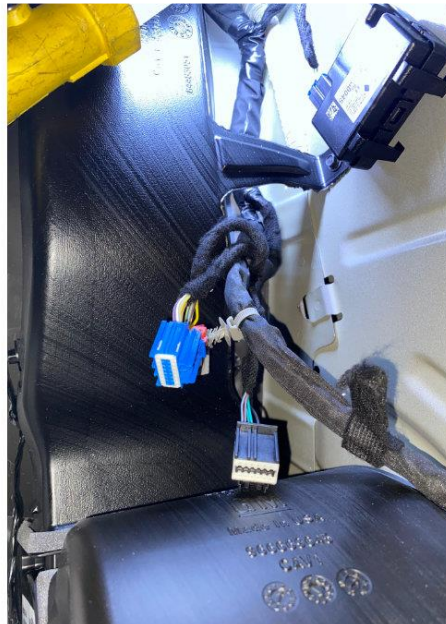
XT5

Note: The wiring harness for the Parking Assist Control Module may be wrapped around an adjacent wiring harness as shown above. Remove the attaching tape by unwrapping. Do NOT cut the tape as it could damage the wiring harness.

1. Install the new Parking Assist Control Module. Refer to *Parking Assist Control Module Replacement* in SI.

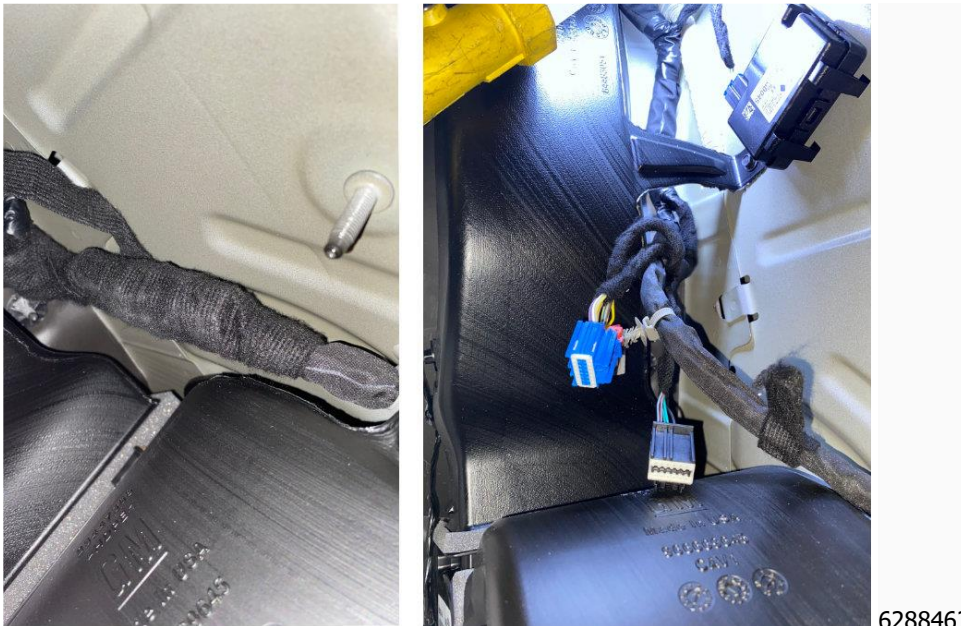
Note: The wiring harness for the Parking Assist Control Module may be wrapped around an adjacent wiring harness as shown above. Remove the attaching tape by unwrapping. Do NOT cut the tape as it could damage the wiring harness.

1. Install the new Parking Assist Control Module. Refer to *Parking Assist Control Module Replacement* in SI.

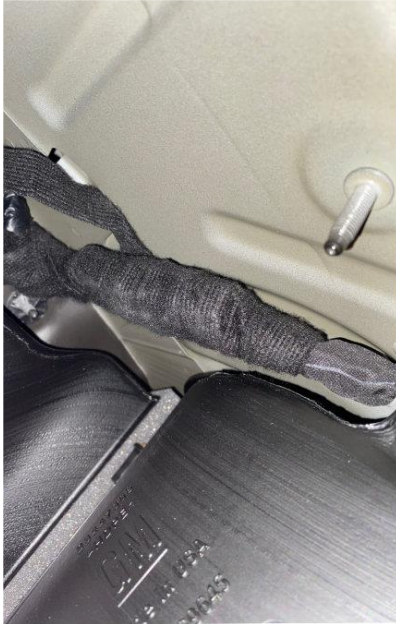
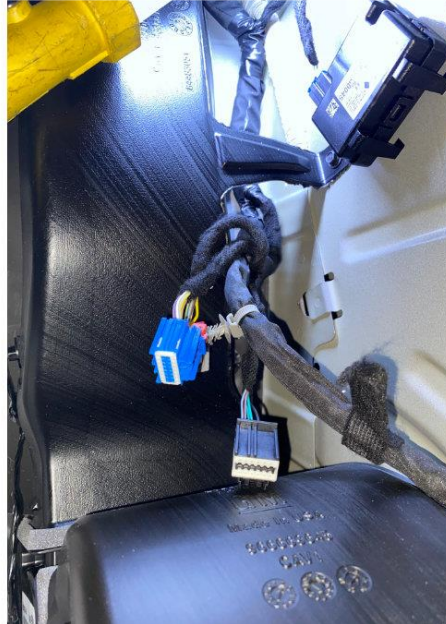
XT4 with UD5 without UGN, UVZ, or UKL

Note: The wiring harness for the Parking Assist Control Module may be wrapped around an adjacent wiring harness as shown above. Remove the attaching tape by unwrapping. Do NOT cut the tape as it could damage the wiring harness.

1. Install the new Parking Assist Control Module. Refer to *Parking Assist Control Module Replacement* in SI.

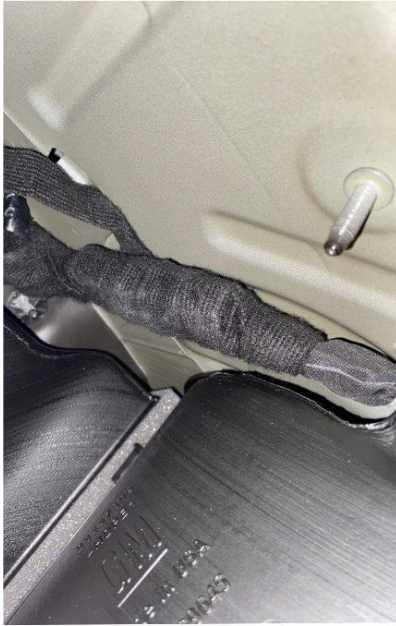
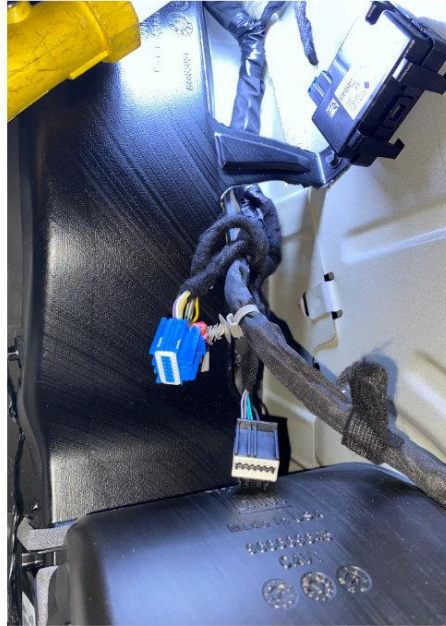
XT4 with UD5 with UGN, UVZ, or UKL

Note: The wiring harness for the Parking Assist Control Module may be wrapped around an adjacent wiring harness as shown above. Remove the attaching tape by unwrapping. Do NOT cut the tape as it could damage the wiring harness.

1. Install the new Parking Assist Control Module. Refer to *Parking Assist Control Module Replacement* in SI.

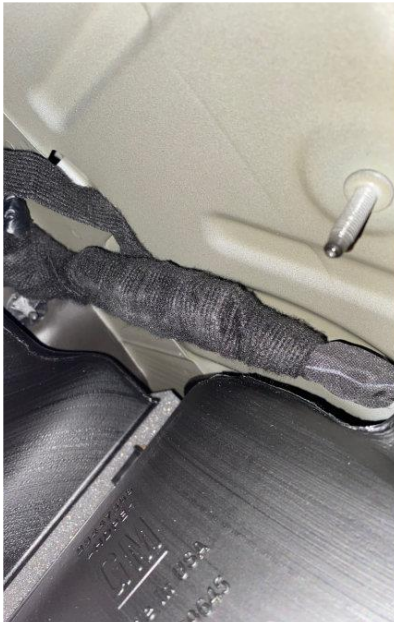
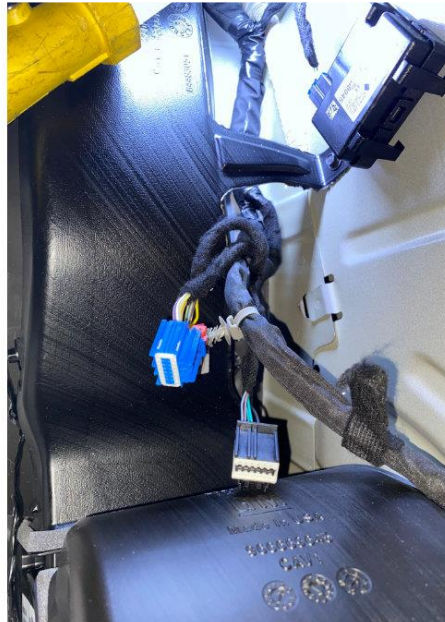
Silverado/Sierra (Includes both 2022 and 2023 LDs and HDs)

Note: The wiring harness for the Parking Assist Control Module may be wrapped around an adjacent wiring harness as shown above. Remove the attaching tape by unwrapping. Do NOT cut the tape as it could damage the wiring harness.

1. Install the new Parking Assist Control Module. Refer to *Parking Assist Control Module Replacement* in SI.

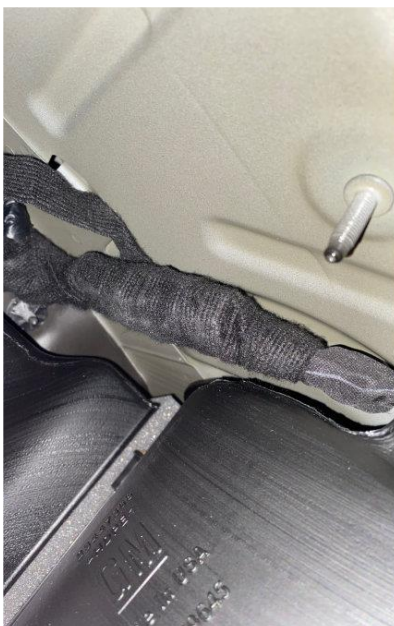
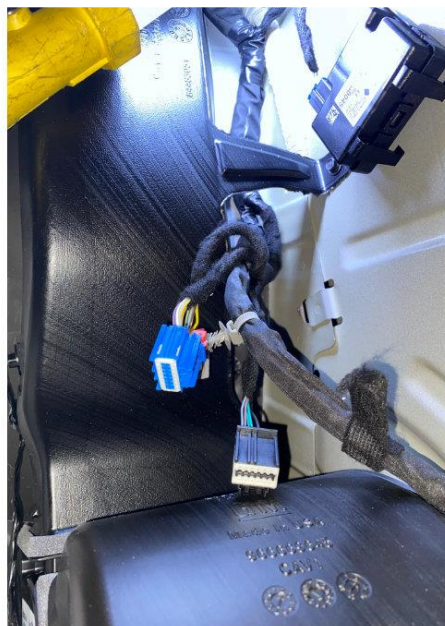
Enclave with UGN, UVZ, or UKL

Note: The wiring harness for the Parking Assist Control Module may be wrapped around an adjacent wiring harness as shown above. Remove the attaching tape by unwrapping. Do NOT cut the tape as it could damage the wiring harness.

1. Install the new Parking Assist Control Module. Refer to *Parking Assist Control Module Replacement* in SI.

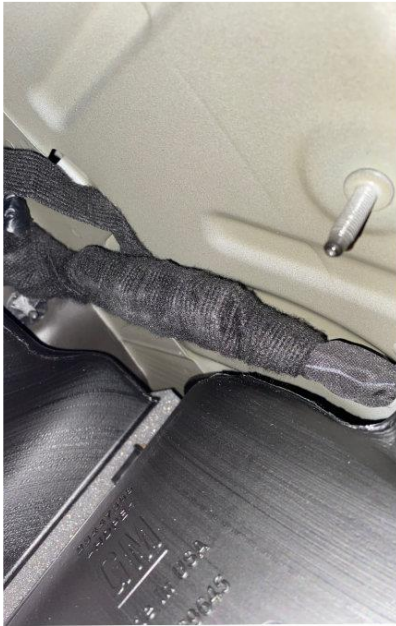
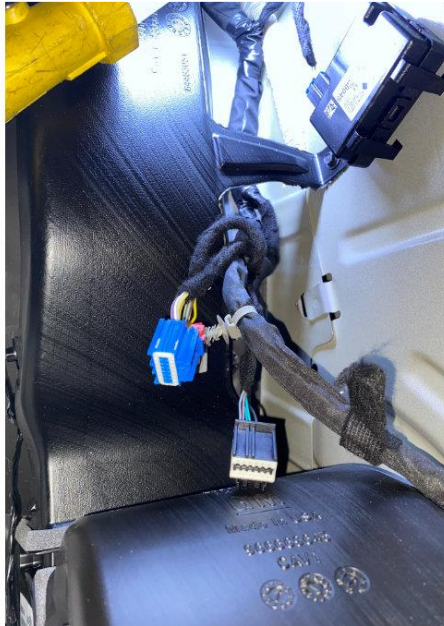
Enclave without UGN, UVZ, or UKL

Note: The wiring harness for the Parking Assist Control Module may be wrapped around an adjacent wiring harness as shown above. Remove the attaching tape by unwrapping. Do NOT cut the tape as it could damage the wiring harness.

1. Install the new Parking Assist Control Module. Refer to *Parking Assist Control Module Replacement* in SI.

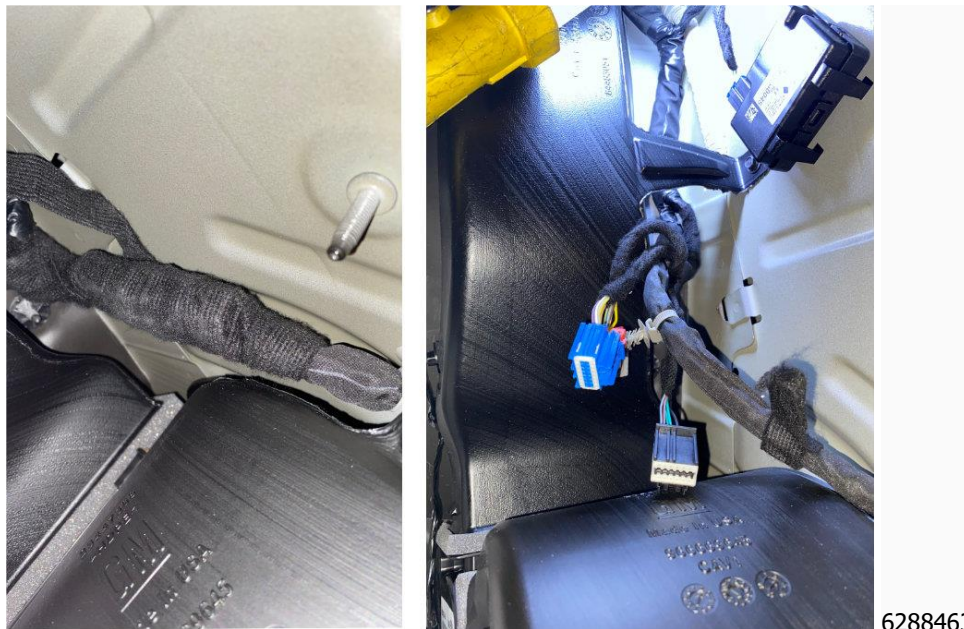
Acadia with UGN, UVZ, or UKL

Note: The wiring harness for the Parking Assist Control Module may be wrapped around an adjacent wiring harness as shown above. Remove the attaching tape by unwrapping. Do NOT cut the tape as it could damage the wiring harness.

- Install the new Parking Assist Control Module. Refer to *Parking Assist Control Module Replacement* in SI.

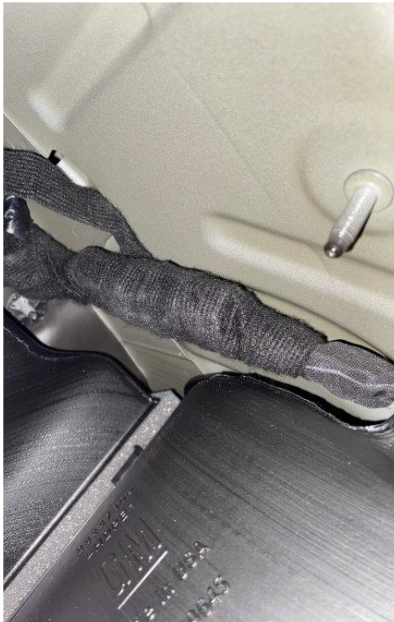
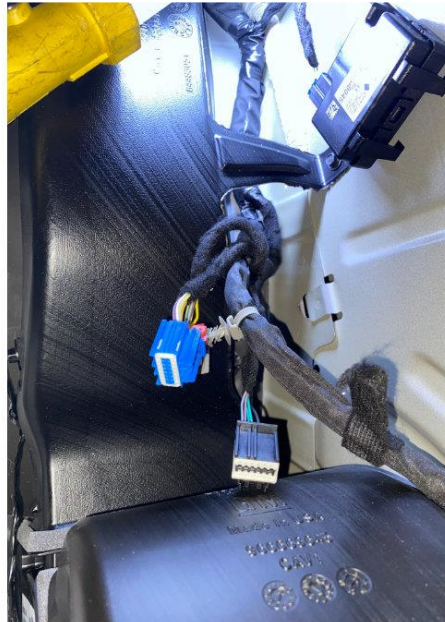
Acadia without UGN, UVZ, or UKL

Note: The wiring harness for the Parking Assist Control Module may be wrapped around an adjacent wiring harness as shown above. Remove the attaching tape by unwrapping. Do NOT cut the tape as it could damage the wiring harness.

1. Install the new Parking Assist Control Module. Refer to *Parking Assist Control Module Replacement* in SI.

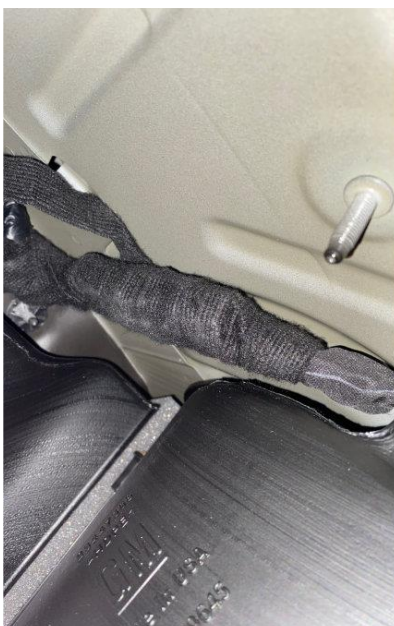
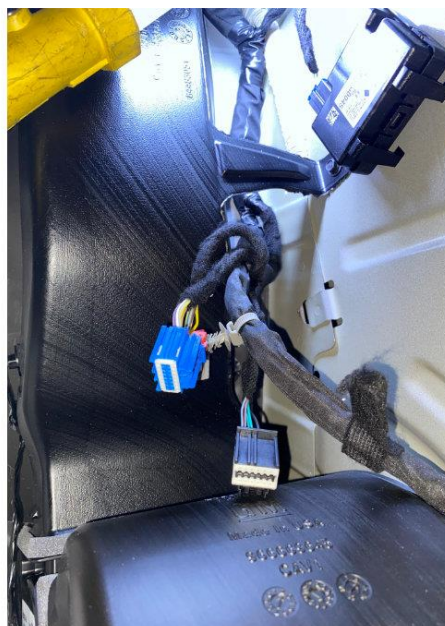
Blazer with UGN, UVZ, or UKL

Note: The wiring harness for the Parking Assist Control Module may be wrapped around an adjacent wiring harness as shown above. Remove the attaching tape by unwrapping. Do **NOT** cut the tape as it could damage the wiring harness.

1. Install the new Parking Assist Control Module. Refer to *Parking Assist Control Module Replacement* in SI.

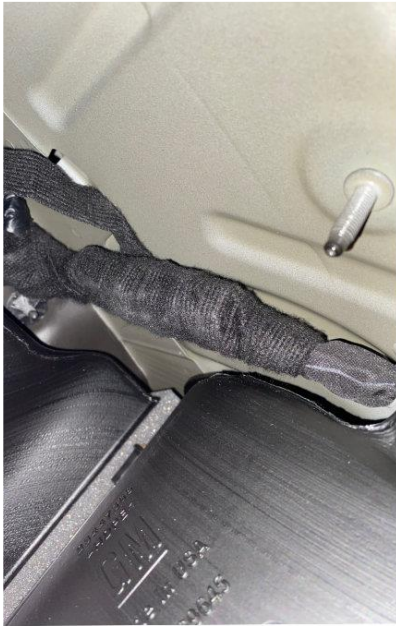
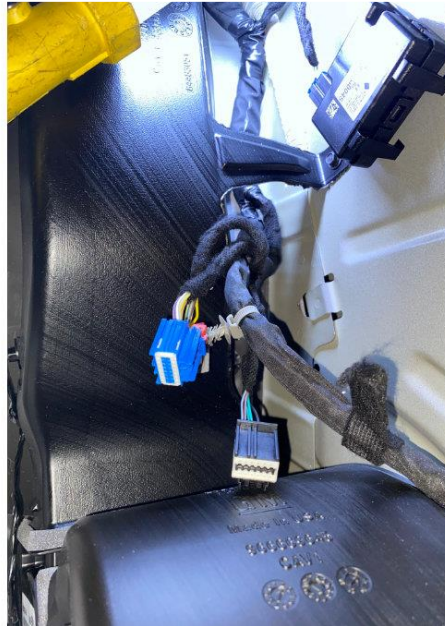
Blazer without UGN, UVZ, or UKL

Note: The wiring harness for the Parking Assist Control Module may be wrapped around an adjacent wiring harness as shown above. Remove the attaching tape by unwrapping. Do NOT cut the tape as it could damage the wiring harness.

1. Install the new Parking Assist Control Module. Refer to *Parking Assist Control Module Replacement* in SI.

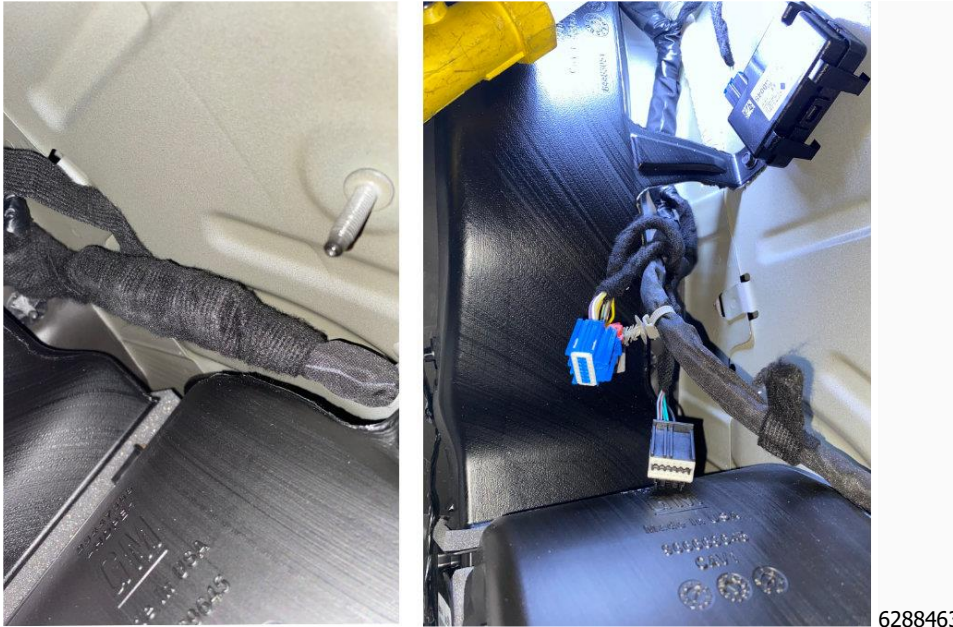
Colorado/Canyon

Note: The wiring harness for the Parking Assist Control Module may be wrapped around an adjacent wiring harness as shown above. Remove the attaching tape by unwrapping. Do NOT cut the tape as it could damage the wiring harness.

1. Install the new Parking Assist Control Module. Refer to *Parking Assist Control Module Replacement* in SI.

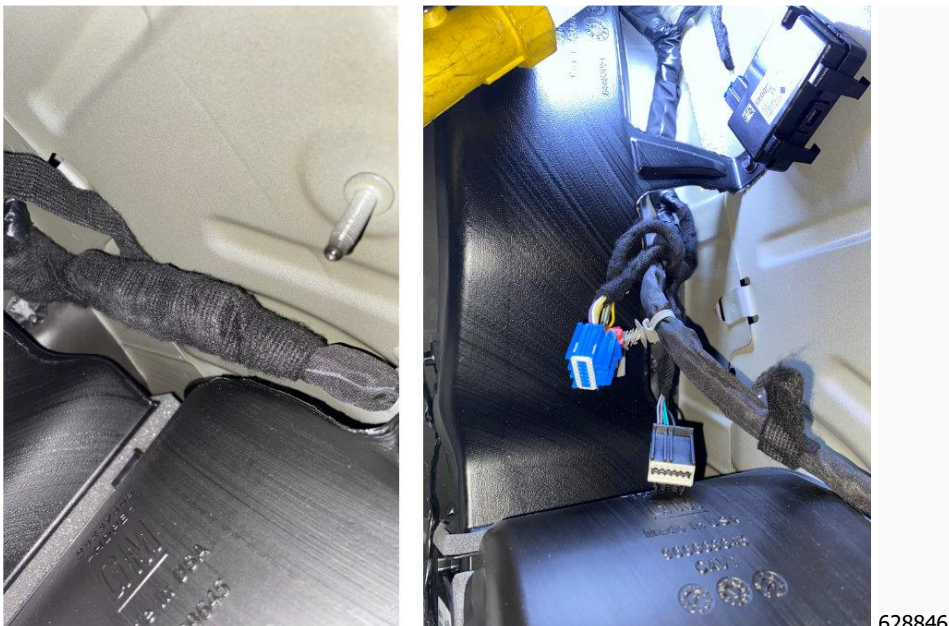
Encore GX/Trailblazer

Note: The wiring harness for the Parking Assist Control Module may be wrapped around an adjacent wiring harness as shown above. Remove the attaching tape by unwrapping. Do NOT cut the tape as it could damage the wiring harness.

1. Install the new Parking Assist Control Module. Refer to *Parking Assist Control Module Replacement* in SI.

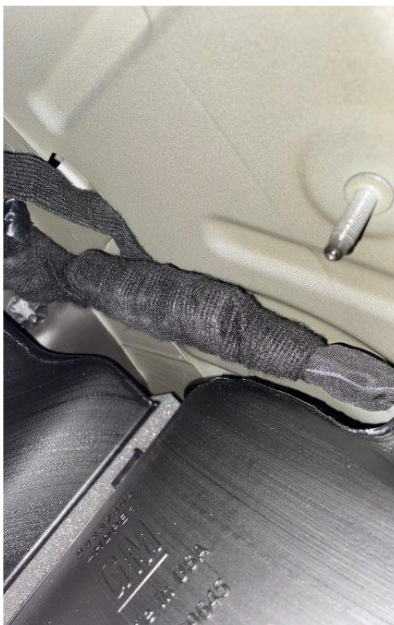
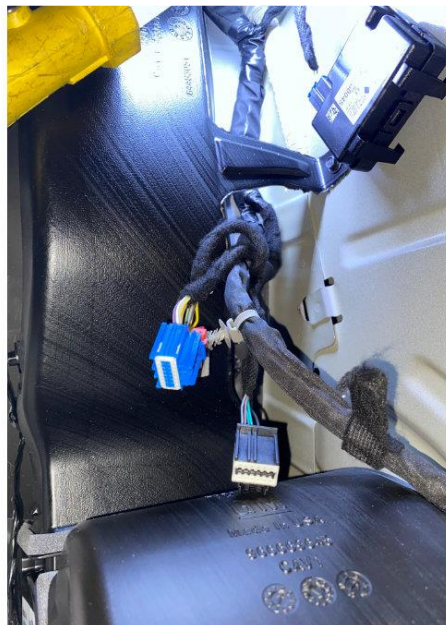
Traverse without UGN, UVZ, or UKL

Note: The wiring harness for the Parking Assist Control Module may be wrapped around an adjacent wiring harness as shown above. Remove the attaching tape by unwrapping. Do NOT cut the tape as it could damage the wiring harness.

1. Install the new Parking Assist Control Module. Refer to *Parking Assist Control Module Replacement* in SI.

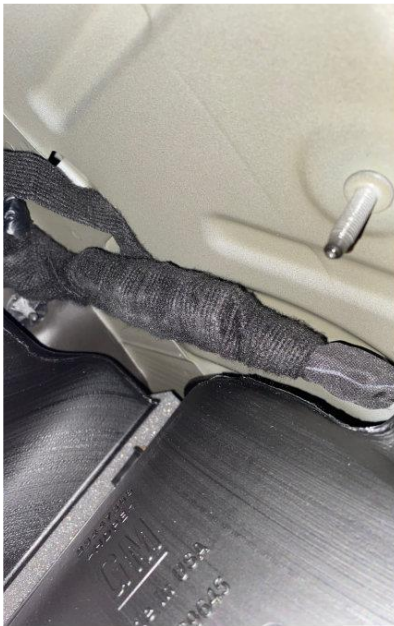
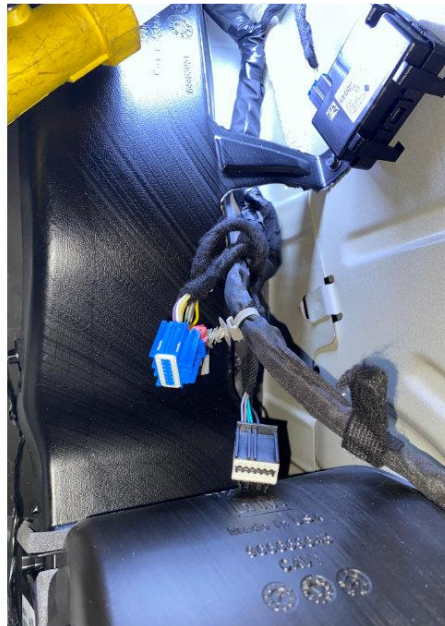
Note: The wiring harness for the Parking Assist Control Module may be wrapped around an adjacent wiring harness as shown above. Remove the attaching tape by unwrapping. Do NOT cut the tape as it could damage the wiring harness.

1. Install the new Parking Assist Control Module. Refer to *Parking Assist Control Module Replacement* in SI.
