## Trunk Lid/Tailgate Unlocks But Does Not Open

Topic number	LI72.20-P-075232
Version	4
Function group	72.20 - Tailgate, rear door
Date	8/17/23
Validity	MODEL 206 with code 881 or 890 up to manufacturing date June 30, 2023. MODEL 295 with code 881 up to manufacturing date June 30, 2023. MODEL 254 up to manufacturing date June 30, 2023. MODEL 294 up to manufacturing date June 30, 2023. MODEL 296 up to manufacturing date June 30, 2023. MODEL 297 up to manufacturing date June 30, 2023. MODEL 232 up to manufacturing date June 30, 2023.
Reason for change	Validity extended

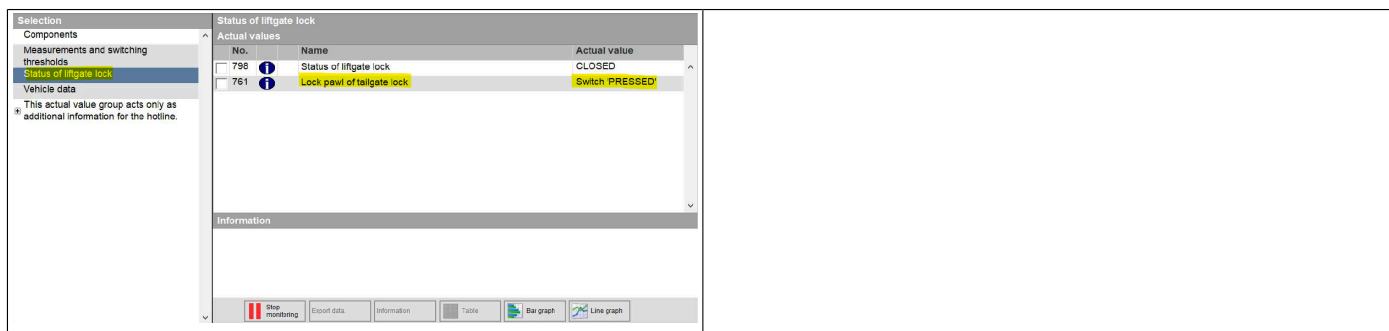
In the event of a problem, the status of the trunk lock (picture 1) does not change during opening/closing of the trunk lid or tailgate.

XENTRY Diagnosis COM Kit path: XD > HKS/KDS CU (N121/1) > ACTUAL values > Status of trunk locka

Attachments	
File	Description
<a href="#">XENTRY+Still.png</a>	XENTRY Diagnosis - Status of Trunk Lock

Replace trunk lock (A85/5).
