## AUTHORIZED FIELD CHANGE – 23901

17 August 2023

**SUBJECT:** Sealing roof joints during Safety Recall 23501 or 23502 is performed if required.

IC Bus® RE, CE, and Electric CE Series buses

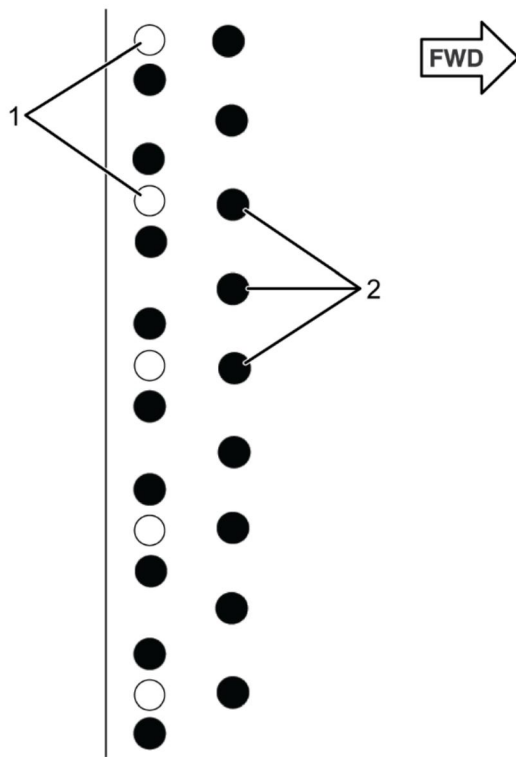
**Figure 1. Roof Joint Leak Repair Rivet Location**

1. Rear row of screws
2. Forward row of rivets

6. Starting with rearmost top panel that required screws (Figure 1, Item 1), locate forward row of rivets (Figure 1, Item 2).

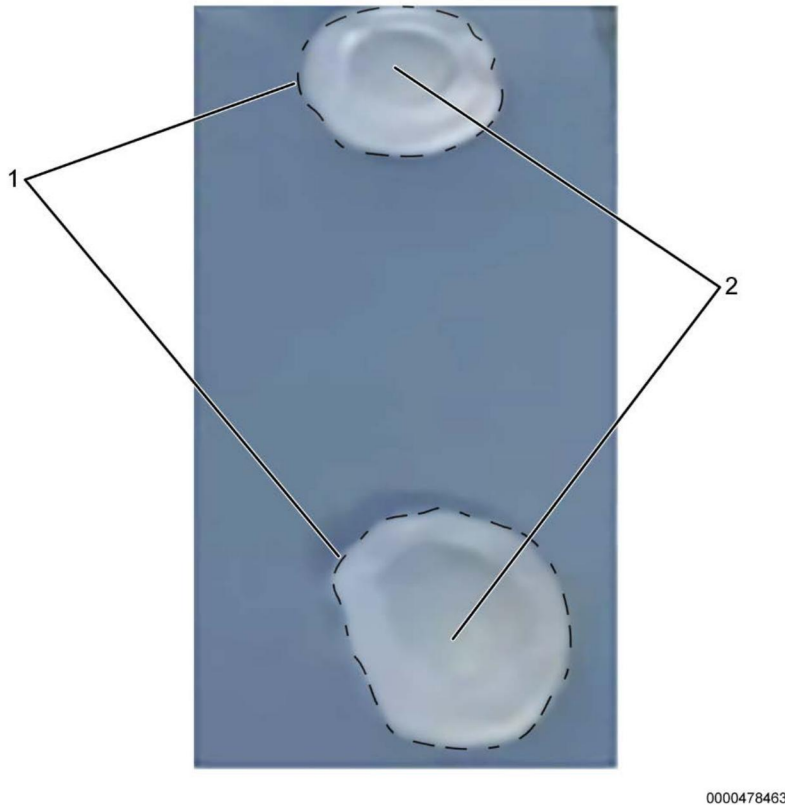
**Figure 2. Add Sealant to Rivets**

1. Sealant
2. Rivet head

**NOTE: In line with the forward row of rivets of the repaired joint, up to approximately 35 rivets will require sealant.**

8. Starting at 20 in (508 mm) up from drip rail, apply appropriate color sealant (Figure 2, Item 1) to perimeter of rivet head (Figure 2, Item 2).
9. Repeat Steps 7 and 8 for each rivet in forward row of rivets of repaired joint.
10. Repeat Steps 7 through 9 for each repaired joint.

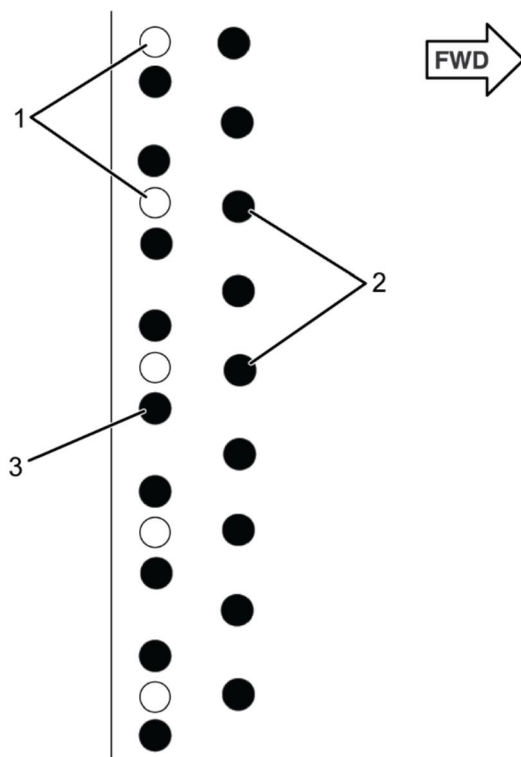
**Figure 3. Roof Joint Leak Repair Screw Location**

1. Rear row of screws
2. Forward row of rivets
3. Existing rivet

11. Starting with rearmost top panel that required screws, locate forward row of rivets (Figure 3, Item 2) and rear row of screws (Figure 3, Item 1).

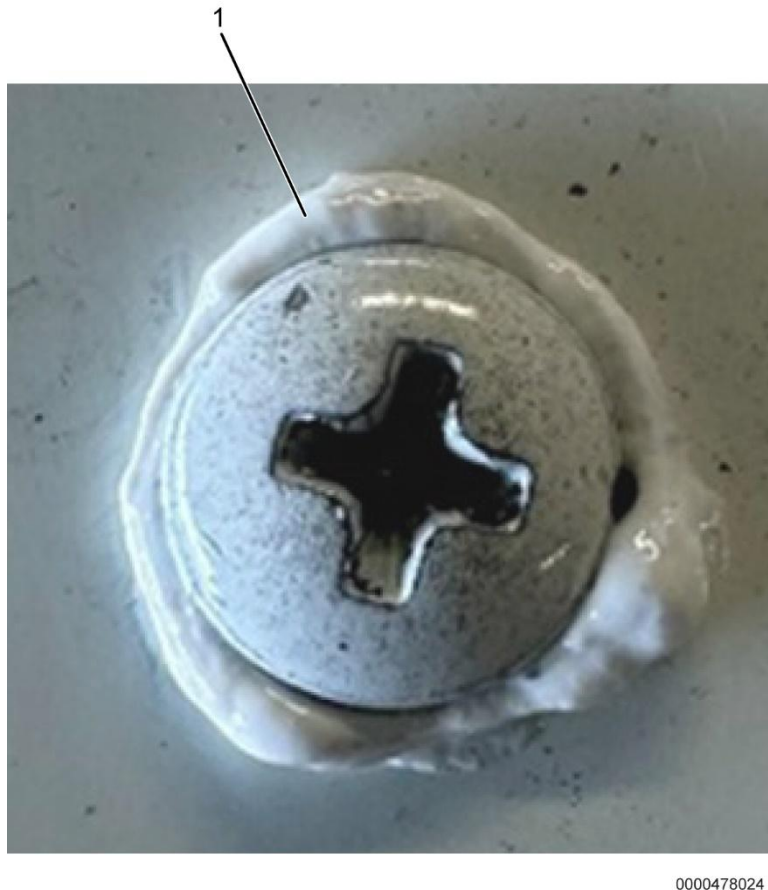
**Figure 4. Add Sealant to Screws**

1. Sealant

**NOTE:** In line with the rearmost row of rivets of the repaired joint, up to approximately 19 screws and 35 rivets will require sealant.

13. Starting at 20 in (508 mm) up from drip rail, apply appropriate color sealant (Figure 4, Item 1) to perimeter of rivet and screw head.
14. Repeat Steps 12 and 13 for each rivet in forward row of rivets and each screw in rear row of rivets of repaired joint.
15. Repeat Steps 12 through 14 for each repaired joint.
