**Title: Starter kicks out after 1 second on MV/HVs with L9 engines**

**Applies To: MVs and HVs with Cummins L9 engines.**

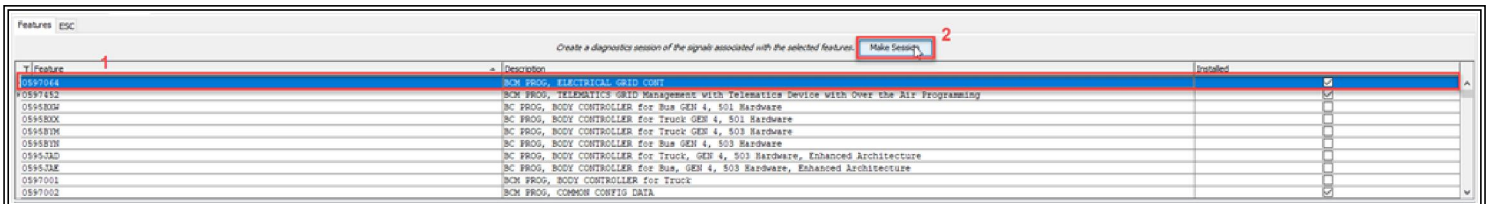
Figure 1: Create a session

Item 1: Feature 597064

Item 2: Make Session Button

2. Create a session with feature 597064 BCM PROG, ELECTRICAL GRID CONT by selecting feature 597064 (Figure 1, Item 1) and then selecting the "Make Session" button (Figure 1, Item 2).

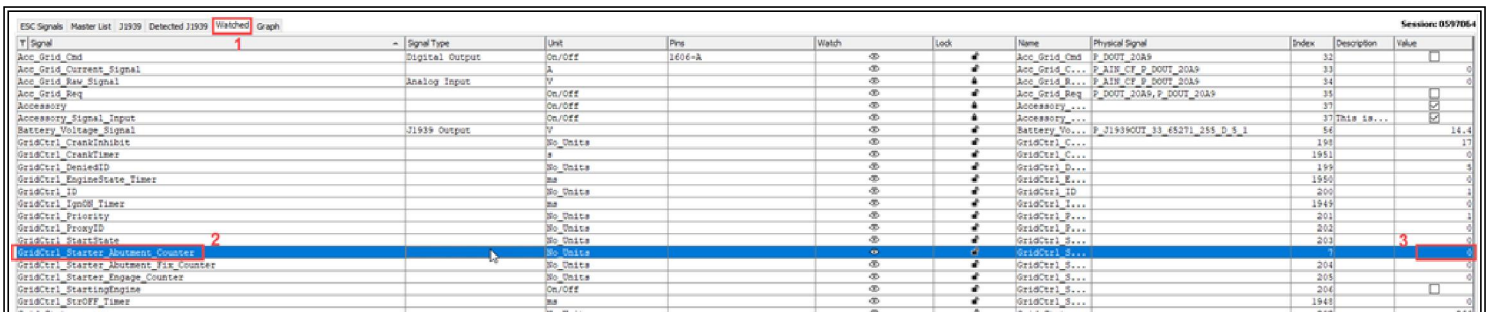
Figure 2: Abutment signal

Item 1: Watched tab

Item 2: GridCtrl\_Starter\_Abutment\_Counter Signal

Item 3: GridCtrl\_Starter\_Abutment\_Counter Signal Value

3. In the "Watched" tab (Figure 2, Item 1) select the signal named GridCtrl\_Starter\_Abutment\_Counter

4. Attempt to crank the engine. If the starter kicks out and the value of GridCtrl\_Starter\_Abutment\_Counter (Figure 2, Item 2) goes up then the abutment feature is causing the starter to kick out. Proceed to the repair steps below.

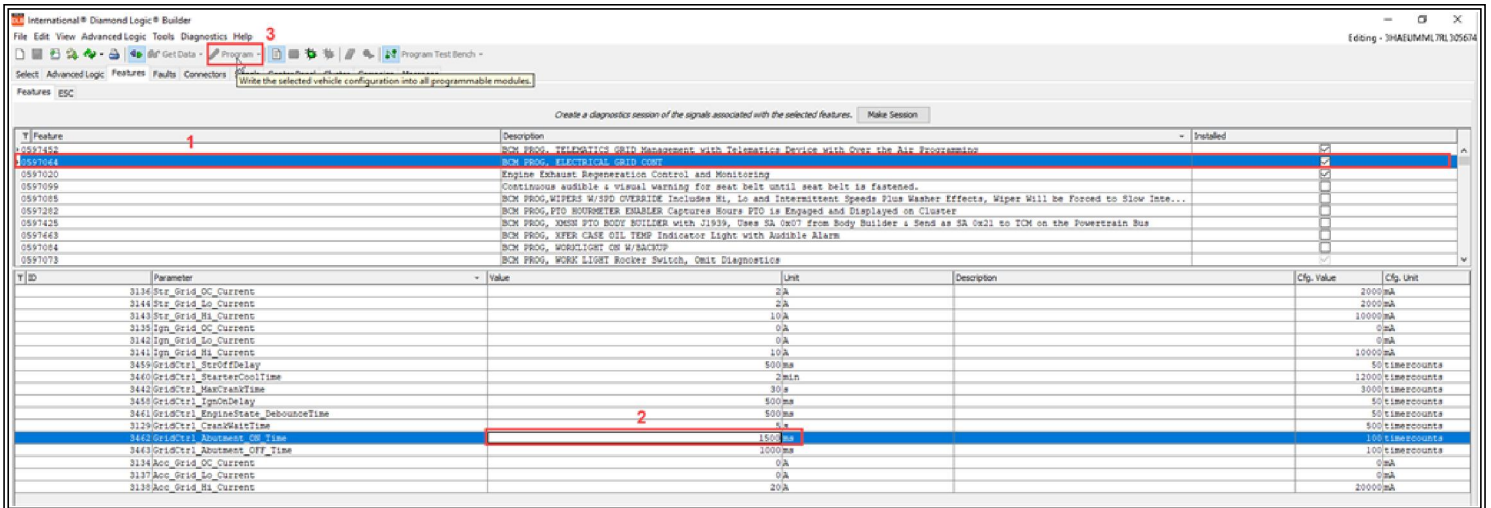
**Figure 3: Programming Procedure**

- Item 1: Feature 597064
- Item 2: Parameter 3462
- Item 3: Program Button

3. In the features tab select feature 597064 (Figure 3, Item 1).

**Note:** Do not use a higher value than 1500ms. Damage to the starter or starter wiring can result.

4. Change the value of parameter 3462 GridCtrl\_Abutment\_ON\_Time from 1000ms to 1500ms (Figure 3, Item 2)

5. Press the program button to commit the changes to the BCM (Figure 3, Item 3)
