Document ID: IK0900152
Revision: 0
Created: 7/12/2023
Last Modified: 8/4/2023
Author: George Mooney

Title: CAC to Air Compressor Intake Tube Separating at Connection

Applies To: MV build between Nov 30 2022 to Feb 9 2023

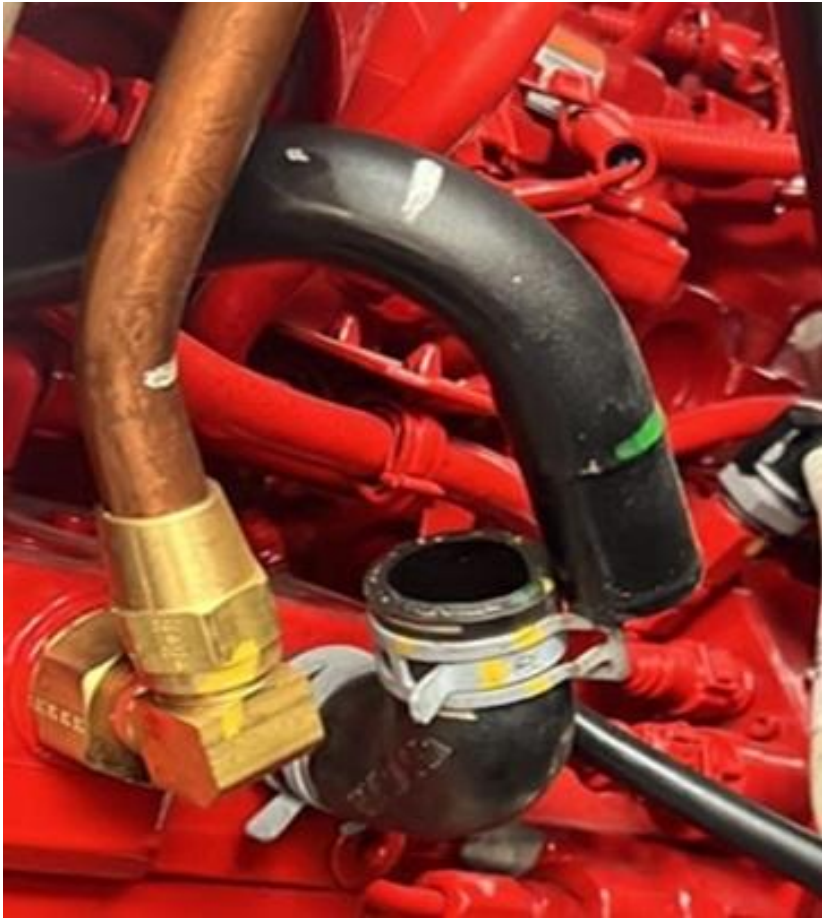
Figure #1: CAC to Air Compressor Intake hose separated

On some MV models, the CAC to Air compressor intake tube could separate from the rubber elbow under boost pressure (See Fig 1 & 2 for Reference).

Item 1: CAC to Air Compressor intake pipe and rubber elbow separated at the air compressor.

This document will guide the user through measuring the barb at the end of the steel tube and replacing the spring clamp with a constant tension clamp. If the barb on the end of the pipe is smaller than 26.9mm (+-0.25mm), it will need to be replaced.

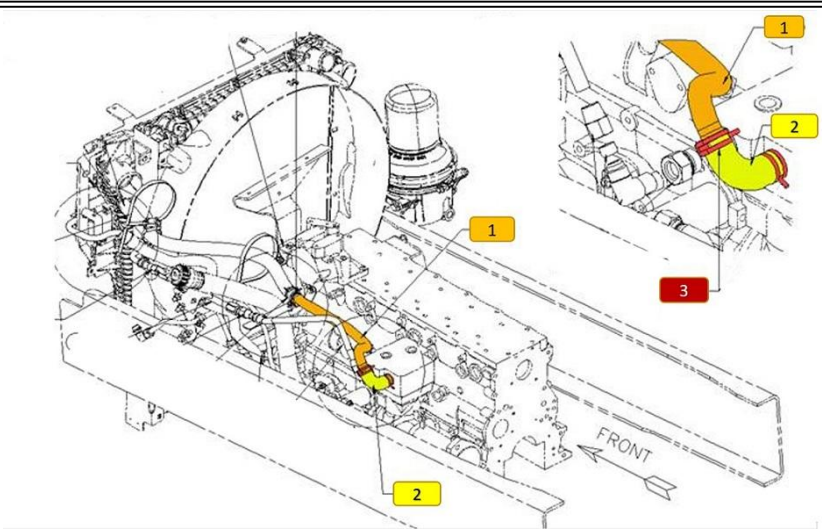
Figure #2: CAC to Air Compressor Intake hose

Item 1: Tube, ISB Compressor Inlet Pipe - PN 4181656C3
Item 2: Hose, ISB Compressor Inlet Elbow - PN 4221851C1
Item 3: Clamp, Duct Hose - (This spring clamp is being replaced with a constant tension breeze clamp (PN 1622034C1) * Note - Its only being replaced between the pipe and hose)

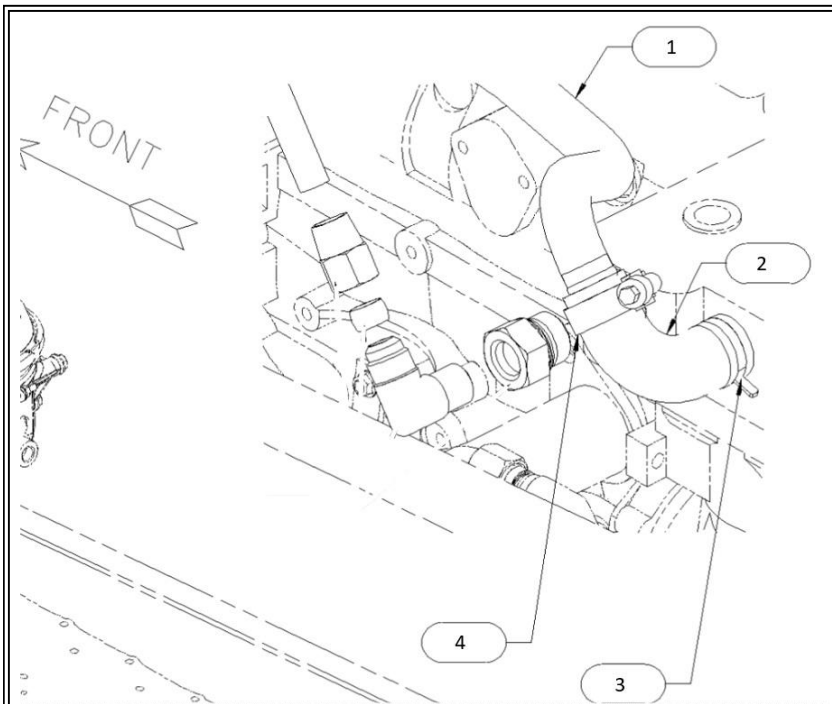
Figure #3: CAC to Air Compressor Intake Pipe and rubber elbow

Item 1: Tube, ISB Compressor Inlet Pipe - PN 4181656C3
Item 2: Hose, ISB Compressor Inlet Elbow - PN 4221851C1
Item 3: Clamp, Duct Hose - (This spring clamp remains in place)
Item 4: Clamp, Air Duct Hose (New Constant Tension Breeze Clamp)
PN 1622034C1 * Note - It's only being replaced between the pipe and hose)

1. Using Dial Caliper, measure the barb at the end of the Air Compressor Intake Pipe and rubber elbow, See Figures 1, 2 & 4 for location, If barb is smaller than 26.9mm (+0.25mm), replace the pipe. The current PDC inventory was certified to be within specifications.
2. If the barb measures within specification, replace the spring clamp with constant tension Breeze clamp, see parts information for PN. Air Compressor Intake Pipe does not need to be replaced.
3. Remove the spring clamp and replace with a constant tension breeze clamp. See Figure 3 - Item 4, for the location of the new constant tension breeze clamp.
