08/16/2023  
CAL WS 41-002b

**Subject: 47X Driveline Carrier Bearing Inspection  
and Replacement**

**Models Affected: 47X vehicles built from September 6, 2022,  
through October 10, 2022.**

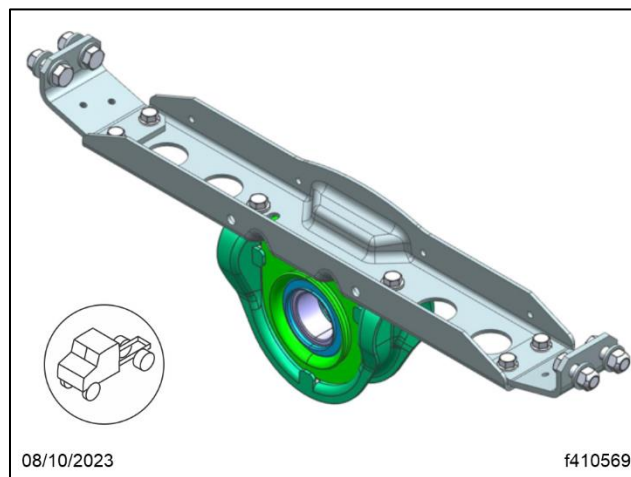
**Fig. 1, Bearing Support without Spacer**

Western Star 47X vehicles equipped with certain driveline configurations and carrier bearing installations may have inadequate angles, creating a shorter life of the carrier bearings.

1. Park the vehicle on a level surface, shut down the engine, and set the parking brake. Chock the tires.
2. Support the driveline for removal of existing carrier bearing brackets.
3. For instructions to remove and install the drivelines, carrier bearings, and brackets, see **Group 41** of the *47X and 49X Workshop Manual*.
4. Install the forward carrier bearing bracket (09-11769-000) at the driveline support bracket, and replace the existing bracket (09-11769-003) with the new bracket (09-11769-004) at the rear 567 crossmember location. See [Fig. 1](#) and [Fig. 2](#).
