# Service Alert

Subject:	
LIFTGATE LATCH RATTLE	Service Alert No.: SA-045/23
	Last Issued : 08/29/2023

2024 CX-90

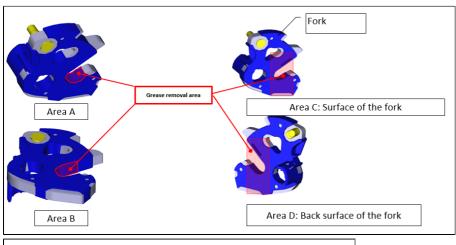
Some customers may report the liftgate rattles or clunks and the sound is coming from the latch. This is due to the coating from the lock striker scratching off due to repeated opening/closing of the liftgates. To eliminate the noise, the grease coating from the latch must be completely removed.

# 5. Completely clean areas A through D with a swab and parts cleaner.

7. Reapply grease to areas A through D with a swab.
