Service Alert

Subject: CONNECTED VEHICLE SYMPTOM TROUBLESHOOTING	Service Alert No.: SA-009/23
	Last Issued : 08/15/2023

2019-2024 Mazda3
2020-2024 CX-30
2021-2024 CX-5
2021-2023 CX-9
2022-2023 MX-30
2023-2024 CX-50
2024 CX-90

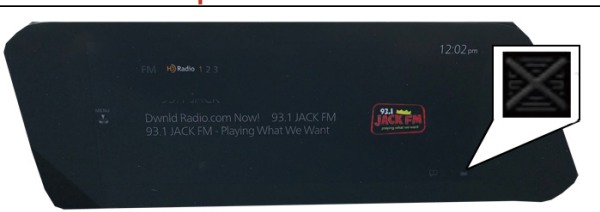
<p>Infotainment Center Display</p>	<ul style="list-style-type: none"> • TCU in Deactivation Mode • One Time Passcode (OTP) is processing 	<p style="text-align: center;">Reception Icon Shows "X"</p>

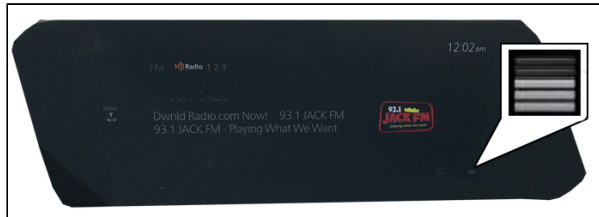
3. Go to [eMDCS Vehicle Inquiry](#) and confirm CSP04 is not shown.
4. Confirm the customer's phone and vehicle have good to strong reception during the concern as shown in the table below.

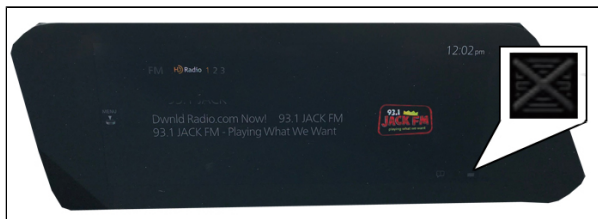
- If the reception icon shows "X", the vehicle is possibly in Deactivation Mode.

- Customer/Dealer can activate CV services anytime via MyMazda app
 - Customer - There might be a slight delay in making the backend connection since it was temporarily deactivated.
 - Dealer - Go to [TCU Activation](#)
- If the reception is weak, move the vehicle to a location where the reception is good to strong as shown in the table, then try to get the Authorization Code and/or operate the remote functions before proceeding to the Repair Procedure if there is still an issue.
- If the reception is good to strong, proceed to Connected Vehicle Troubleshooting below.

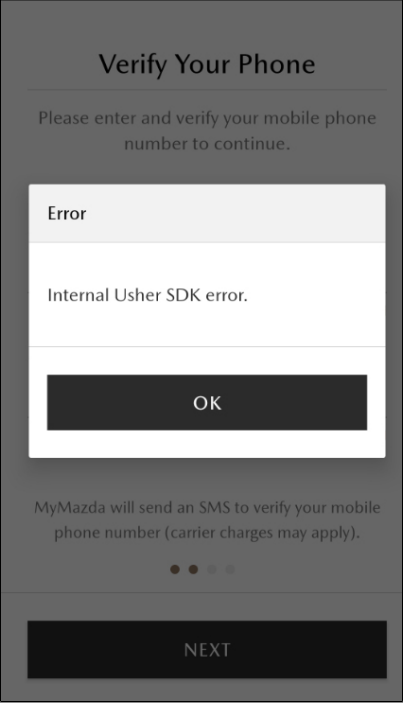
Connected Vehicle Troubleshooting		
Symptom	Cause	Action
<p>The customer is not able to create a MyMazda account. The customer receives the following error:</p> <p>MyMazda App - Internal Usher SDK error.</p>

<p>MyMazda Website - ERROR! Unable to send one-time password.</p>	<p>Customer inadvertently texted "Stop" to 1-949 518-0058 (Twilio SMS for Mazda)</p>	<ol style="list-style-type: none"> Text "Start" to 1-949 518-0058 (Twilio SMS for Mazda) Retry to create a MyMazda account. <p>NOTE: USA and Canada only</p>

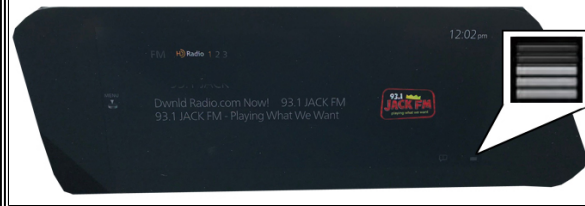
- Reception strength icon shows normal strength. The TCU is active and ready for enrollment. Go to [Enrollment](#).

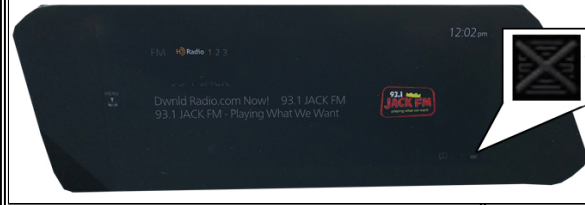
- Reception strength icon shows "X". The TCU is deactivated. Enrollment is not possible. Go to [TCU Activation](#).

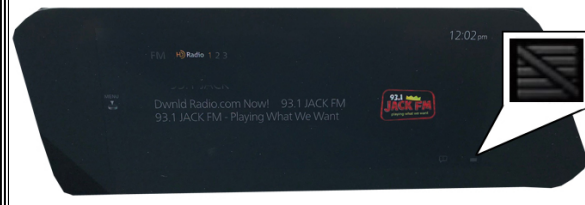
- Reception strength icon shows "\". Move the vehicle to an area with a clear view of the sky.

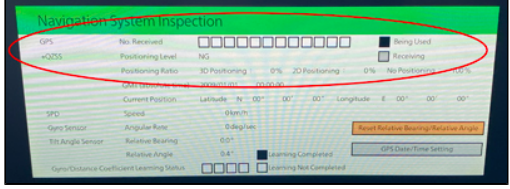
<p>No Good - Swap Tel antenna No. 1 with known good vehicle</p>
