Service Alert

Subject: CONNECTED VEHICLE SYMPTOM TROUBLESHOOTING	Service Alert No.: SA-009/23
	Last Issued : 08/28/2023

2019-2024 Mazda3
2020-2024 CX-30
2021-2024 CX-5
2021-2023 CX-9
2022-2023 MX-30
2023-2024 CX-50
2024 CX-90

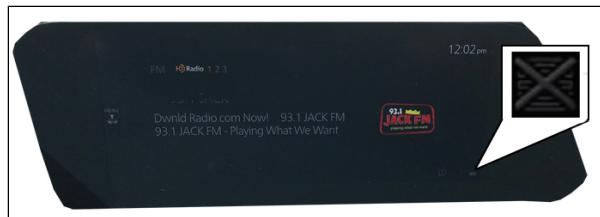
- If the reception icon shows "X", the TCU is deactivated. Enrollment is not possible. Go to [TCU Activation](#).

- Customer/Dealer can activate CV services anytime via MyMazda app
 - Customer - There might be a slight delay in making the backend connection since it was temporarily deactivated.
 - Dealer - Go to [TCU Activation](#)

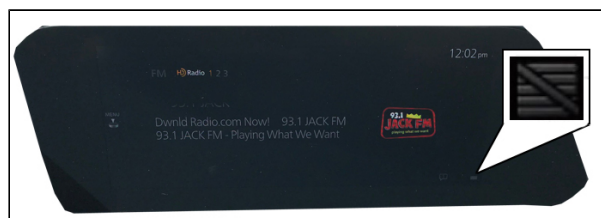
- If the reception icon shows "\", move the vehicle to an area with a clear view of the sky.

- If the reception is weak, move the vehicle to a location where the reception is good to strong as shown in the table, then try to get the Authorization Code and/or operate the remote functions before proceeding to the Repair Procedure if there is still an issue.
- If the reception is good to strong, proceed to Connected Vehicle Troubleshooting below.

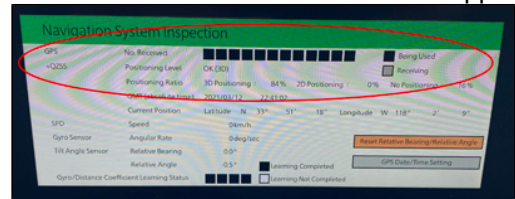
Good - Contact Hotline for technical support

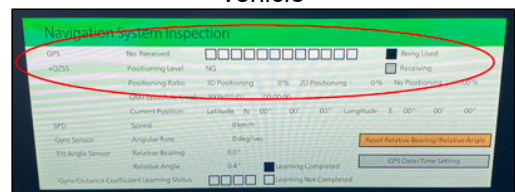
No Good - Swap Tel antenna No. 1 with known good vehicle

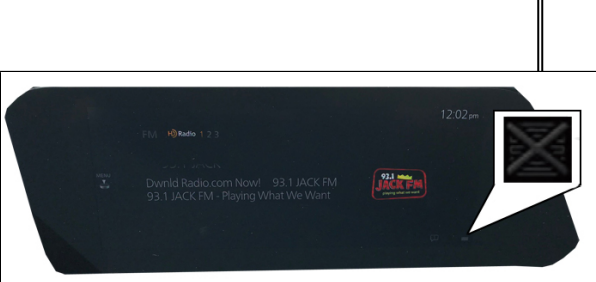
<ul style="list-style-type: none"> Reception strength icon shows "X". TCU activation is still processing. Repeat steps 16-18. <p>Note:</p> <ul style="list-style-type: none"> This step may need to be repeated a few times until normal strength is shown. If steps 16-18 was repeated several times with no change, disconnect 12V battery for 1 hour, then recheck reception strength icon.
