Volvo Car USA LLC

Technical Journal

Technical Journal Title White patch defect in paint when removed rapgard		Ref. No. TJ 36277.1.0	
Issuer (Dept.) Technical Service		Issue Date 6/14/23	Status Date 6/20/23
Car Market United States and Canada	Partner 3 US 7510 Volvo Car USA	Function Group 8000	
Function Description Body, cab and interior		Page Page 1 of 3

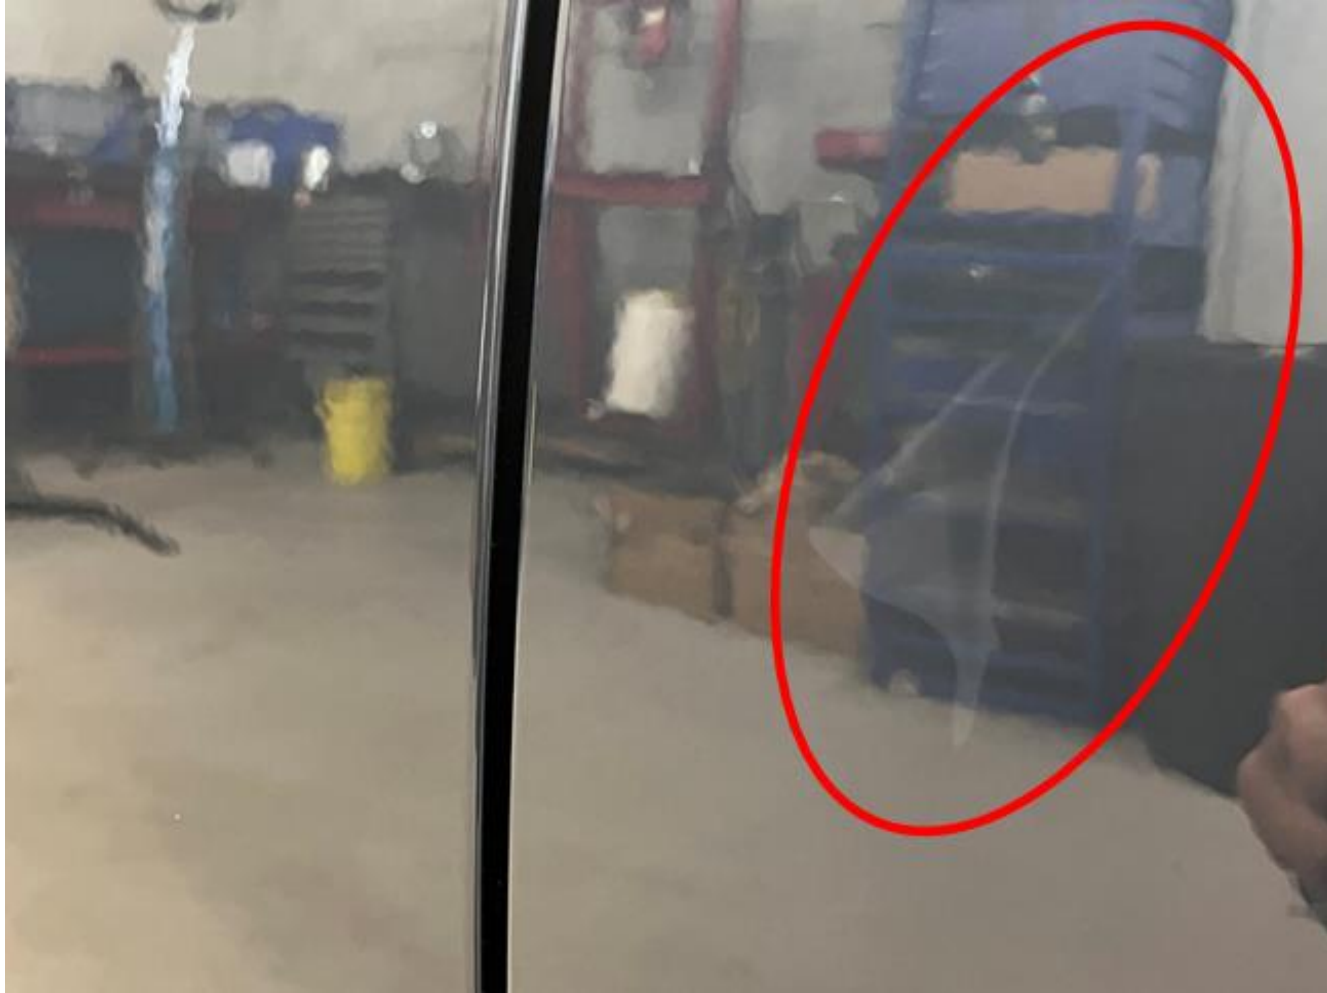
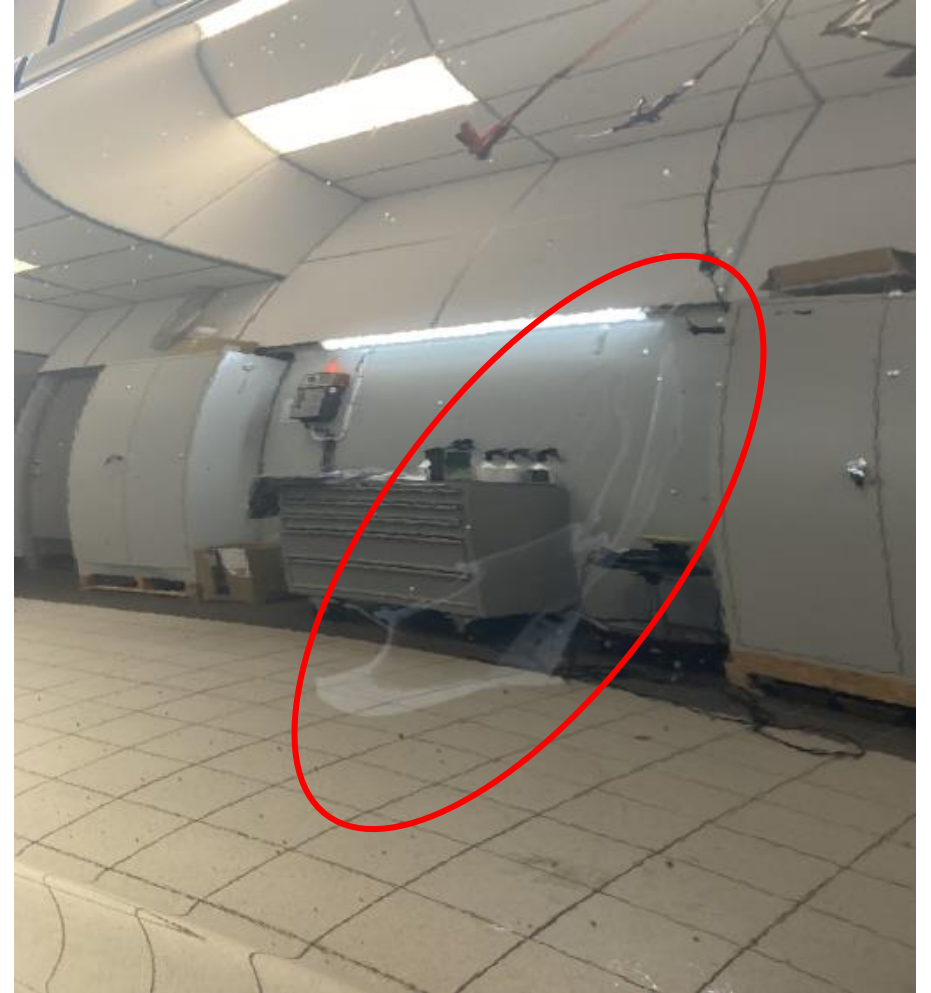
TJ-36277

If experiencing milky stripes/white patch defects in the paint when the rapgard is removed, please see advice under "Service". For example pictures of the defect, see attachment.

If milky stripes/white patch defects occur when the rapgard is removed, do NOT polish, wax or repaint the area. The defect can be removed by exposure to outside daylight for 48hrs. Or an IR-radiator can be used, carefully heat up the area with a temperature of 50-70°C for 30 minutes. Note! The temperature of paintwork must not exceed 100 °C.

To prevent these defects from occurring, please follow the instruction of how to remove the rapgard in a correct way. Instruction to be found in VIDA with below address:
