## FRONT CAP BADGE REPAIR

<b>Bulletin Type:</b>	TSB	<b>Publication Date:</b>	August 2023
<b>Bulletin #(s):</b>	23-113	<b>Make(s):</b>	Jayco
<b>Job Code(s):</b>	9801589	<b>Model(s):</b>	Eagle FW, Eagle HT FW
<b>Flat Rate(s):</b>	9801589A .10 HR Inspection of Front Cap Badge 9801589B 1.0 HR – Front Cap Badge Inspection and Repair	<b>Model Year(s):</b>	2024

<b>Incident:</b>	Debris/dirt behind front cap badge
<b>Affected Units:</b>	2024 Jayco Eagle FW, Eagle HT FW
<b>Parts Kit:</b>	Parts Kit #: 23-113JT
	8 Ft - SEAL,WDO .63X.38 RIB W/ADH BK 1 Tube - SEALANT,GEOCEL CLR 2300 VBS 10Pcs - NUT,HEX LK NYL ZINC 8-32 20 Pcs - WASHER,NEOBOND GALV #14X1.00
<b>Misc. Tools &amp; Supplies:</b>	Screwgun #2 sq bit 9mm socket 3/32" drill bit Torque wrench
<b>Parts Return Information:</b>	N/A

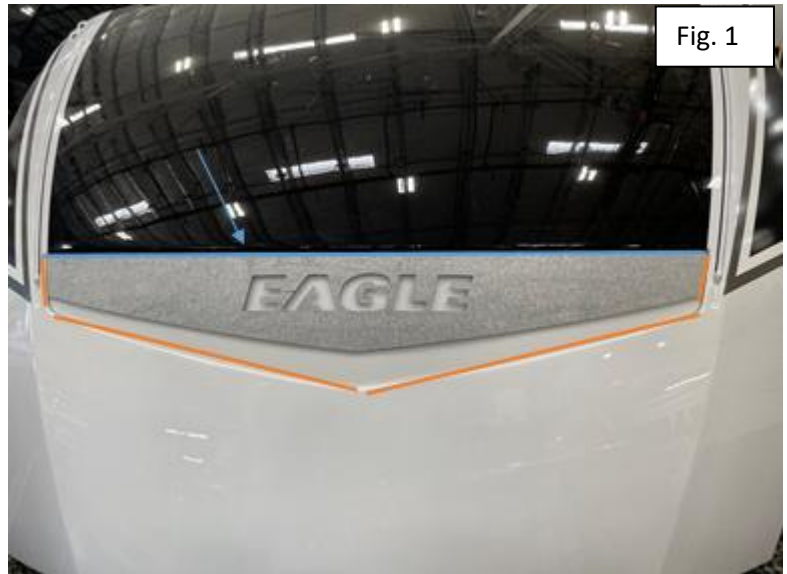
Fig. 1

1. Ensure Foam strip or seal is present around perimeter of the badge. If foam is present it will only be at the top of the badge, but cap seal is adequate as well. Marked in blue is foam or cap seal and marked in orange should be cap seal. (Figure 1)
  - a. Note: If dirt/debris is present, proceed to the instructions below.
