HYUNDAI Technical Service Bulletin	GROUP AUTOMATIC TRANSMISSION	NUMBER 23-AT-006H-1
	DATE AUGUST 2023	MODEL PALISADE (LX2) SANTA FE (TMA) SANTA FE HYBRID (TM/TMa HEV) SONATA (DN8A) SONATA HYBRID (DN8 HEV) TUCSON (NX4/NX4A) TUCSON HYBRID (NX4 HEV)
SUBJECT: AUTOMATIC TRANSAXLE PUSH-BUTTON SHIFTER DIAGNOSIS

This TSB supersedes TSB 23-AT-006H to add an additional applicable model, an additional diagnostic trouble code (DTC) P0706, and modify the service procedure on step 6.**

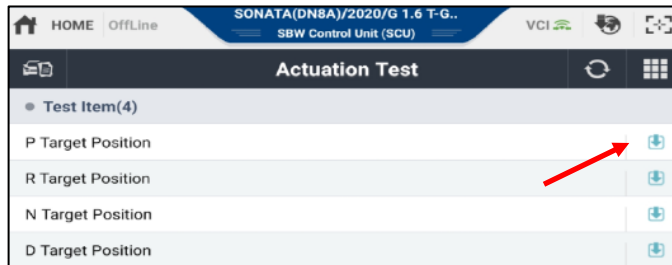
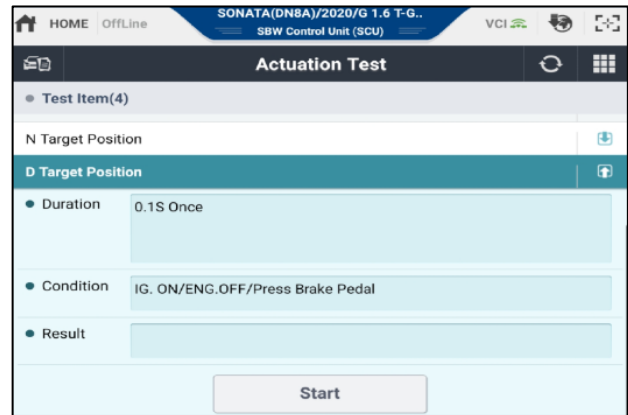
5. Turn the engine off and push the SSB 2 times to turn the ignition **ON**. Press the brake pedal. From the GDS home screen, select **Actuation Test** and **SCU** menu. Test the Target position for P, R, N and D. Press the arrow to change the selection. If the GDS and cluster show:
- Correct **Target Position** for P, R, N and D: The SCU sent electrical current to the SBW actuator, the SCU and SBW actuator are currently operating correctly and the related harness currently does not have an open/short circuit. Go to Step 6.
 - Does not show the correct **Target Position** for P, R, N and D: The SCU, SBW actuator or related harness may have a fault.

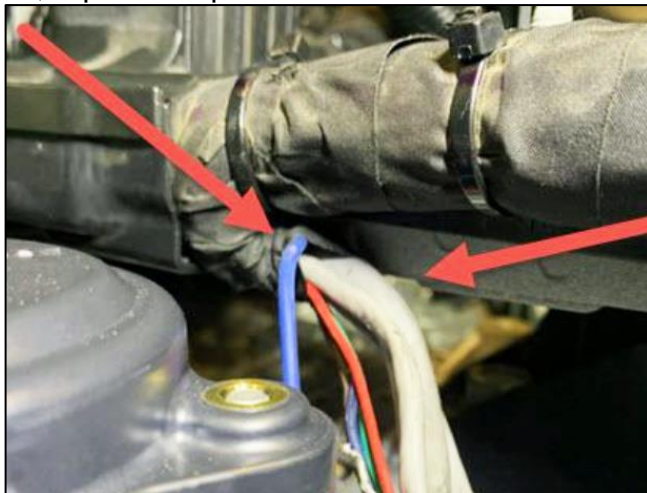
Santa Fe (TMa) 2.5L – (VINs begin with 5NM)

Carefully unwrap the harness protector in the area shown below. Check the insulation on the wires to see if the insulation has been damaged by contact with the battery tray. If so, repair or replace the control harness.

If replacing the control harness, make sure the replacement harness does not contact the battery tray/other components. Otherwise, the harness may become damaged again.

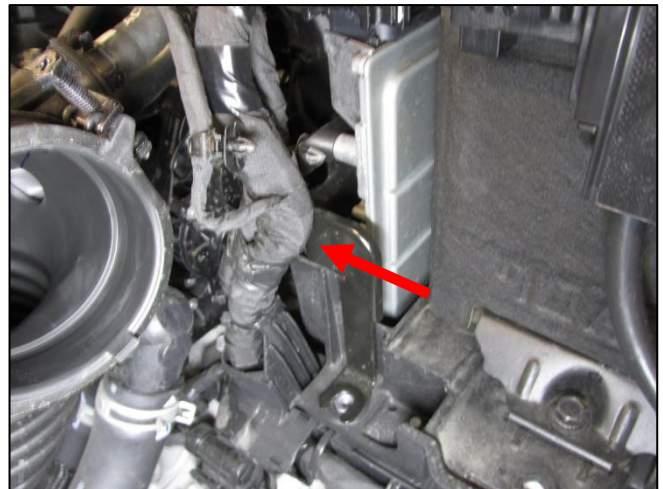
Tucson (NX4) 2.5L – (VINs begin with KM8)

Carefully unwrap the harness protector in the area shown below. Check if the insulation has been damaged by contact with the metal bracket. If so, repair or replace the control harness.

Damage to the wiring harness may still be present, even if there is no external damage to the harness protector. Even slight damage to the wiring harness can cause these faults.
