SERVICE BULLETIN

APPLICABILITY: 2019-22MY Ascent

NUMBER: 07-219-23R

SUBJECT: Genuine Alternative Battery Replacement

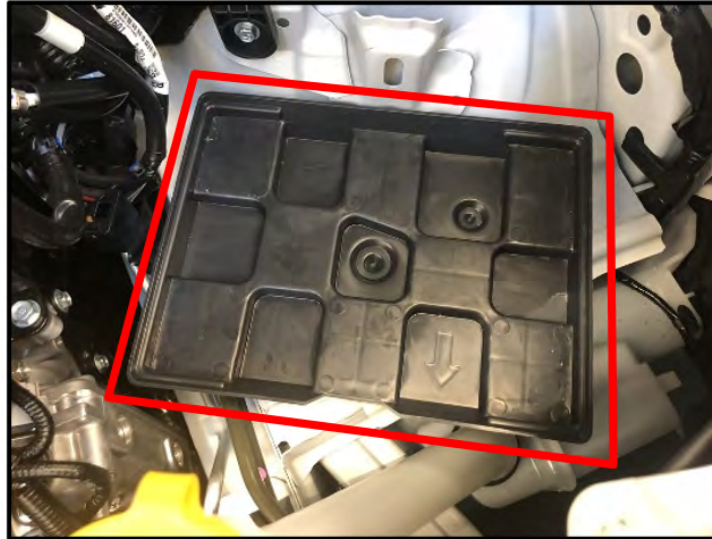
STEP 3: Replace the battery tray with the new part (p.n. 82190AN000).

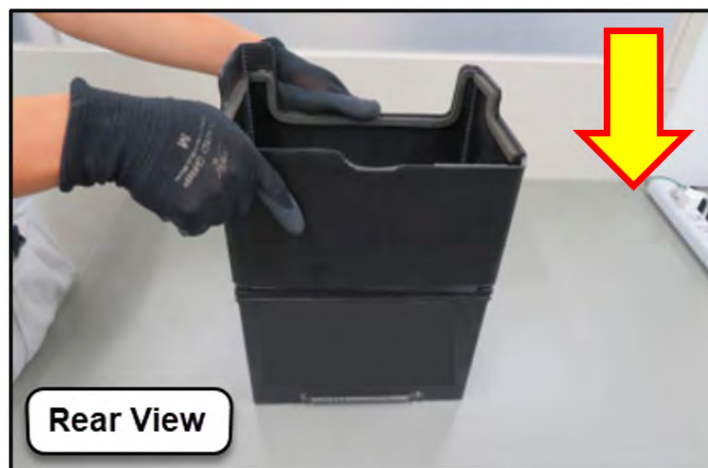
STEP 4: Install the replacement battery cover (p.n. 82123AN000) to the alternative replacement battery. Confirm the bottom of the cover is aligned flush with the bottom of the battery. **DO NOT** discard, this must be returned to the customer.

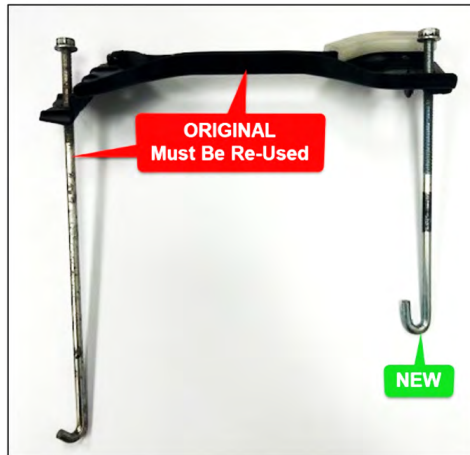
STEP 5: Assemble the **ORIGINAL** battery holder, **NEW** rear holding rod (p.n. 82161SJ000), and the ORIGINAL front holding rod as shown below. The original rod nut can be transferred to the new rear holding rod.

NOTE: DO NOT discard the original rear rod. This part is to be returned to be returned to the customer.

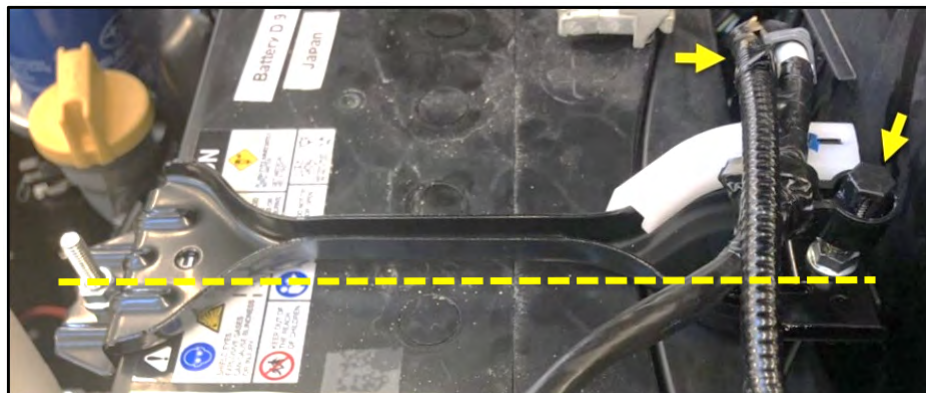
NOTE: Confirm the battery holder is center mounted with the battery cables secured and routed correctly.

STEP 7: Install the battery holder and holding rods on to the battery.

- A. Torque the two holding rod mounting nuts to **3.5 N·m (2.6ft-lbs. or 31inch-lbs.)**.
- B. Torque the positive terminal to **6 N·m (4.4ft-lbs. or 53inch-lbs.)**.
- C. Torque the negative terminal to **7.5Nm (5.5ft.-lbs. or 66inch-lbs.)**.
- D. If the battery sensor is removed or disconnected torque to 7.5Nm (5.5ft.-lbs. or 66inch-lbs.) while supporting the sensor with the other hand as outlined in the applicable Service Manual under: STARTING/CHARGING SYSTSEMS > Battery Sensor.
