PRODUCT CAMPAIGN BULLETIN

APPLICABILITY: 2024 MY Impreza and Crosstrek

NUMBER: WRL-23

SUBJECT: Safety Recall – Instrument Panel Harness Clearance

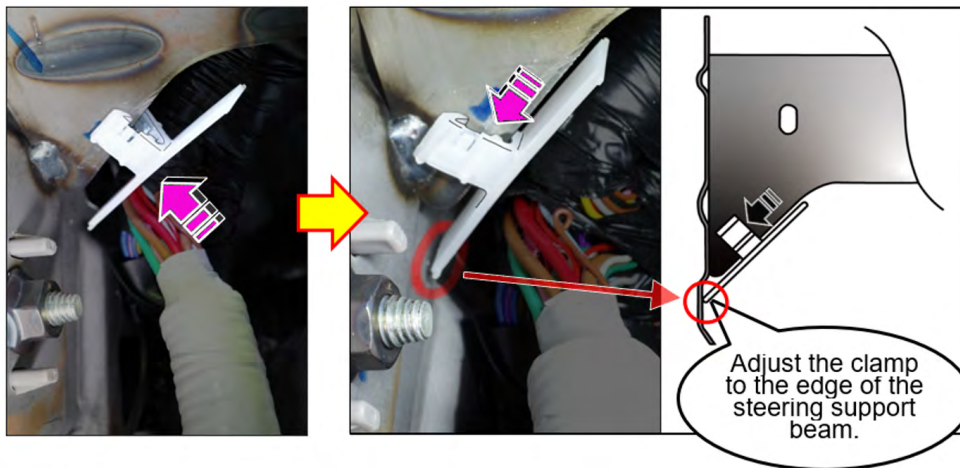
The affected vehicles have insufficient clearance around the instrument panel harness which may allow the harness to contact the steering beam bracket. If the harness contacts the bracket, the wire insulation could be damaged and/or a wire could short circuit.

STEP 15: Install the new clamp (p.n. 81904FN030) onto the edge of the steering support beam.
