SERVICE BULLETIN

APPLICABILITY: 2020-23MY Outback & Legacy With 2.4L DIT
2019-23MY Ascent

NUMBER: 09-106-23R

SUBJECT: Exhaust Pipe Front (EPF) Design Change

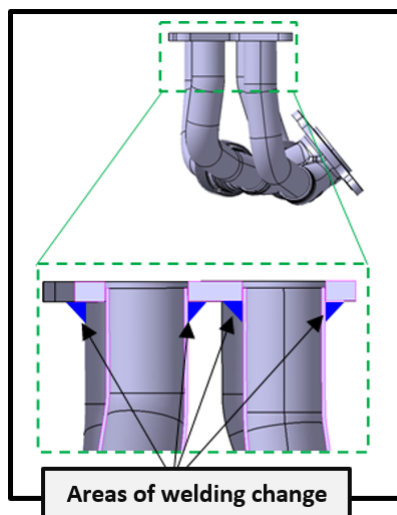
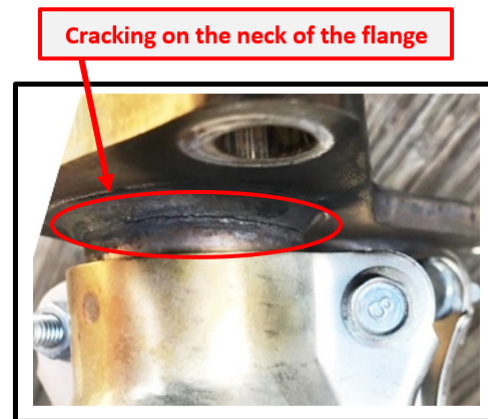
DESCRIPTION OF DESIGN CHANGE:

This bulletin announces design changes made to the Exhaust Pipe Front (EPF) to address concerns of rattle-type or fluttering sounds coming from the undercarriage during acceleration caused by cracking in the EPF. A welding material with enhanced durability has been incorporated into the production of the EPF. If the condition described is confirmed, the EPF should be inspected and if determined necessary, replaced.
