## SERVICE BULLETIN

**APPLICABILITY:** 2017-23MY Impreza  
 2018-23MY Crosstrek  
 2019-23MY Forester  
 2022MY WRX

**NUMBER:** 07-221-23  
**DATE:** 08/31/23

**SUBJECT:** Instrument Panel Wiring Harness & Rear Wiring Harness – Connector Corrosion

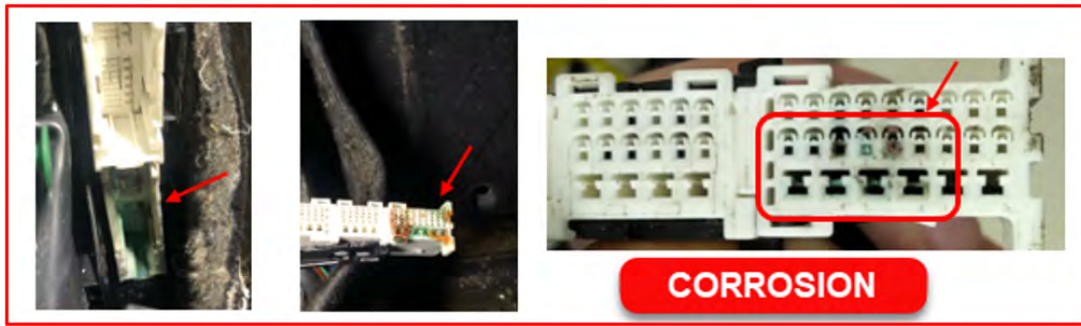
## EXAMPLES OF CORROSION:

This bulletin announces the repair procedures when corrosion is encountered within the instrument panel wiring harness and the rear wiring harness connectors. The corrosion is typically found in the footwell area as a result from moisture such as rain, snow, ice, and salt water being brought in from driver and/or passenger footwear. Corrosion in this area can cause multiple electrical malfunctions such as warning indicators and/or incorrect door position detection. If corrosion is found within this area(s), replace the affected wiring harness and perform the added procedure detailed below using the new repair kit. The purpose of the repair kit is to isolate the connections from any moisture damage.

There have been no changes to the wiring harnesses. The new repair kit and outlined procedures **MUST** be applied when replacing the affected harnesses for corrosion intrusion.
