SERVICE INFORMATION BULLETIN

NUMBER: 15-282-21R

SUBJECT: STARLINK Remote Engine Start (RES)

Diagnostic Information

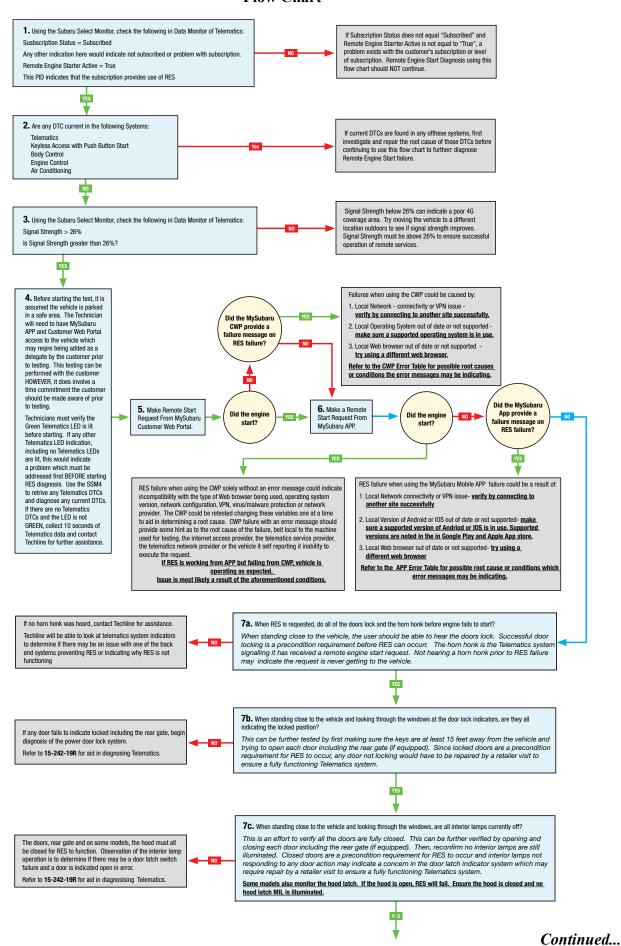
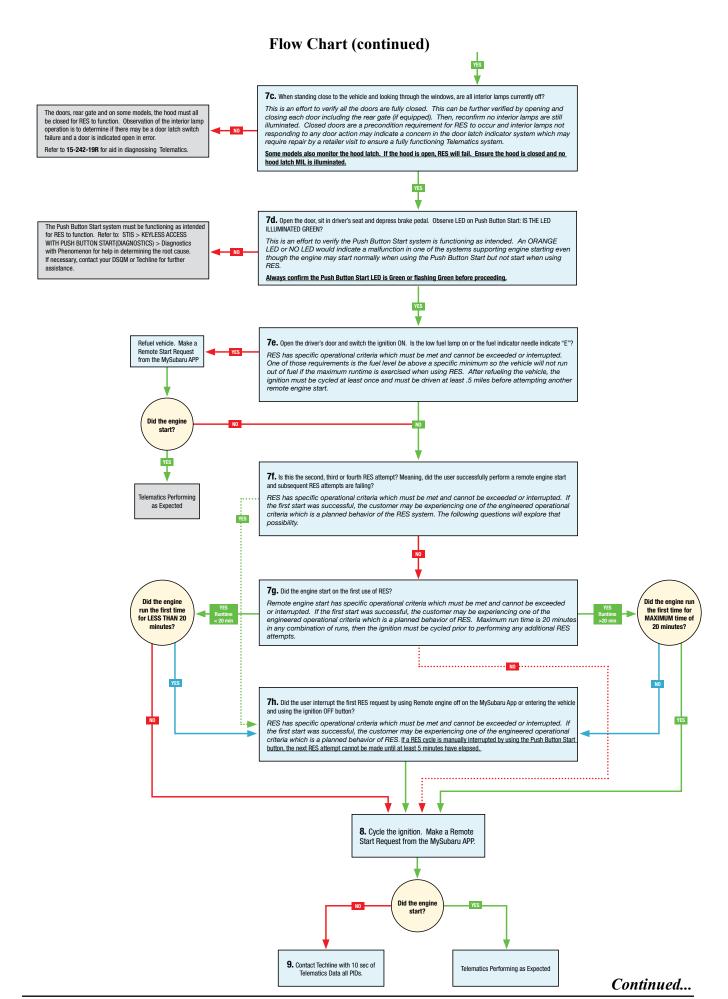
Flow Chart

This Service Information Bulletin announces additional diagnostic procedures and a detailed flow chart to be used when diagnosing customer concerns regarding the operation of the STARLINK Remote Engine Start (RES) feature.
