Technical product information

Bentayga Series and New Flying Spur

Touch Screen Remote (TSR) has no visible display or does not function

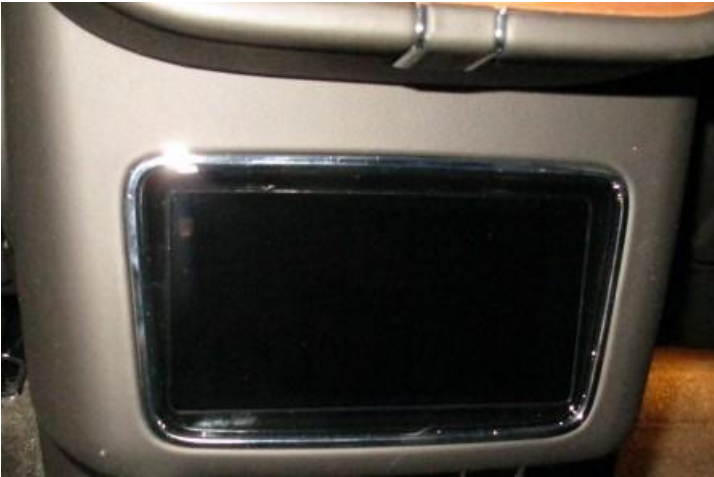
The Touch Screen Remote (TSR) has no visible display or does not function, see the example shown in Figure 1

The issue described can be evident regardless if the TSR is located in the cradle or not
