Service Bulletin

Bulletin No.: 20-NA-136

Subject: Diagnostic Tips for DTCs Set at a Low Mileage for 9T65 Transmissions

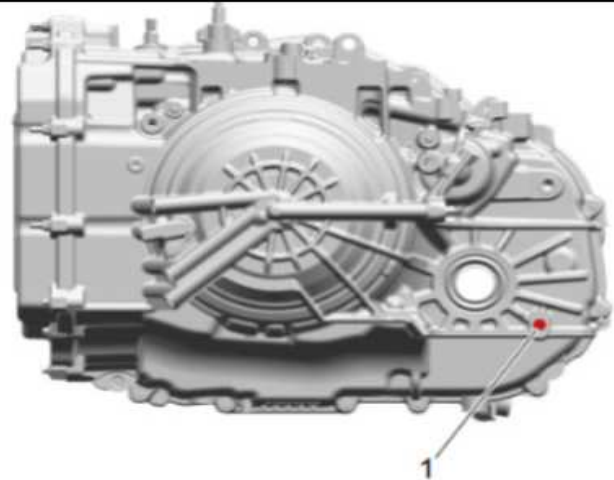
5619626

6. While the vehicle is idling, remove the oil level set plug (1). Allow any fluid to drain:
 - If the fluid is flowing as a steady stream, wait until the fluid begins to drip.
 - If no fluid comes out, add fluid until fluid drips out.
7. Record fluid level; overfilled, under-filled, correct on repair order and how much was needed to fill or came out:
 - If fluid is overfilled, set correct level and retest.
 - If fluid is under-filled, inspect for external leaks. Refer to *Fluid Leak Diagnosis*.
8. If fluid level is correct, then check condition of the fluid.
