# Service Bulletin

Bulletin No.: 23-NA-058

**Subject:** Cold Start Rattle Noise from the Engine Compartment, Malfunction Indicator Lamp (MIL) Illuminated - DTC P0299 Set

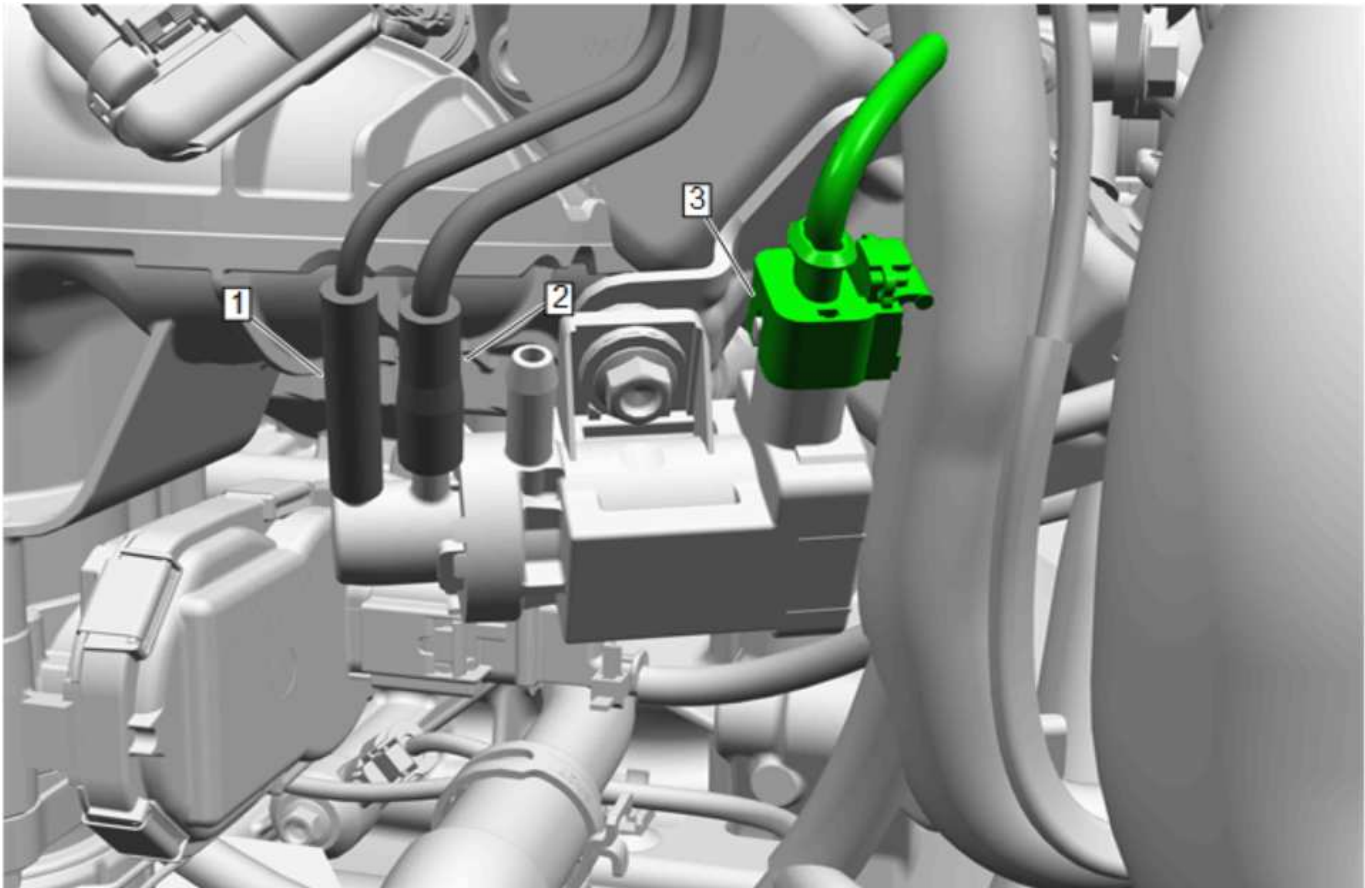
5392518

1. Disconnect the Turbocharger Wastegate Actuator Vacuum Control Solenoid Valve Hose (1) from the Turbocharger Wastegate Regulator Solenoid Valve.
  2. Utilizing EN-23738-A Vacuum Pump with an integral vacuum gauge, connect said pump to the Turbocharger Wastegate Actuator Vacuum Control Solenoid Valve Hose.

3. Engine at operating temperature at idle.
  4. Verify the tool reading: EN-23738-A Vacuum Pump =  $-50$  kPa ( $-0.5$  bar, 15 in Hg).
    - If the desired pressure/vacuum cannot be achieved or does not hold steady:

- ⇒ Ignition/Vehicle » Off.
- ⇒ Test or replace the component: Vacuum Pump Assembly and related hoses.
- If the desired pressure/vacuum can be achieved and holds steady:

- Engine » Off.
    - Reconnect the Turbocharger Wastegate Actuator Vacuum Control Solenoid Valve Hose to the Turbocharger Wastegate Regulator Solenoid Valve and refer to Check Wastegate Vacuum Regulator Valve Function.

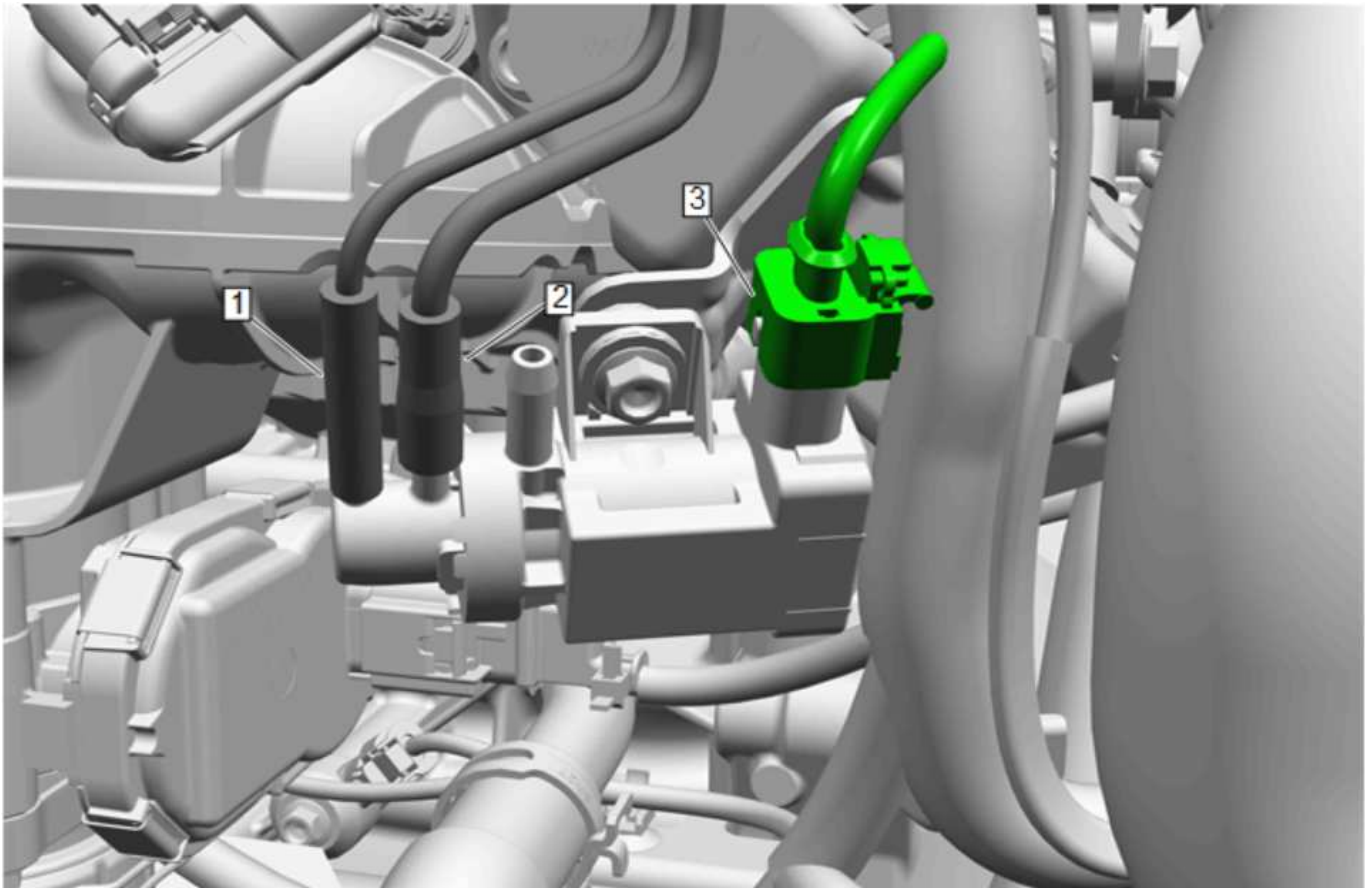
5392518

1. Disconnect the Turbocharger Wastegate Actuator Vacuum Tank Solenoid Valve Tub (2) from the Turbocharger Wastegate Regulator Solenoid Valve.
  2. Connect the EN-23738-A Vacuum Pump to the Turbocharger Wastegate Solenoid Valve Actuator supply port.

3. Engine at operating temperature at idle.
  4. Verify the tool reading: EN-23738-A Vacuum Pump = Less than  $-17$  kPa ( $-0.17$  bar, 5 in Hg).
    - If  $-17$  kPa ( $-0.17$  bar, 5 in Hg) or greater.

- If less than  $-17$  kPa ( $-0.17$  bar, 5 in Hg).
- ⇒ Engine Speed Greater than 5000 RPM — For 2 s.
- ⇒ Verify the tool reading: EN-23738-A Vacuum Pump = Greater than  $-50$  kPa ( $-0.5$  bar, 15 in Hg).

- If Greater than  $-50$  kPa ( $-0.5$  bar, 15 in Hg). The Turbocharger Wastegate Regulator Solenoid Valve has been validated to be functioning correctly and proceed to Turbocharger Inspection.

- ⇒ Test or replace the component: Turbocharger Wastegate Regulator Solenoid Valve. Refer to *Turbocharger Wastegate Regulator Solenoid Valve Removal* in the Service Manual and *Turbocharger Wastegate Regulator Solenoid Valve Installation* in the Service Manual.

- If less than  $-50$  kPa ( $-0.5$  bar, 15 in Hg).
- ⇒ Test or replace the component: Turbocharger Wastegate Regulator Solenoid Valve. Refer to *Turbocharger Wastegate Regulator Solenoid Valve*

*Removal* in the Service Manual and *Turbocharger Wastegate Regulator Solenoid Valve Installation* in the Service Manual.
