GROUP	NUMBER			
EV SYSTEMS	23-EV-006H			
DATE	MODEL(S)			
AUGUST 2023	IONIQ 5 (NE1) IONIQ 6 (CE1)

SUBJECT: INSPECTION/REPLACEMENT OF EV CHARGING PORT INSULATION CAP

Description: This bulletin provides service information on how to inspect the charging port and if needed, replace any missing/damaged insulation cap(s) at the charging port on certain 2022-2023MY loniq 5 (NE1) and 2023MY (CE1). The charging insulation caps are important to ensure proper charger connector orientation and fit to the vehicle charge port.

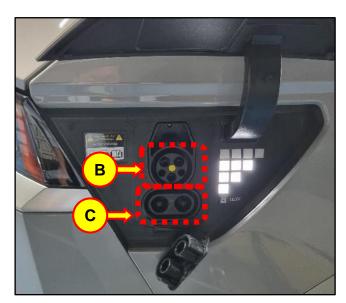
2. Charging Port Inspection for abnormal condition:

- AC charging terminals (B)
- Quick (DC) charging terminal (C).
- a) Check for any missing, damaged or significantly deteriorated insulation caps.
- b) Check for any foreign matter found inside the port.

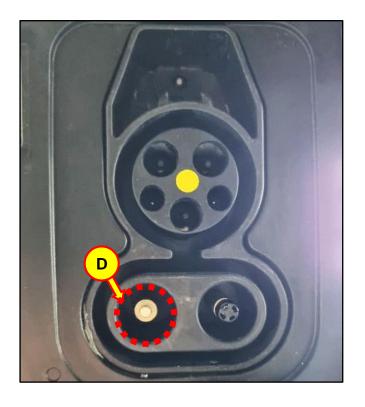
The photo shown at right is an example is of a DC charging insulation cap missing/removed at the left terminal (D).

Remove the insulation cap if it is damaged, and/or significantly deterioriated.

Use needle nose pliers and gently grab and pull up the cap.

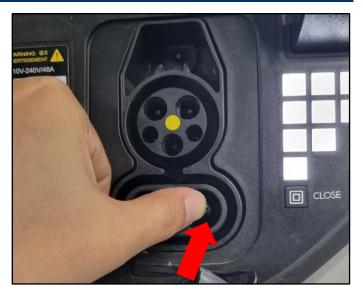
In example at right, insulation cap is in temporarily mounted position.

5. Temporarily mount the replacement insulation cap (E) on the DC terminal by pressing in firmly by hand.
