Technical Service Bulletin

GROUP AUTOMATIC TRANSMISSION	NUMBER 23-AT-013H
DATE AUGUST 2023	MODEL(S) VELOSTER N (JSN) KONA N (OSN) ELANTRA N (CN7N)

SUBJECT: 8-SPEED WET DCT TCU UPGRADE – TOUCH POINT LEARNING IMPROVEMENT FOR 2.0T VEHICLES

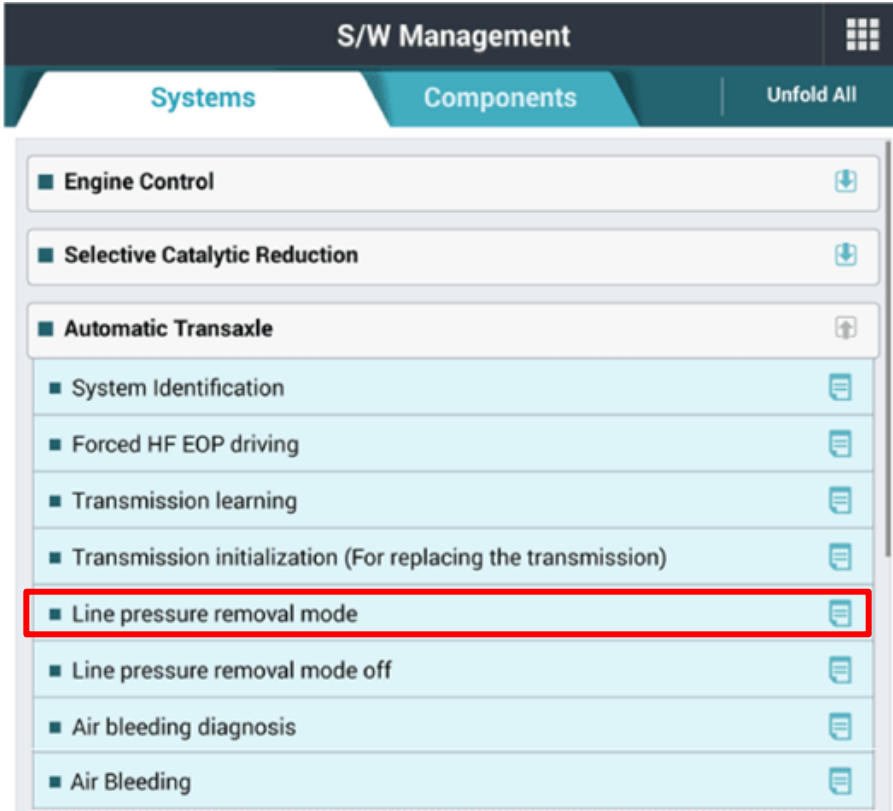
If the “Line pressure removal mode” is not performed, drivability concerns and warning lights/DTCs can occur (P193B79, P0868, rattling/shift shock, unable to drive forward/reverse).

1. Prior to replacing a DCT/TCU, it is necessary to perform the “Line Pressure Removal” mode in GDS.

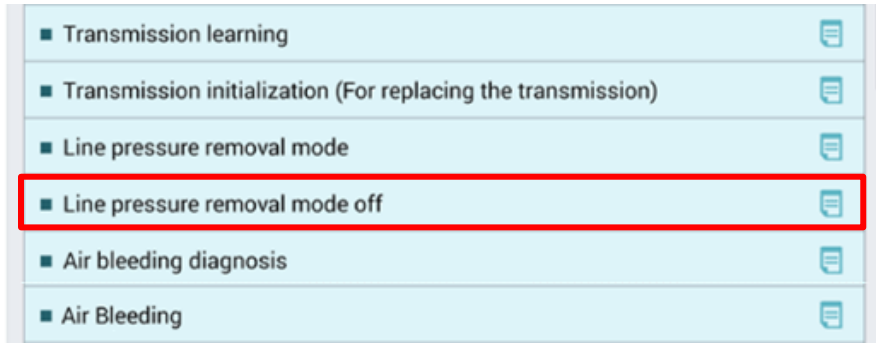
If the “Line pressure removal mode off” is not performed, drivability concerns can occur (shift shock).

2. After performing “Line pressure removal mode,” leave IG on and wait for 1 minute.
3. Turn the **engine on** and let the engine idle for **1 minute**.
4. Turn the engine **off**. After 3 seconds, turn the **engine on again**.
5. With the engine running, scan the vehicle for DTCs.
 - 5a. If DTC P086800 **is detected** – check and replace the control fluid according to the shop manual.
 - 5b. If DTC P086800 **is not detected** – proceed to the next step.
6. Perform the “Line pressure removal mode off” within the GDS.
