HYUNDAI
Technical Service Bulletin

GROUP AUTOMATIC TRANSMISSION	NUMBER 23-AT-012H
DATE AUGUST 2023	MODEL(S) SANTA FE (TMa) SONATA (DN8a) SANTA CRUZ (NXT)

SUBJECT: 8-SPEED WET DCT TCU UPGRADE – TOUCH POINT LEARNING IMPROVEMENT FOR 2.5T VEHICLES

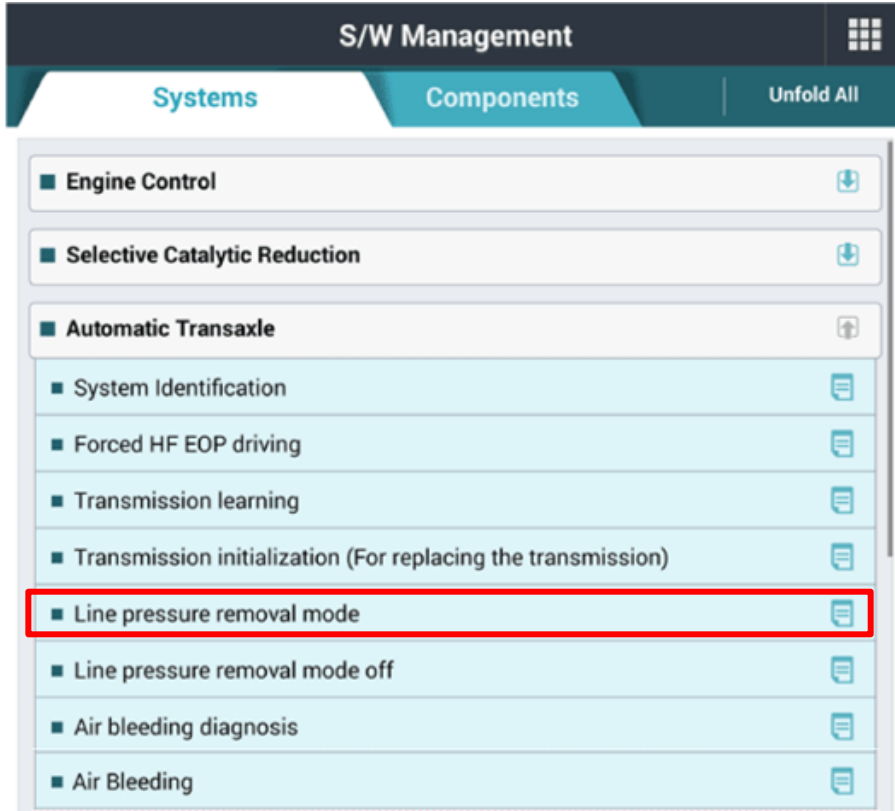
1. Prior to replacing a DCT/TCU, it is necessary to perform the “Line Pressure Removal” mode in GDS.

If the “Line pressure removal mode” is not performed, drivability concerns and warning lights/DTCs can occur (P193B79, P0868, rattling/shift shock, unable to drive forward/reverse).

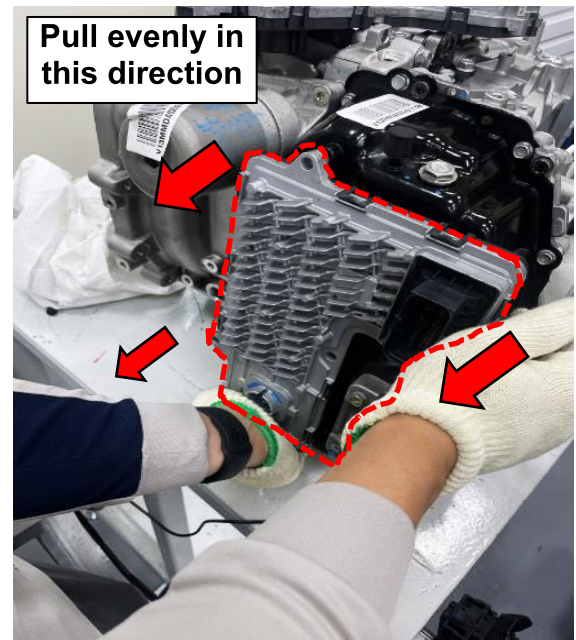
Make sure the TCU 24-pin terminal is aligned properly during removal/installation, otherwise the pins may get damaged.

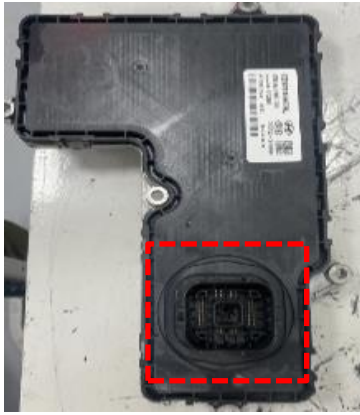
Male terminal of TCU

2. When reinstalling the TCU, make sure to align the connector on the TCU to the E-module on the DCT.

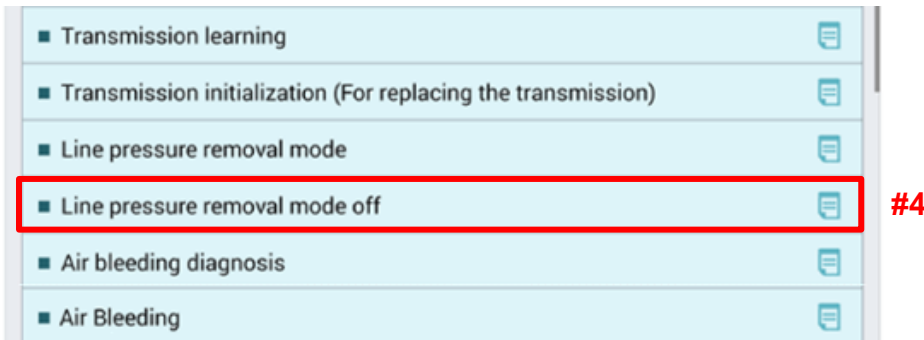
6. Perform the “Line pressure removal mode off” within the GDS.

If the “Line pressure removal mode off” is not performed, drivability concerns can occur (shift shock).
