# Technical Service Bulletin

SUBJECT:			No: <b>TSB-22-16-001REV</b>
<b>MIL ILLUMINATION WITH DTC P030X AND LOSS OF POWER DUE TO FAIL SAFE MODE - REVISED</b>			DATE: <b>August 2023</b>
			MODEL: <b>See Below</b>
<b>CIRCULATE TO:</b>	<input type="checkbox"/> GENERAL MANAGER	<input checked="" type="checkbox"/> PARTS MANAGER	<input checked="" type="checkbox"/> TECHNICIAN
<input checked="" type="checkbox"/> SERVICE ADVISOR	<input checked="" type="checkbox"/> SERVICE MANAGER	<input checked="" type="checkbox"/> WARRANTY PROCESSOR	<input type="checkbox"/> SALES MANAGER

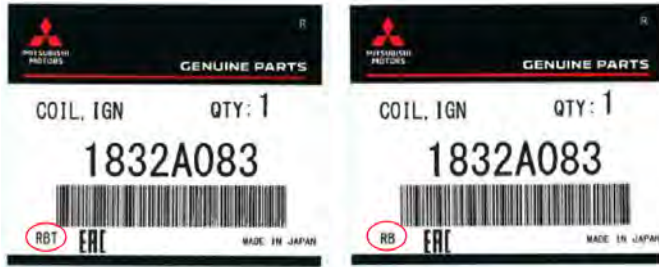
1. The genuine part label for the countermeasure parts will have a total of 3 digits and the third one will be a "T".
2. Please note that the countermeasure parts will have the "T" until March 2022.
3. After April 2022, the countermeasure parts will no longer have the "T" on the genuine part label and will return to 2 digits.

Countermeasure Part

Old Part

Upon customer complaint basis and after diagnosis, **please replace the ignition coils of ALL cylinders with countermeasure parts**. Please follow the procedure below to identify the countermeasure parts.
