Technical Service Bulletin

CHANGE TO SPLASH SHIELD REMOVAL/INSTALLATION – SERVICE MANUAL REVISION

No: TSB-23-42A-003

MODEL: Outlander Sport

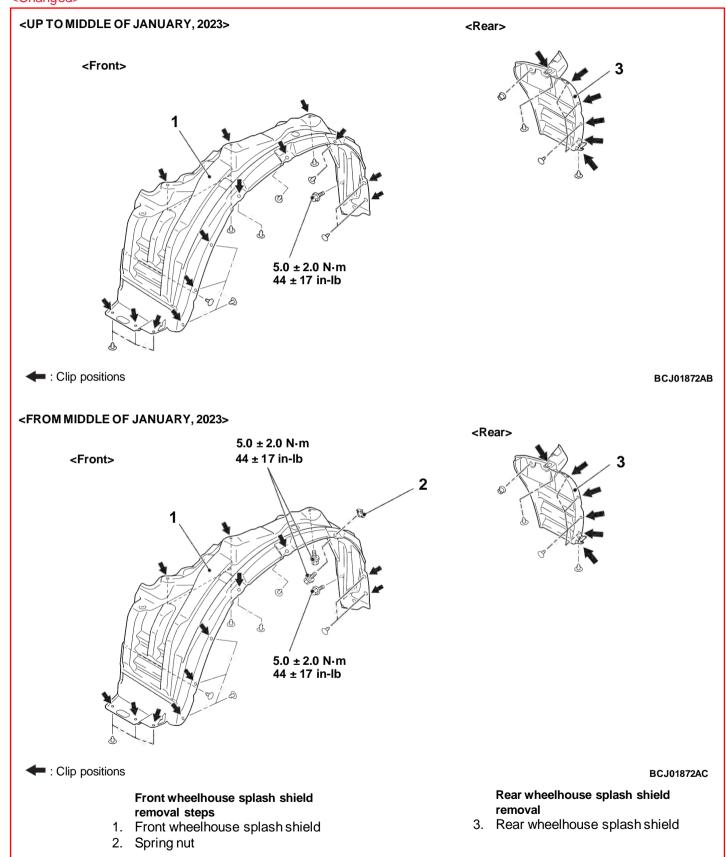
<Changed> M14210097A0056

This TSB provides a change to the number of clips (reduced from 14 to 12) for the Splash Shield Removal and Installation section of the applicable Service Manual.

Previous		New
Application timing of production	Up to early January 2023		From Middle January 2023
Repair method (for Left/Right side)	Clip x 14pcs, Bolt (& Weld nut) x 1pc	\rightarrow	Clip x 12pcs, Bolt (& Weld nut) x 2pcs, Spring nut & Bolt x 1pc

Please use the following chart as a guide to replace the indicated page in the affected Service Manual, Group 42, Body, Splash Shield.
