Subject: REVISION: N222375790-07 - Customer Satisfaction Program
Park Assist Retrofit
Warranty Information Table Improvements

Models: 2022 – 2023 Buick Envision
2022 – 2023 Cadillac CT4
2022 – 2023 Cadillac CT5
2022 Cadillac Escalade/Escalade ESV
2022 – 2023 Chevrolet Corvette
2022 Chevrolet Silverado 1500 New
2022 Chevrolet Suburban
2022 Chevrolet Tahoe
2022 GMC Sierra 1500 New
2022 GMC Yukon/Yukon XL

N222375790 Park Assist Retrofit

Revision: 07

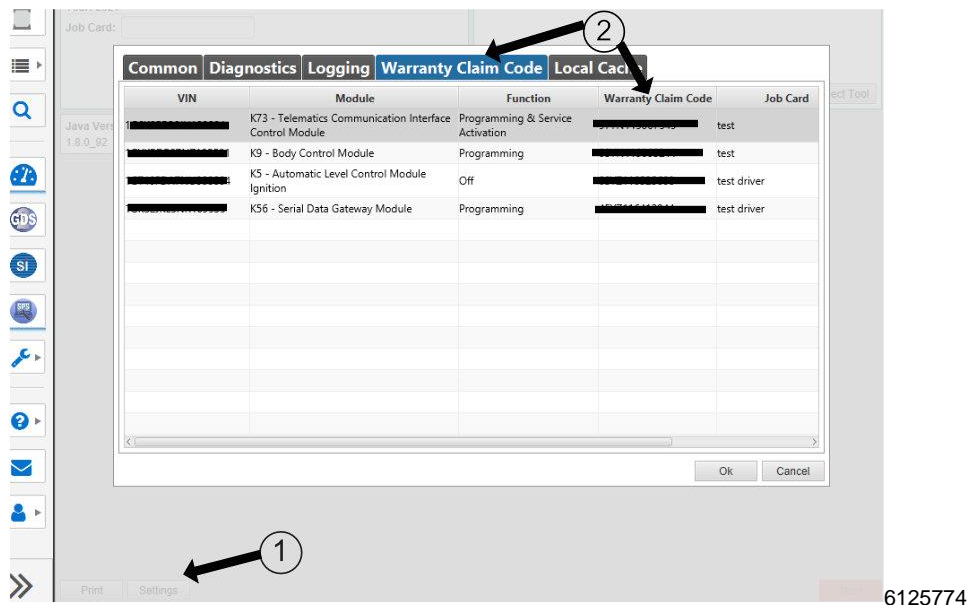
Warranty Claim Code Information Retrieval

If the Warranty Claim Code was not recorded on the Job Card, the code can be retrieved in the SPS2 system as follows:

1. Open TLC on the computer used to program the vehicle.
2. Select and start SPS2.
3. Select Settings (1).
4. Select the Warranty Claim Code tab (2).

The VIN, Warranty Claim Code and Date/Time will be listed on a roster of recent programming events. If the code is retrievable, dealers should resubmit the transaction making sure to include the code in the SPS Warranty Claim Code field.

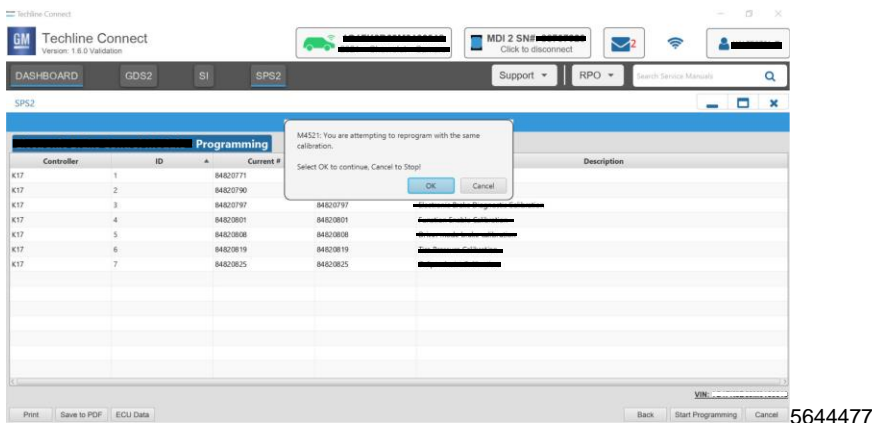
Important: If the vehicle VIN DOES NOT match, the message below will be shown.
