GLOBAL SAFETY FIELD INVESTIGATIONS DCS6666 URGENT - DISTRIBUTE IMMEDIATELY

Subject: REVISION: N222375791-08 - Customer Satisfaction Program

Park Assist Retrofit

N222375791 Park Assist Retrofit

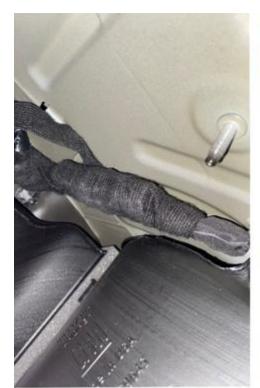
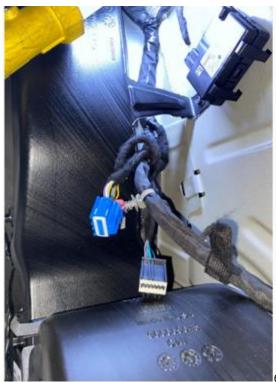
6288463

Note: The wiring harness for the Parking Assist Control Module may be wrapped around an adjacent wiring harness as shown above. Remove the attaching tape by unwrapping. Do NOT cut the tape as it could damage the wiring harness.
