RCA-78-23-005-1: Reroute Cowl Harness

Document Type	Customer Satisfaction Campaign Bulletin
Date	August 9, 2023
Affected Region(s)	USA, Canada
Affected Model(s)	R1T, R1S
Model Year(s)	2023
Approximate Build Dates	February 2023 - March 2023

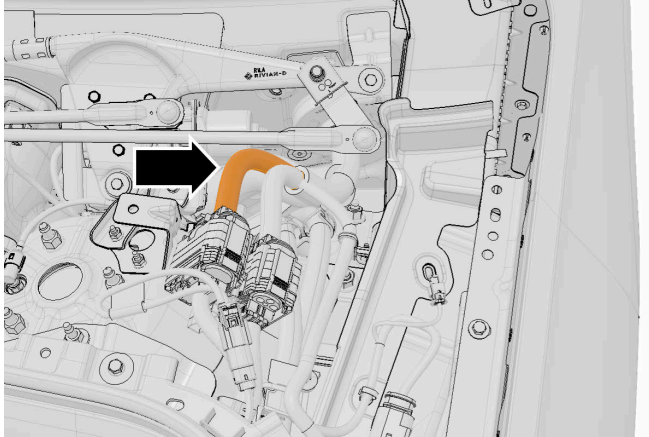
1. Remove: Screen, Leaf (refer to service manual procedure 647920010).
2. Inspect the wires in the highlighted area:

- If abrasion has damaged the wiring insulation:
 - If any of the following wires are affected: Replace: Harness, Cowl (refer to service manual procedure 787054010). Continue to the next step.

- Repair any other damaged wires. Escalate for diagnostic assistance. Continue to the next step.
- If the protective tape has abraded and exposed wiring insulation, but the wiring insulation is not damaged: Rewrap the affected area with new protective tape. Continue to the next step.
- If the wiring and tape are undamaged: Continue to the next step.

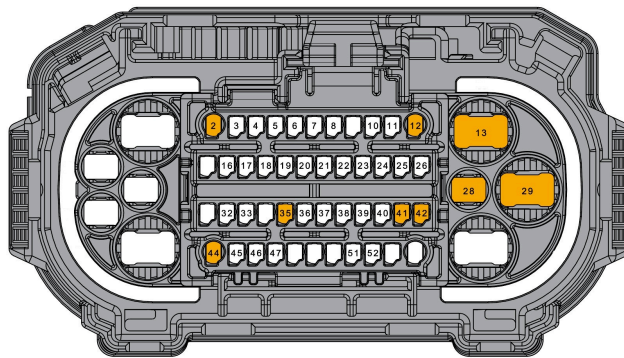
Pin	Color
2	Red/Orange
12	Red/Yellow
13	Brown
28	Black
29	Brown/Blue
35	White/Orange
41	Green/Yellow
42	Red/Yellow
44	Black

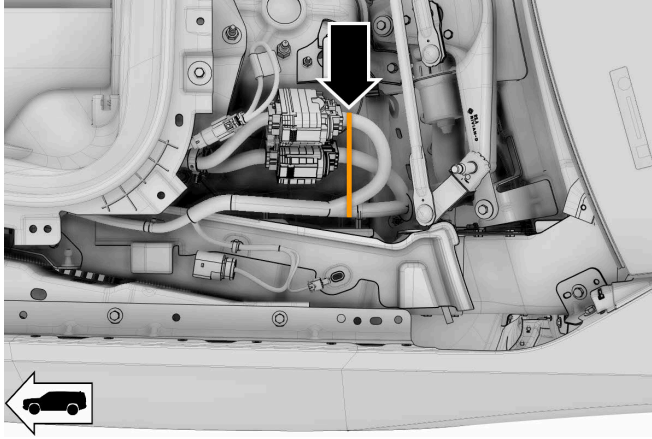
Note: Shown with components removed for clarity.

3. Install: Cable tie. Position the component(s) as shown.

Note: If necessary to fully secure the component: Install additional cable ties.
