SER23-021  
8/11/2023

**SUBJECT: ComfortPro CCU Board JP10 Inspection**

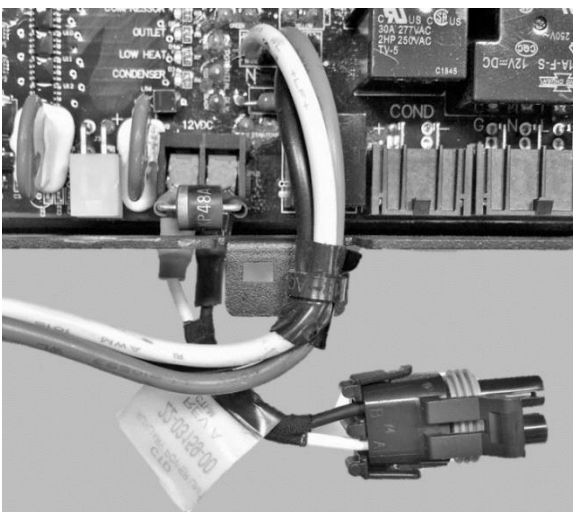
JP10 Connector

Prior to installing new ComfortPro® CCUs or service replacement CCU boards (91-01214-50), the JP10 connection needs to be inspected. Some of these connections may have been assembled incorrectly, and if not corrected prior to installation may result in the CCU board being damaged. Inspect the board/connector as follows:

- White wire is installed in the “A” cavity of the JP10 connector
- Black wire is installed in the “B” cavity of the JP10 connector
- White wire/red fork is installed under the + terminal on the board
- Black wire/blue fork is installed under the – terminal on the board

+ White wire (red fork)

- Black wire (blue fork)

Connector End: Use the appropriate terminal removal tool and swap the connection.

Board Connection:

1. Remove the sealant from the screw terminals.
2. Loosen the screw terminals and remove the fork terminals.
3. Install the fork terminals under the appropriate screw terminals and tighten.
4. Apply electronics grade silicone sealant to the screw terminals
