SER23-025  
08/23/2023

## Subject: Field Action R-1009 Aspen APU Evaporator Drain Pan Inspection

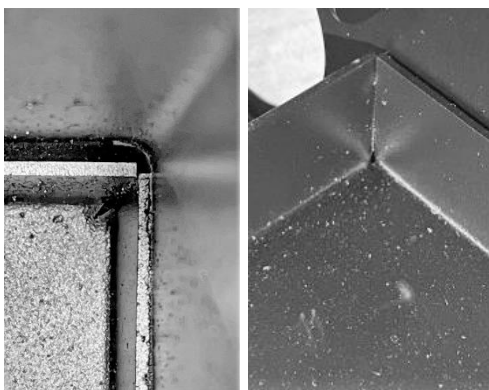
Remove the CCU evaporator cover. Refer to 62-12174 for removal instructions. Inspect the corners of the drain pan for missing or incomplete welds (Figure 1). The inspection can be performed without removing the evaporator. If the welds are present and complete, no further action is required.

Figure 1. Corner Welds Missing

| Rework | Installed | Required Action |
|---|---|---|
| Seal Pan | No | Remove evaporator core and seal drain pan. |
| Seal Pan | Yes | Recover refrigerant, remove evaporator core, seal drain pan, replace filter drier, evacuate/charge system. |

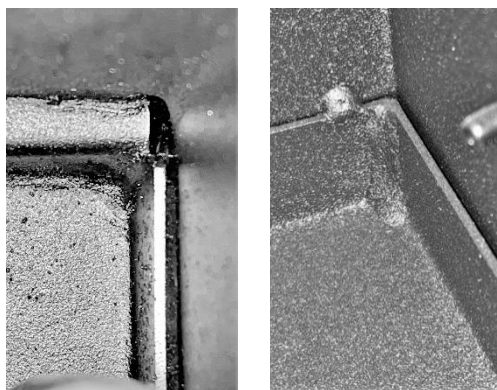
Figure 2. Corner Welds Present
