INSTRUCTION TO SERVICE

ITS: 60778		DATE 8/9/2023
SECTION:	549U – MCC Cable Installation	
WRITTEN BY:	Daniel Tice	
SUBJECT:	MCC Cable and Bracket Rework	
ISSUE:	MCC Cable Rubs Bracket at Side Screens	
SUMMARY:	Replace Bracket and Apply Self Fusing Tape to Damaged Cable Areas

ITS60778

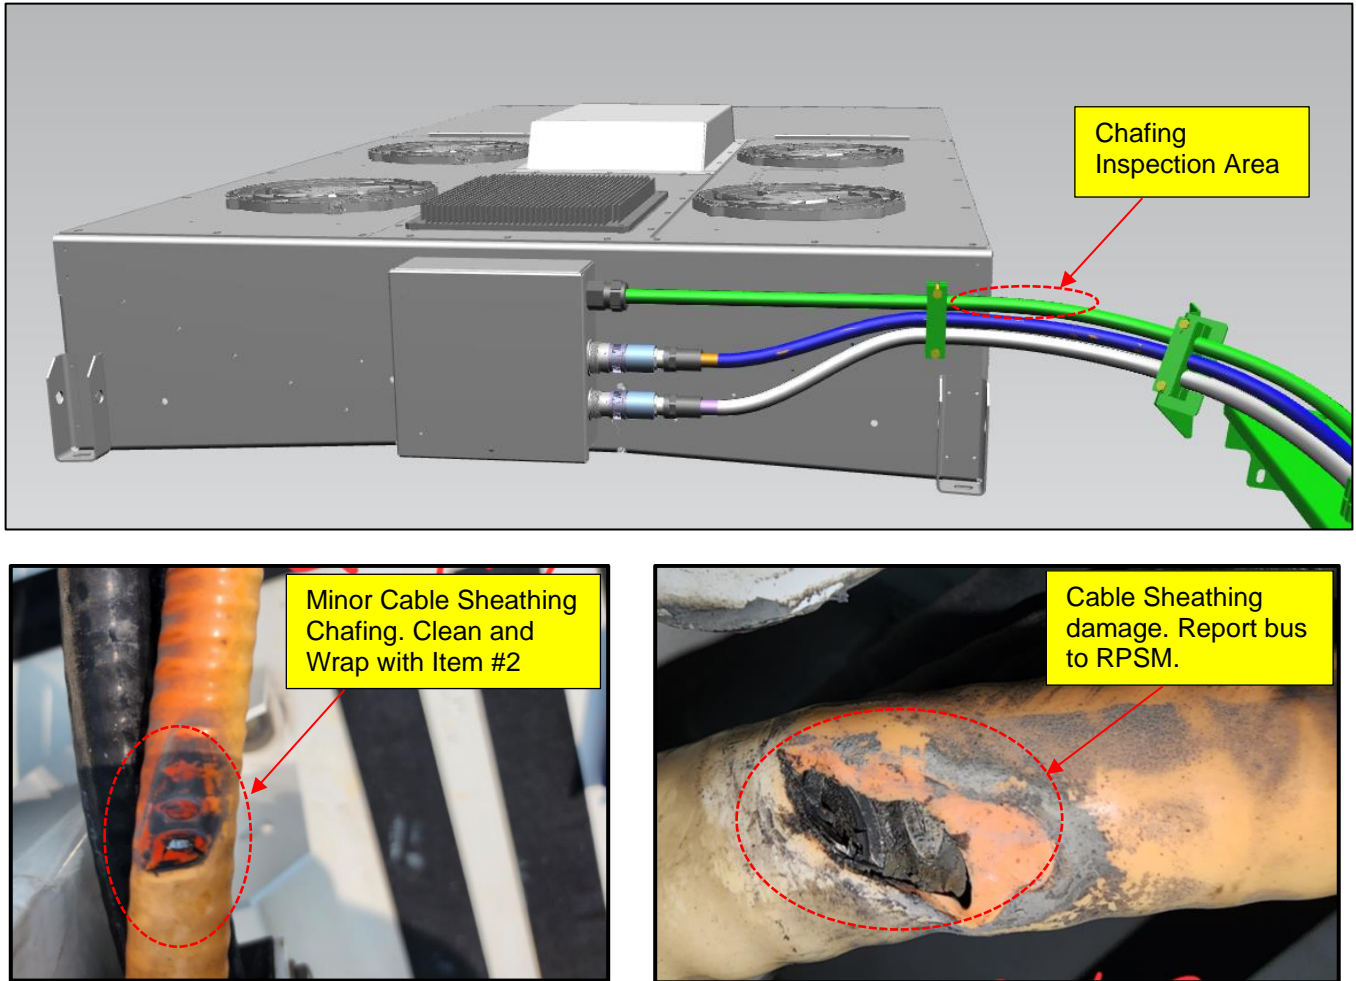
Figure 2: MCC cable cover chafing inspection location reference.

8. Inspect the upper cable for damage or chafing to the cable sheathing surface. See photos below to determine if chafing is present and at what level. See Figure 2.
9. If no chafing or damage has occurred move to step 13 bracket replacement steps in this ITS.
10. If more than surface chafing is present as shown below report the bus number to your RPSM. See Figure 2.
