Location: Powertrain

Topic: McLaren Artura Engine Oil Leak Diagnosis Guide - Front of Engine

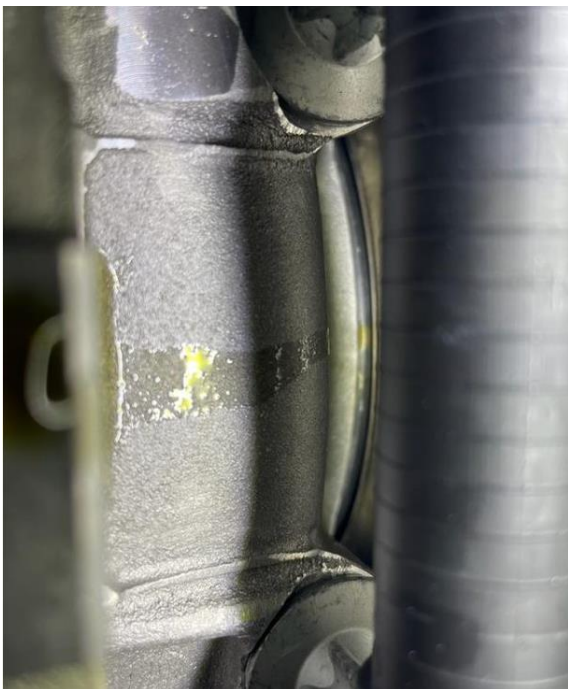
If an Artura is found to have oil traces on the underside of the car at the front of the engine bay, specifically the front of the engine around the torsional vibration damper (TVD) area, please follow the steps below:

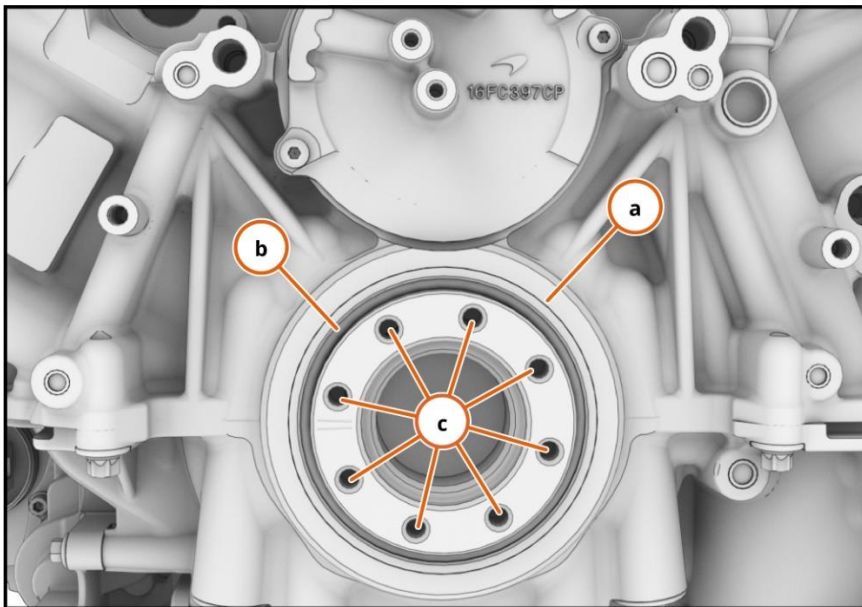
1.
 1. TVD threaded bolt holes (crankshaft flange) and TVD Bolts
 2. Front crank seal OD
 3. Front crank seal ID

Repair: If the engine is only leaking from the TVD bolts skip steps 17 to 19 (front crank seal removal)

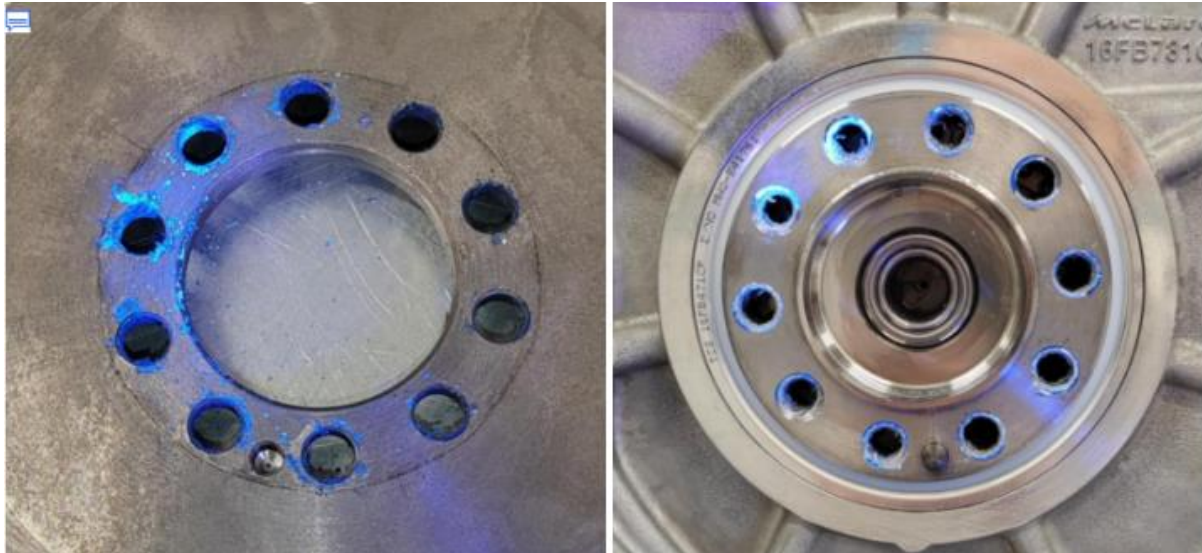
Care Point: to avoid engine contamination, prior to attempting front crank seal removal clean the first 2-3 bolt hole threads (crankshaft flange) from residual threadlocker (from the original bolt fitment) and outer surface of crankshaft flange (threadlocker and oil) without pushing any debris into the engine (through holes), clean with standard automotive degreaser/solvent ensuring a thorough clean of the leak area. Do not leave the area like this:
