Location: Powertrain

Topic: McLaren Artura Oil Leak Diagnosis Guide - Rear of Engine

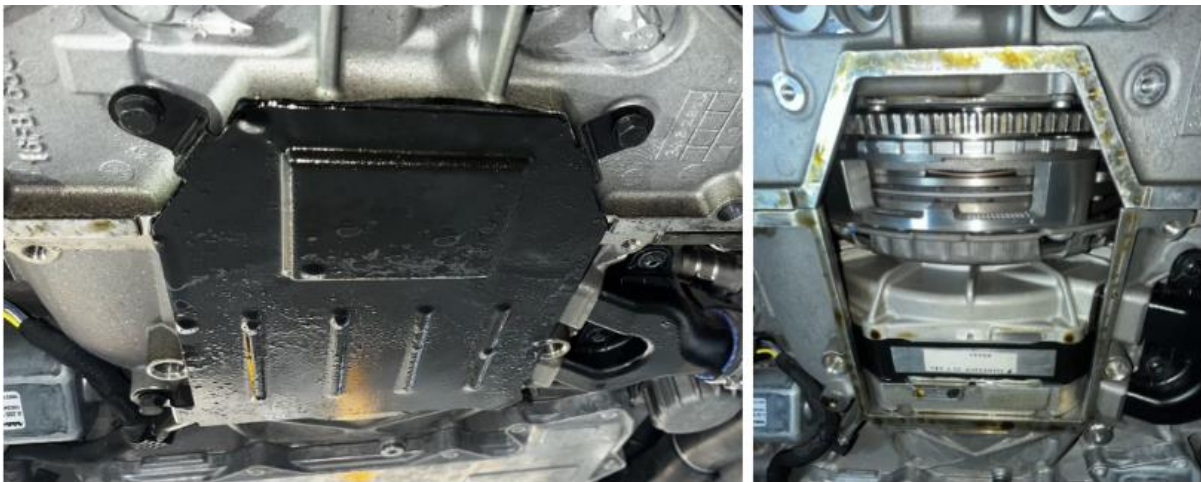
If an Artura is found to have oil traces on the underside of the powertrain at the rear, specifically the rear interface between the engine, transmission and e – motor, please follow the steps below

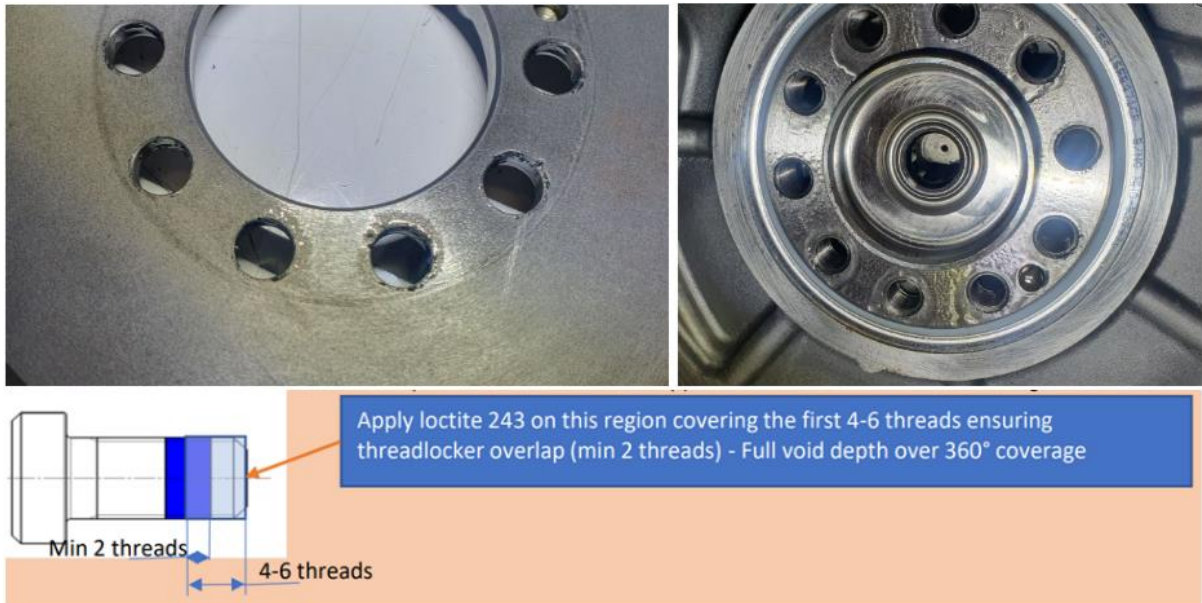
- Capture images immediately of the flywheel, label as “Flywheel Inspection” and inspect. If oil is centralized around the flywheel on the surface this indicates the flywheel bolts are potentially the cause of the leak and new flywheel bolts with added Loctite 243 to the top threads will rectify this

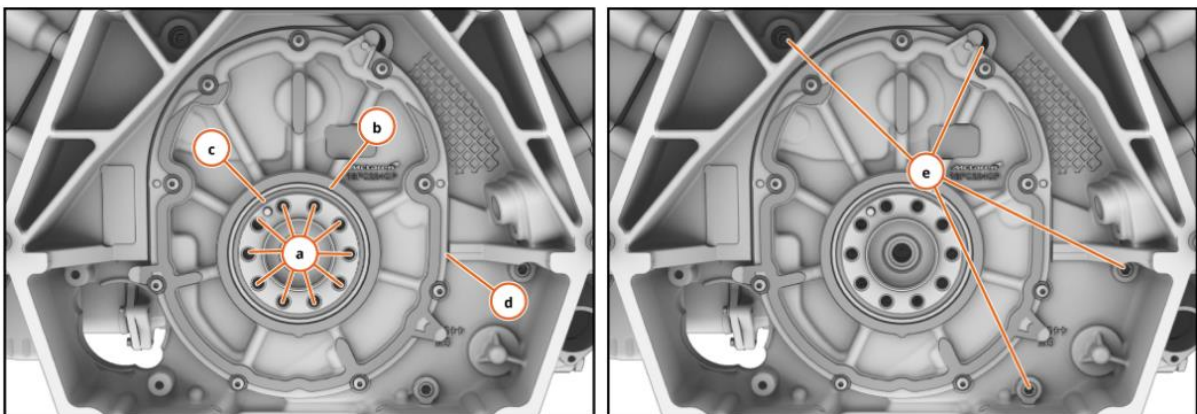
- Identify leaking area of the rear of the engine
 - a. Flywheel threaded bolt holes (crankshaft flange)
 - b. Rear crank seal OD
 - c. Rear crank seal ID
 - d. Rear cover (RTV Seal - identify exact location)
 - e. M14 Pins – Tensioner (escalate with images)

- If it is determined that the outer diameter of the crank seal or the RTV joint of the rear cover is leaking then replacement of the whole rear cover assembly with pre-fit rear seal is required

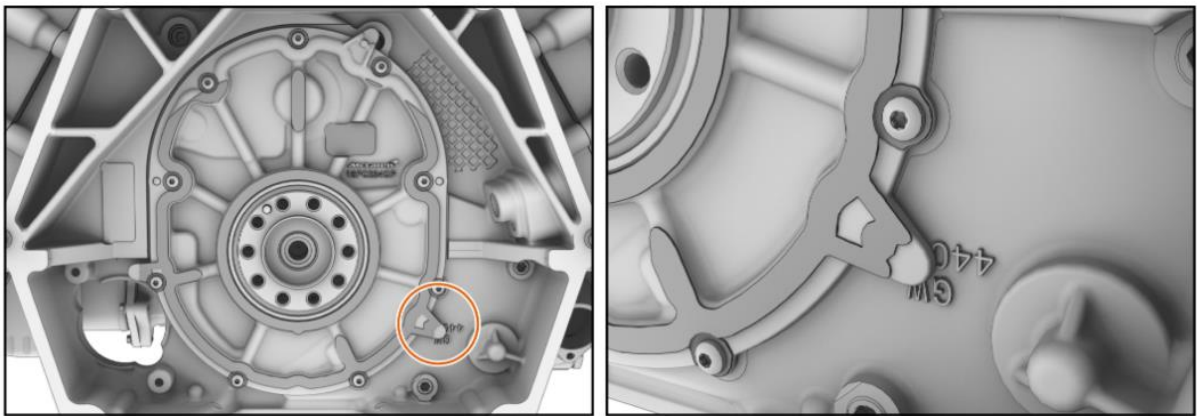
- Check if the rear cover has a tab that clashes with the cylinder block part marking

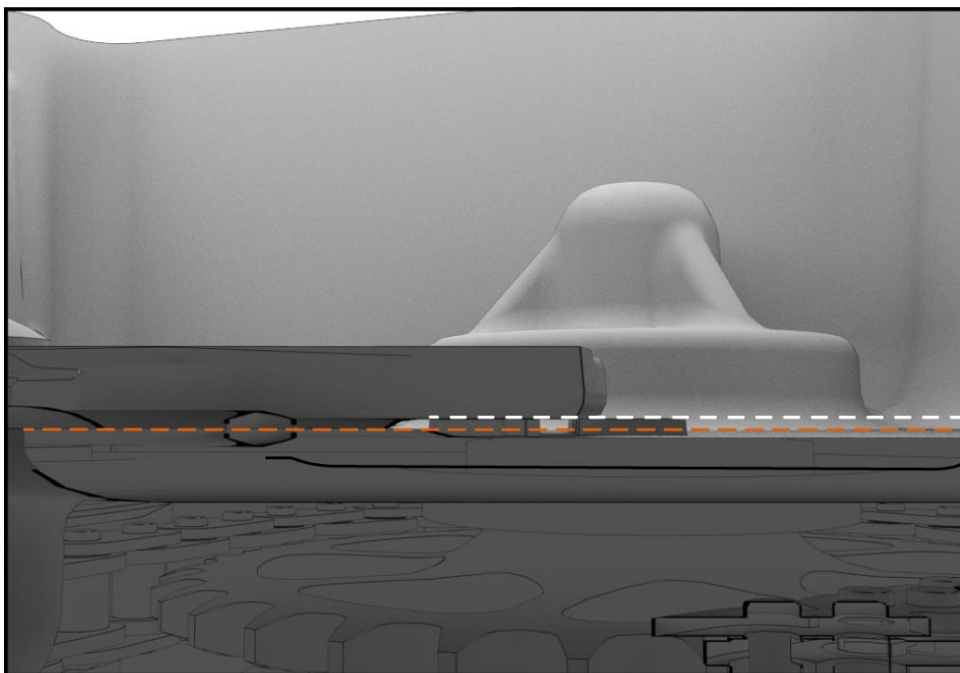
If the Part Marking on the Cylinder Block is present and not machined down, check if the top surface of the lettering is protruding the rear cover sealing surface on the cylinder block

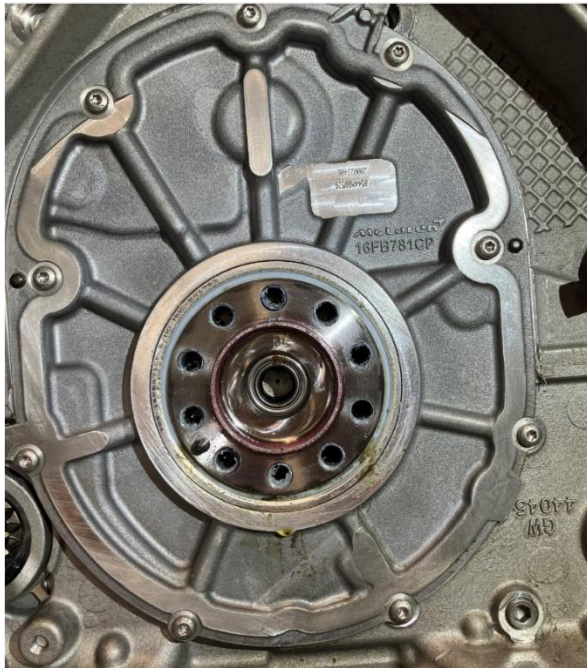
If the Part Marking protrudes, proceed with the tab removal to resolve the potential hard clash of the rear cover which would create a leak path

- Use alignment pins referenced in SIS used for fitment of the rear cover to remove the rear cover to avoid further damage to the rear seal assembly. Do not remove rear crank seal from the rear cover to avoid any damage to the seal
- Follow SIS instructions for correct cleaning, alignment and RTV application when fitting the new rear cover assembly,
- During replacement of the rear cover, it is essential the new mandrel service tool PN16FA063ZT and the guide pins are used during this process to slide the seal onto the crank shaft when fitting the new rear cover assembly
- All other alignment, cleaning, and RTV processes in the SIS are correct and should be adhered to when fitting the cover, the only deviation is the new Mandrel usage as there is a seal fitted now
