## FRONT OVERHEAD CONSOLE RATTLE

### Range Rover

- 22-23MY Range Rover
- 23MY RR Sport

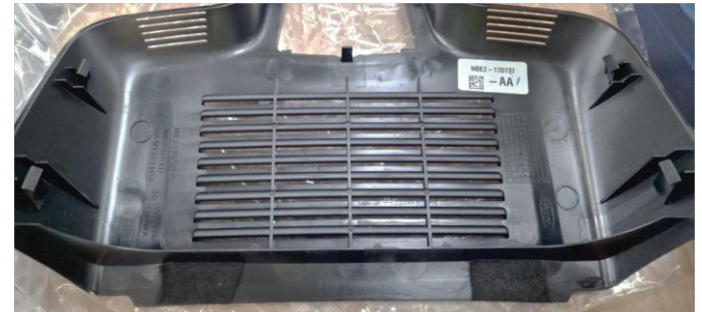
- That there is a rattle or creak type noise emanating from the front overhead console area.

- This may be caused by contact between the console cover and the covered components.

- **SSM 76053** has been published to address this concern, providing repair guidance.
