UPDATE PRIOR TO SALE NOTICE

Global Service Action
Number: H446 UPS2623-2

Subject: Electric Drive Cooler Isolation Valve	Publication No.: H446 UPS2623-2
	Model: I-PACE (X590)
	Model Year: 2024
	Date of Issue: 16 August 2023
	Expiry Date: 17 July 2024

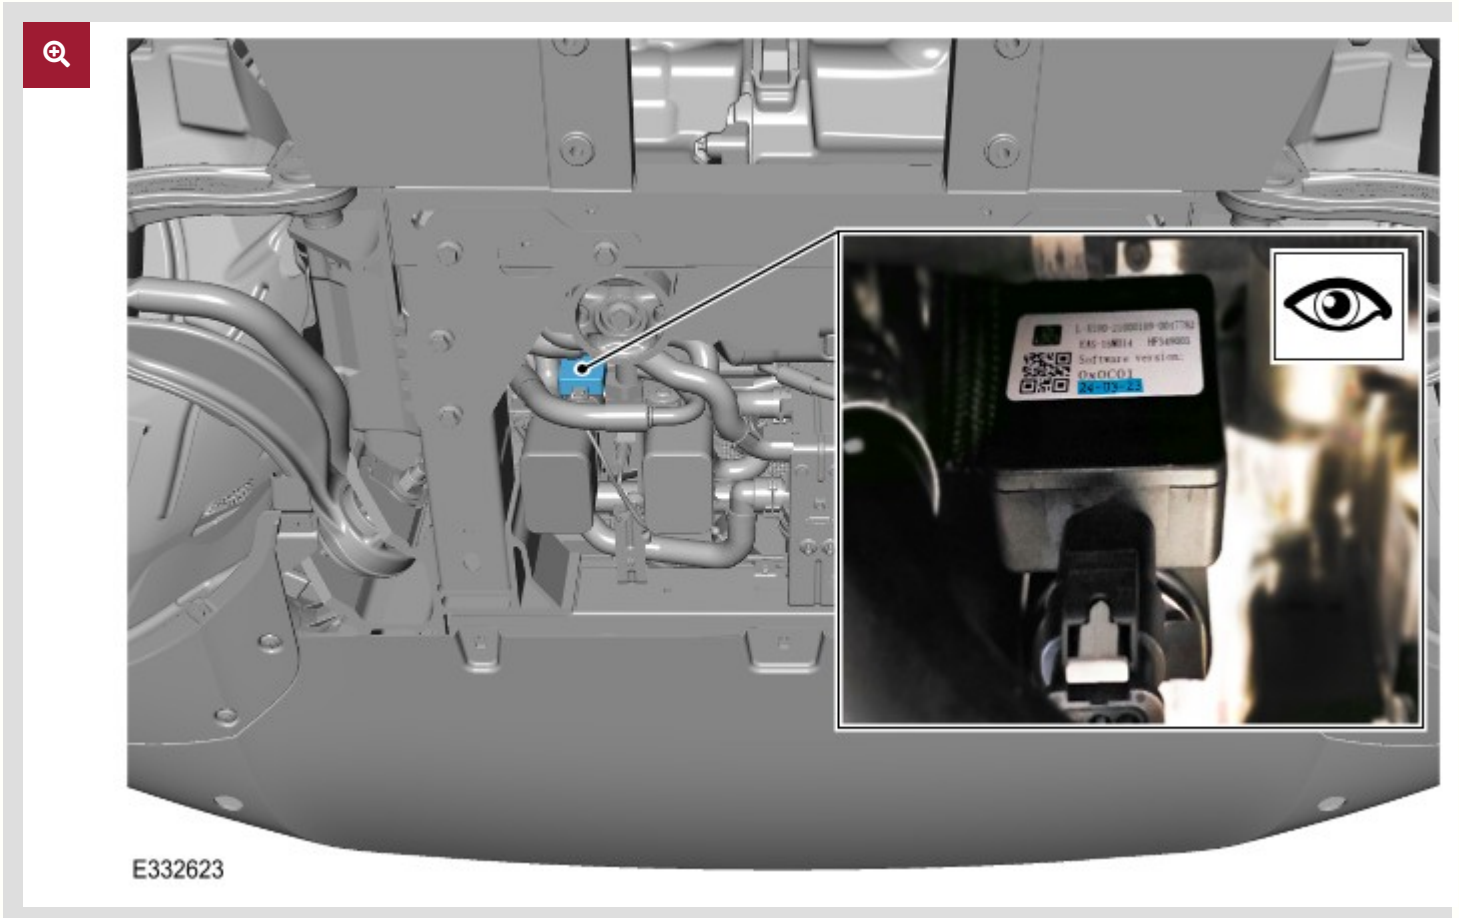
2. Visually inspect the manufacturing date printed on the electric drive cooler isolation valve label.

- If the date printed on the label **IS** either **24-03-23** or **31-03-23** the vehicle has **FAILED** the inspection. Continue to hold the vehicle and await further instruction.
- If the date printed on the label **IS NOT** either **24-03-23** or **31-03-23** the vehicle has **PASSED** the inspection. Reverse step 1 and release the vehicle.
