JLRTB02012NAS5

**TECHNICAL BULLETIN**

'Gearbox Fault Detected' Displayed On The Instrument Panel Cluster (IPC)

MODEL:	MODEL YEAR:	VIN:	ASSEMBLY PLANT:
I-PACE (X590)	2019 Onwards	F60094 Onwards	Graz (Austria)

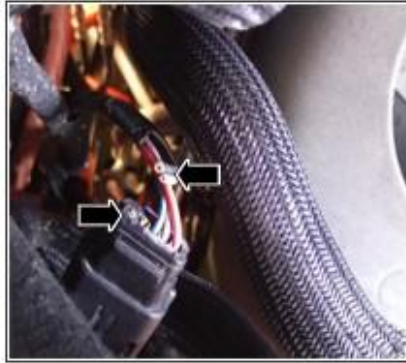
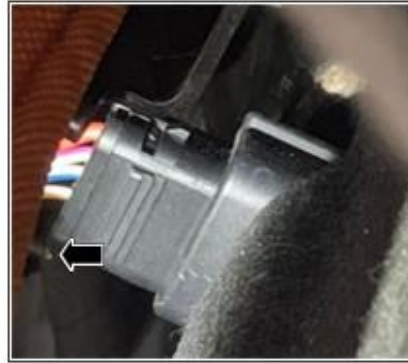
**2019 to 2020 model year vehicles:** No retention to the front Electric Drive Unit (EDU) causing strain on the wiring going to the EDU parking lock actuator connector (C1YE113A).

- If the EDU parking lock actuator connector (C1YE113A) wiring is found to be damaged as per the illustration, **continue to step 2**.
- If no related repairs were identified **and** the customer concern is still present, **continue to step 2**.
- If any related repairs were identified **and** have been rectified **and** the customer concern is still present, **continue to step 2**.
- If any related repairs were identified **and** have been rectified **but** the customer concern is **not** present, **do not continue with this technical bulletin**.

- 
2. Remove the front compartment wiring harness (see TOPIx Workshop Manual section 418-02: Wiring Harnesses - Removal and Installation - Front Compartment Wiring Harness).

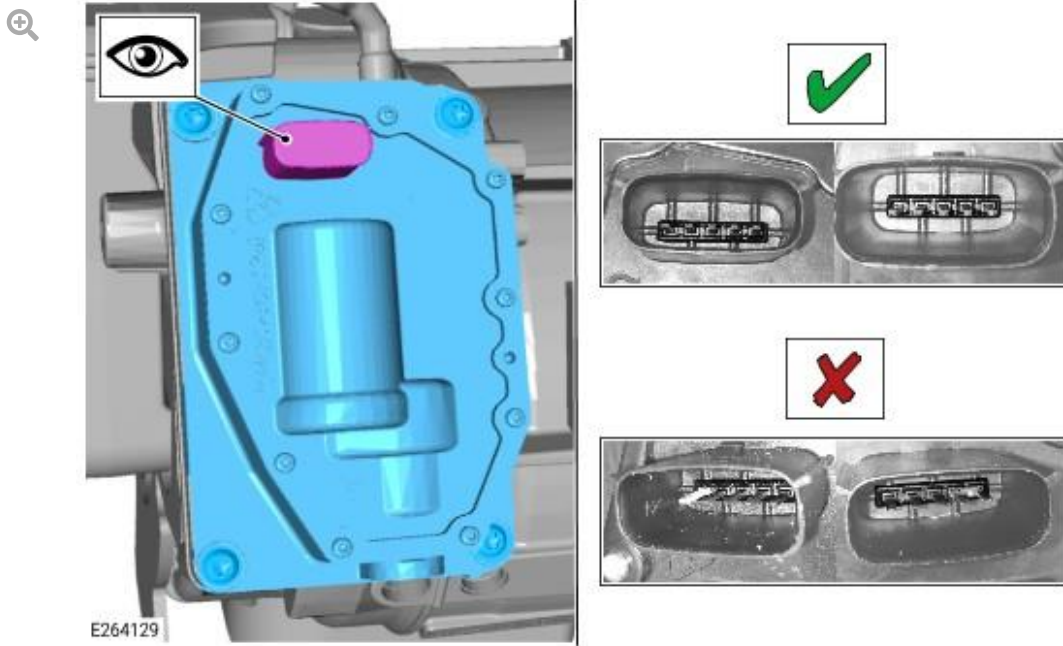
Inspect the electrical connector pins of the EDU parking lock actuator for signs of water ingress or corrosion.

- If signs of water ingress or corrosion **are not** present on the electrical connector pins of the EDU parking lock actuator, as shown in the image with a **GREEN '✓'**, **the vehicle has passed the inspection.**
  - **Continue to step 24.**
- If signs of water ingress or corrosion **are** present on the electrical connector pins of the EDU parking lock actuator, as shown in the images with a **RED 'X'**, **the vehicle has failed the inspection.**
  - **Continue to step 19.**

22. Renew the front **EDU** parking lock actuator (see TOPIx Workshop Manual section 601-01: Electrical Drive Unit - Removal and Installation - Electric Drive Unit Parking Lock Actuator).

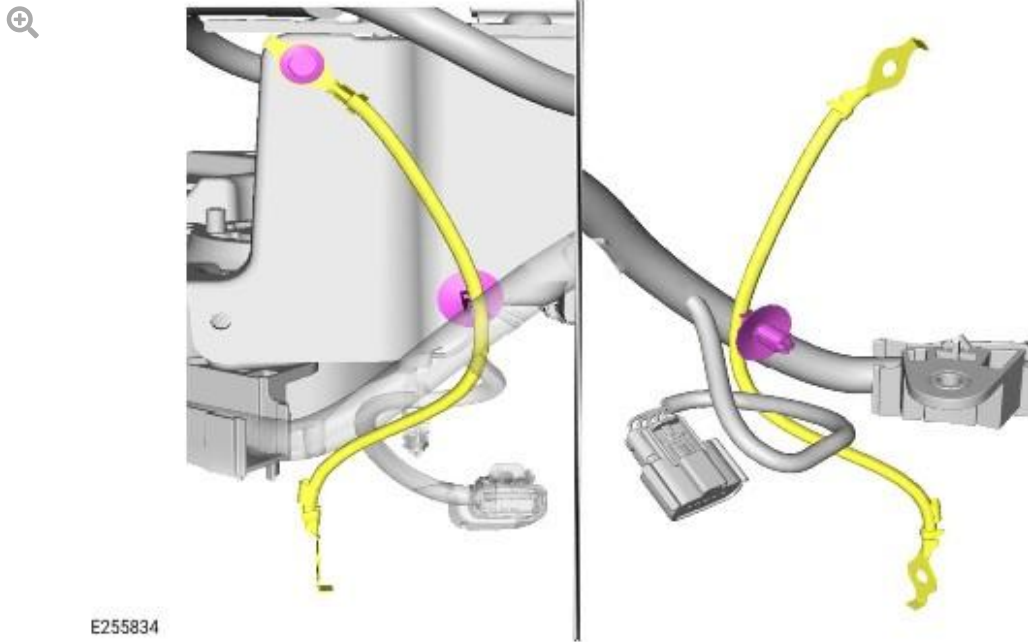
When installing the new front compartment wiring harness make sure the new front EDU ground cable **IS NOT** routed through the loop formed by the front EDU parking lock actuator break out harness, as shown in the illustration.

Install the new updated front compartment wiring harness (see TOPIx Workshop Manual section 418-02: Wiring Harnesses - Removal and Installation - Front Compartment Wiring Harness).

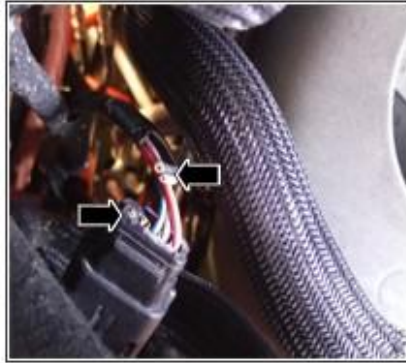
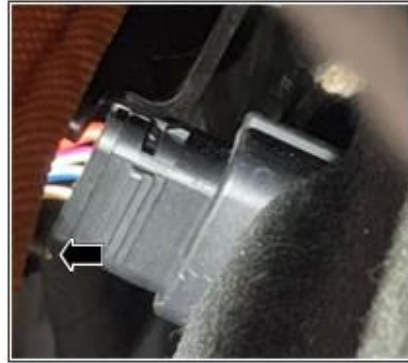
E256857

**2021 model year onwards vehicles:** Incorrectly routed parking lock actuator breakout wiring harness.

- If the EDU parking lock actuator connector (C1YE113A) wiring is found to be damaged as per the illustration, **continue to step 2**.
- If no related repairs were identified **and** the customer concern is still present, **continue to step 2**.
- If any related repairs were identified **and** have been rectified **and** the customer concern is still present, **continue to step 2**.
- If any related repairs were identified **and** have been rectified **but** the customer concern is **not** present, **do not continue with this technical bulletin**.

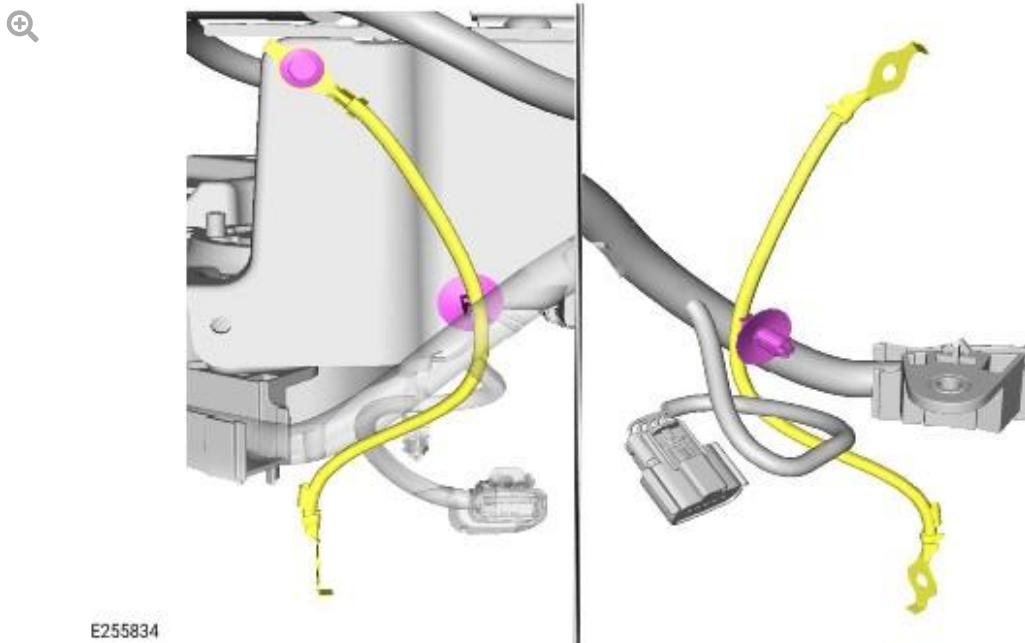
When installing the new front compartment wiring harness make sure the new front EDU ground cable **IS NOT** routed through the loop formed by the front EDU parking lock actuator break out harness, as shown in the illustration.

Renew the front compartment wiring harness (see TOPIx Workshop Manual section 418-02: Wiring Harnesses - Removal and Installation - Front Compartment Wiring Harness).
