Rear Lid Does Not Open / Rear Lid Lock is Faulty: Performing Water Ingress Test (246/22)

Model Line: **Taycan Cross Turismo (Y1B) / Taycan Sport Turismo (Y1C)**

Model Year: **As of 2021 up to 2023**

Concerns: **Lower part of rear lock (rear lid lock)**

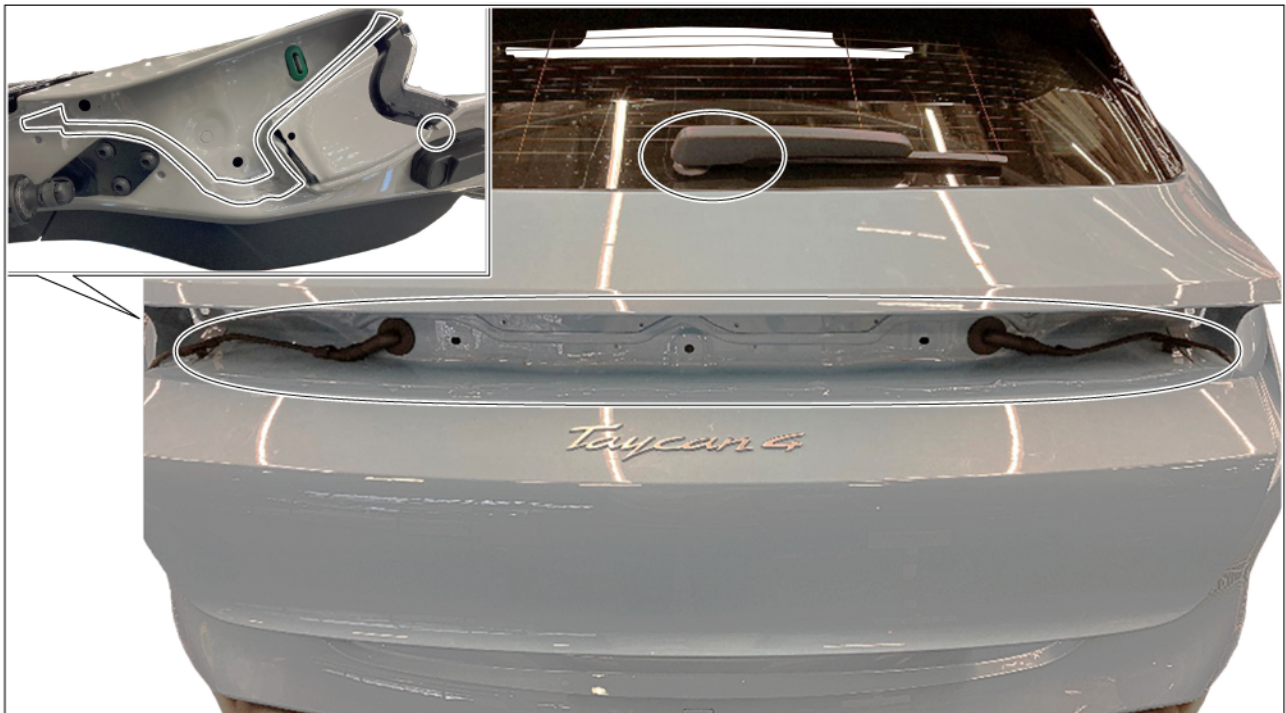
Rear lid areas

Focus on the following areas:

- Gaps in the rear lid
- Center body for the rear and brake lights
- Windshield wiper seal

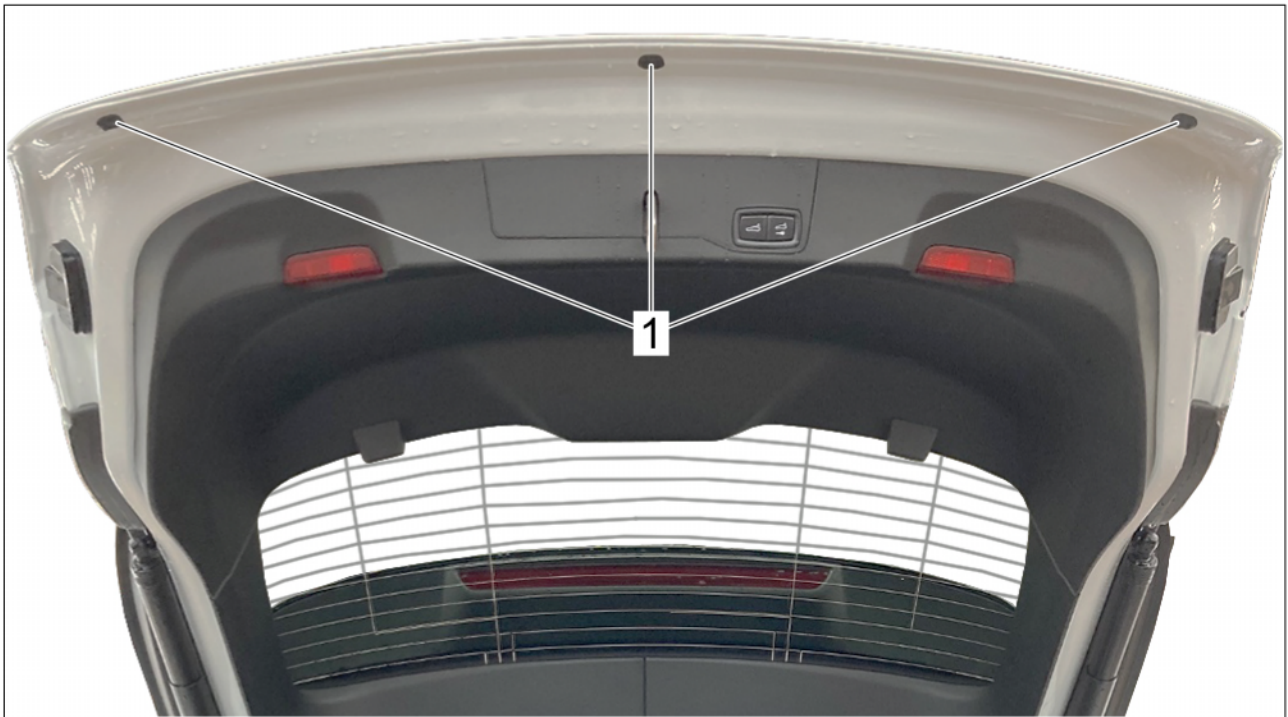
Stopper in rear lid

- 5 Lower the rear lid, and check for leaking water at the openings on the stoppers that were previously removed.
- 6 If water ingress could be detected, search for the cause in the following areas primarily:
 - Body seal ⇒ *Rear lid -2 and 3-*
 - On the washer water line for the rear window washer system
 - Rear wiper seal ⇒ *Rear lid -4-*
- 6.1 After the water ingress has been clearly located, depending on the leakage point either:
 - Seal the affected body area with body sealant, and then rework with a touch-up stick.
 - Replace the rear wiper seal.
 - Repair/replace the washer water line.

Then re-insert the stoppers ⇒ *Stopper in rear lid -1-* in the rear lid.

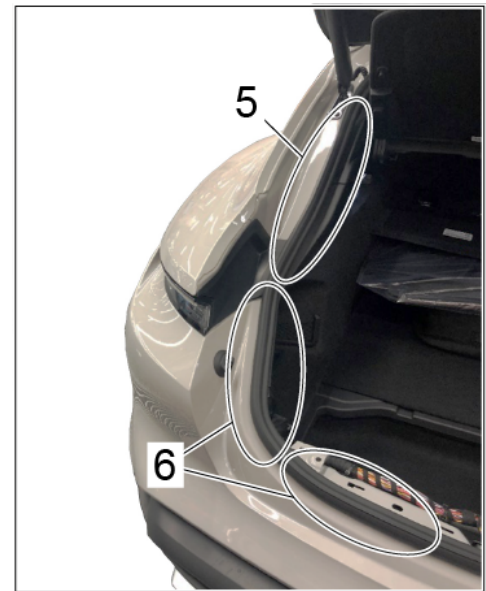
Overview of luggage compartment seal

- 6 Check luggage compartment in the area ⇒ *Overview of luggage compartment seal -6-* for traces of water.
- 7 Repeat the procedure on the other vehicle side of the vehicle.
- 8 If water is found to have entered the luggage compartment, find the cause on the respective side of the vehicle in the area of the rear lid seal or on the body seal area ⇒ *Water ingress into rear lid seal -7-*.
