2023-08-02

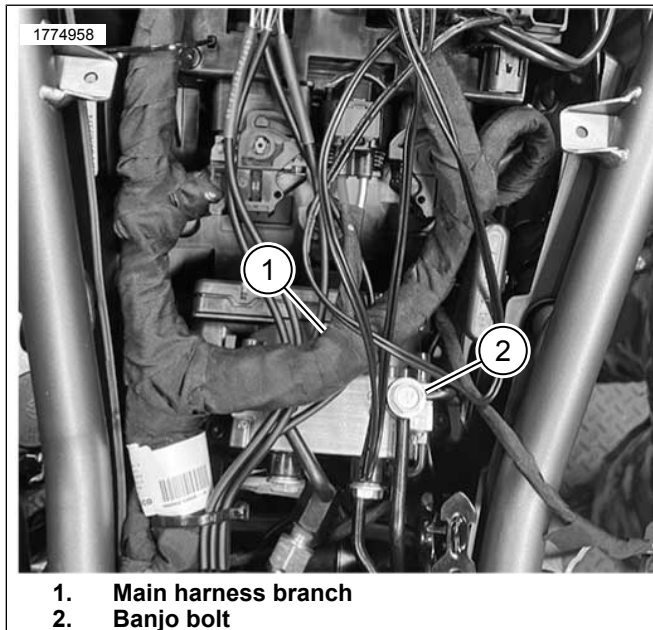
**Figure 2. Main Harness Branch**

- Confirm that the battery ground ring terminal, is below the main harness ground ring terminal. The battery ground ring terminal should be closest to the engine case ground point. Correct as required.
- Inspect starter solenoid connections. If the cable ring terminals move on the stud, tighten. 27–41 **in-lbs** (3–4.6 N·m).
- See Figure 2. Inspect main harness branch as it routes past the Electro Hydraulic Control Unit (EHCU). If routed on top of the banjo bolt, there is potential that it can be damaged after the seat is installed. Manipulate the main harness as needed to obtain clearance with the EHCU unit.

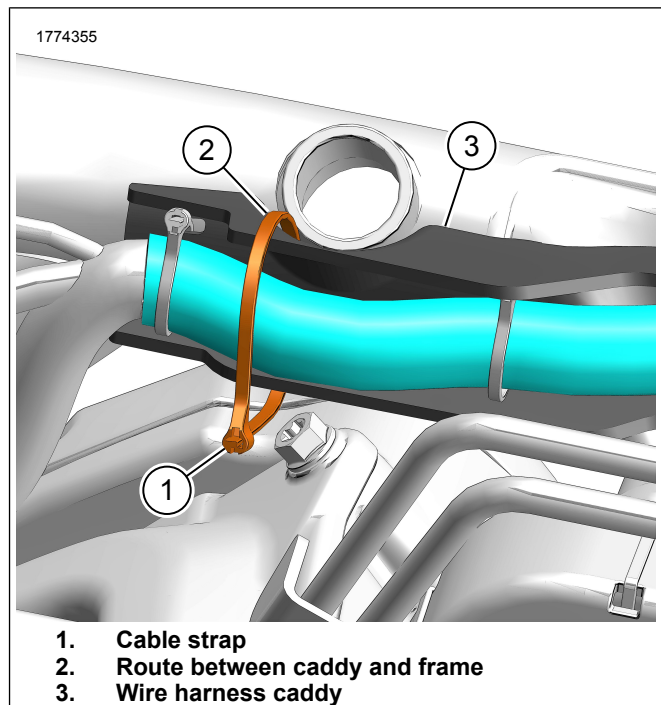
**Figure 3. Wire Harness Caddy**

- Inspect Body Control Module (BCM) connector [242B-1], terminals 1 and 2. Remove terminal from connector using modified tool and check terminal tightness using the interfacing BCM pins. If the crimp on the terminal is found to be bad, replace using (Part No. 69202183).
- See Figure 3. Inspect engine harness at caddy as it routes between the right upper frame rail and front cylinder head. If wire bundle is making contact with the cylinder head or cover screws, use cable straps to secure wires in caddy. Make sure to orientate cable strap(s) as shown in graphic. Make sure there is adequate clearance to the cylinder head.

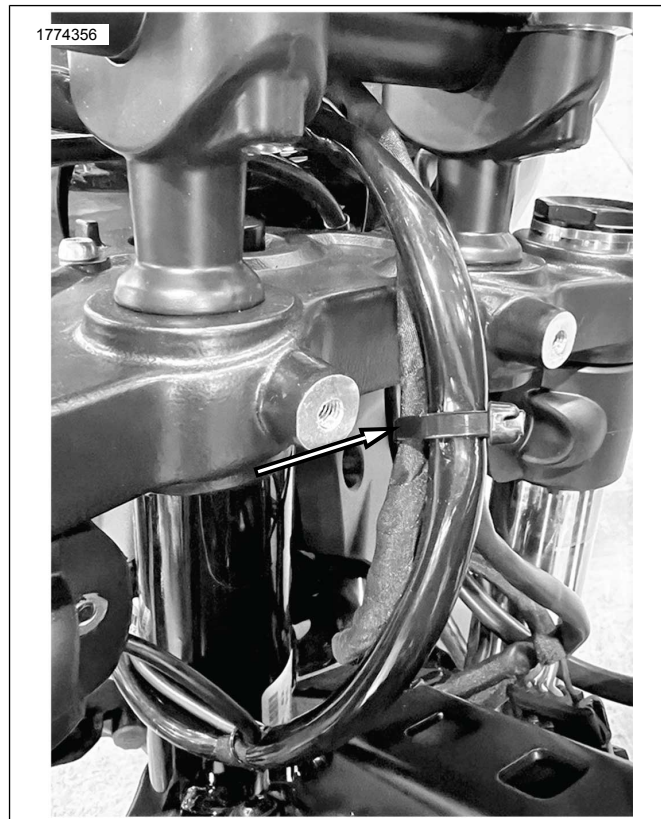
**Figure 4. Harness Routing With Cable Strap**

- See Figure 4. Some RH975 vehicles were built with a cable strap that is causing tension on the Hand Control Module (HCM) harnesses when the steering is in full-left lock or full-right lock. If a cable strap is found, it should be removed.

- Perform a general inspection of HCM jumper harness routing and correct cable strap locations. Confirming full-left lock to full-right lock that there is no excessive tension on the wire harness.
- Inspect for pinched wires near lower left engine guard mounting point.  
PAN AMERICA (RA1250, RA1250S)
- See Figure 5 and Figure 6. Inspect semi-active equipped suspension connectors [344A/B] and [345A/B] for properly seated terminals.
- Correct as needed and if a correction was performed, also perform a BCM Suspension Calibration procedure using Digital Technician II (DT II).

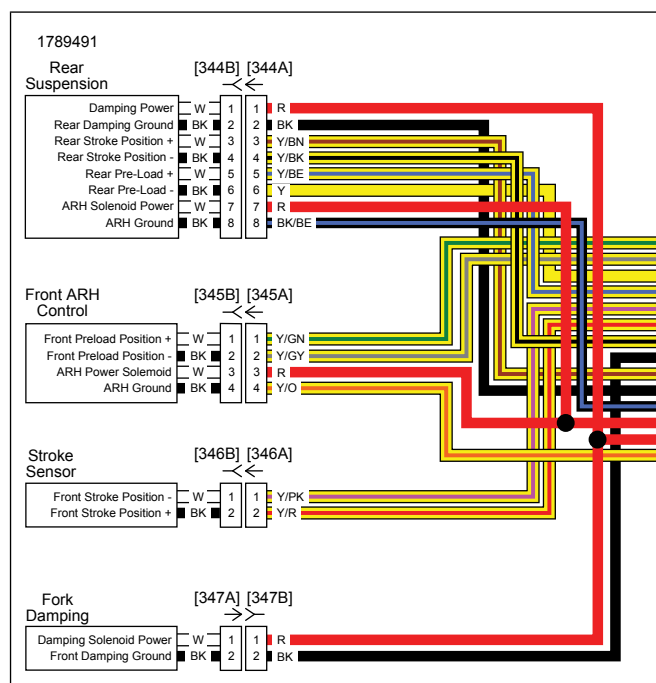
Figure 6. Black and White Wires

- **Note wire locations.** If the black and white wires are switched on a single sensor, this does not affect the function of the system. If the wires are switched between sensors, this must be corrected.
