**Complaint - Warning Message "Lift System Fault – Service required" in Instrument Cluster: Observe Specified Procedure (40/21)**

Revision: This bulletin replaces bulletin Group 4 40/21, dated March 2, 2021.

Model Line: **911 Carrera (992)**

Equipment: **Front axle lift function (M-No. 2UH)**

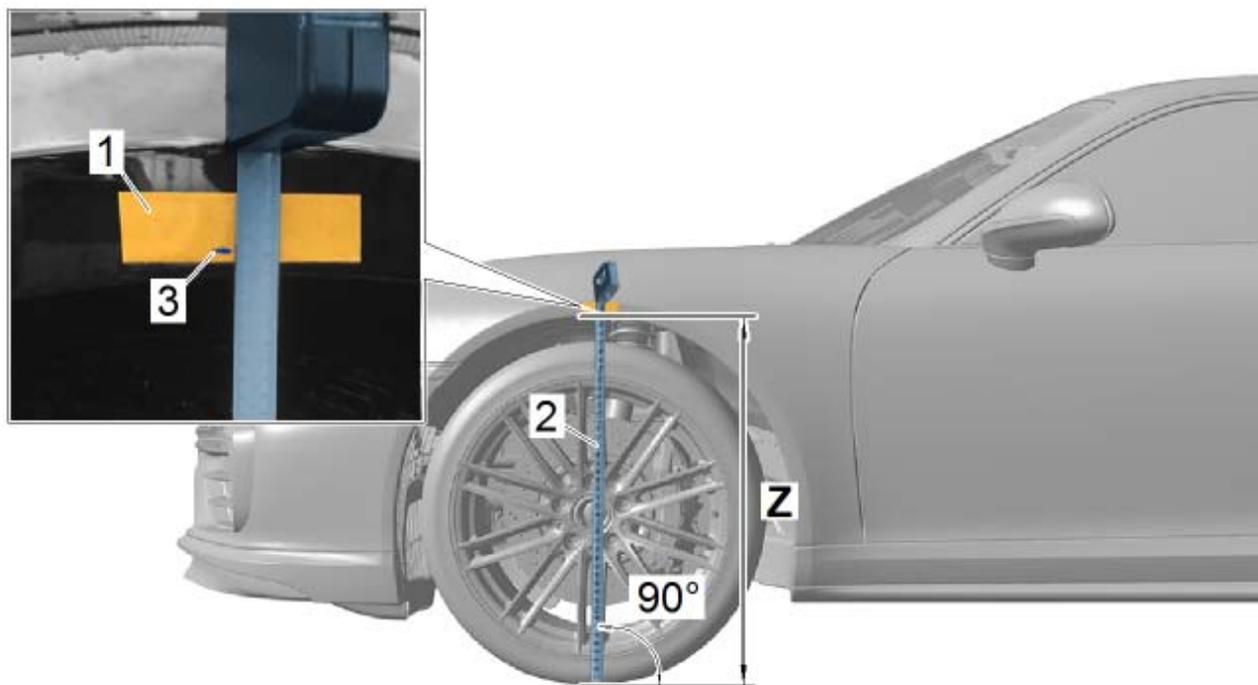
Ride height measurement, front left

- 1.2 Determine the ride height at the front left ⇒ *Ride height measurement, front left -Z-*.
  - 1.2.1 Apply adhesive strips (e.g. adhesive tape) ⇒ *Ride height measurement, front left -1-* to the wing.
  - 1.2.2 Align the measurement tool ⇒ *Ride height measurement, front left -2-* vertically and mark the measuring point ⇒ *Ride height measurement, front left -3-*.
  - 1.2.3 Carefully measure the ride height and write it down.
  - 1.2.4 Repeat the procedure for the right side.
- 1.3 **Observe an idle period of three hours.**
- 1.4 Repeat the measurements, write them down and compare values:

| Assessment | | Action |
| (✓) | Stand height left or right has decreased by less than 10 mm (0.4 inch). | Please inform the customer that the vehicle must only be parked with the front end lowered. Further information can be found in the 'Front-axle lift system' section of the Driver's Manual.<br><br>There is not necessarily a technical fault if the fault type occurs again. The error message can be corrected by raising and lowering the front axle again. |
| (✗) | Stand height left or right has decreased by more than 10 mm (0.4 inch). | Replace compressor for front axle lift system, see ⇒ <i>Workshop Manual '431519 Removing and installing compressor (front axle lift system)'</i> . |
