Repair Procedure MSP60 – 2023 CX-50 Door Key Lock Cylinder

**REPAIR PROCEDURE
Mazda Service Program MSP60**

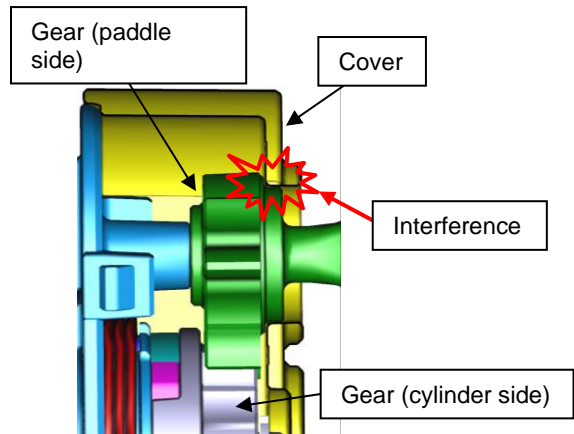
The driver’s door may be hard to unlock using the auxiliary key due to increased rotational resistance. All vehicles in the campaign will need to have the front driver door inspected to ensure proper mechanical key lock and unlock function. The expected failure rate is approximately 2% of the vehicle population.

Cycle the lock and unlock operations five (5) times using the manual (auxiliary) key in order to increase the clearance between the gear and cover (see photo above).
