Service Bulletin

Bulletin No.: 21-NA-214

Date: August, 2023

Subject: Service Engine Soon Lamp Illuminated, Harsh or Delayed Transmission Shifts Including Slip, Surge, Shudder, Noise, Whine, Growl, Shake and/or Vibration, DTCs P2002, P2463, P2459, P144E, P0421, P0422, P0106 P20EE, P129F, P16F3, P20FF, P226D, P249D, P249E, P11CC and / or P11D5 Set Current or in Recent History

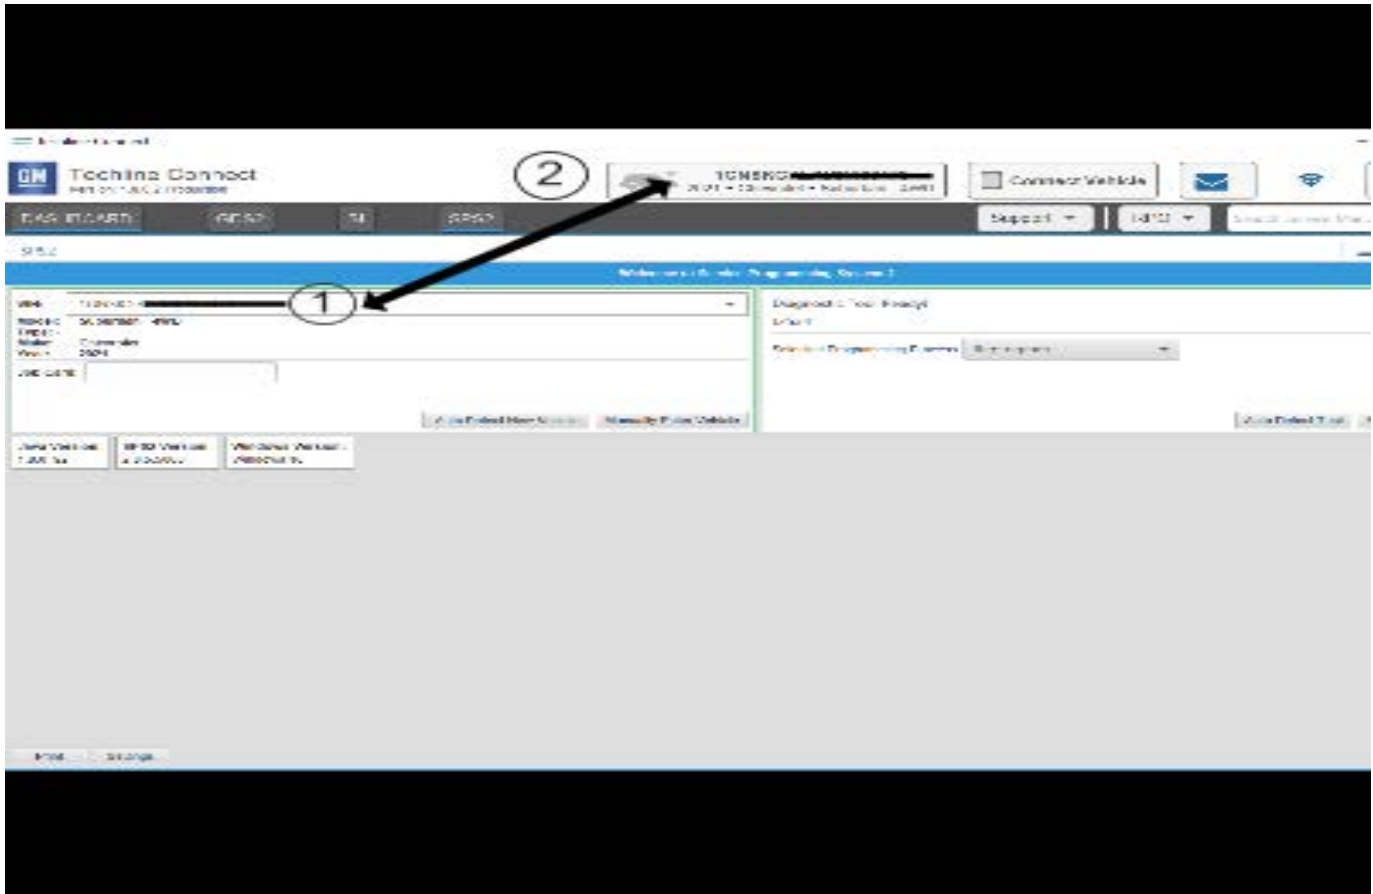
5743643

Caution: Be sure the VIN selected in the drop down menu (1) is the same as the vehicle connected (2) before beginning programming.

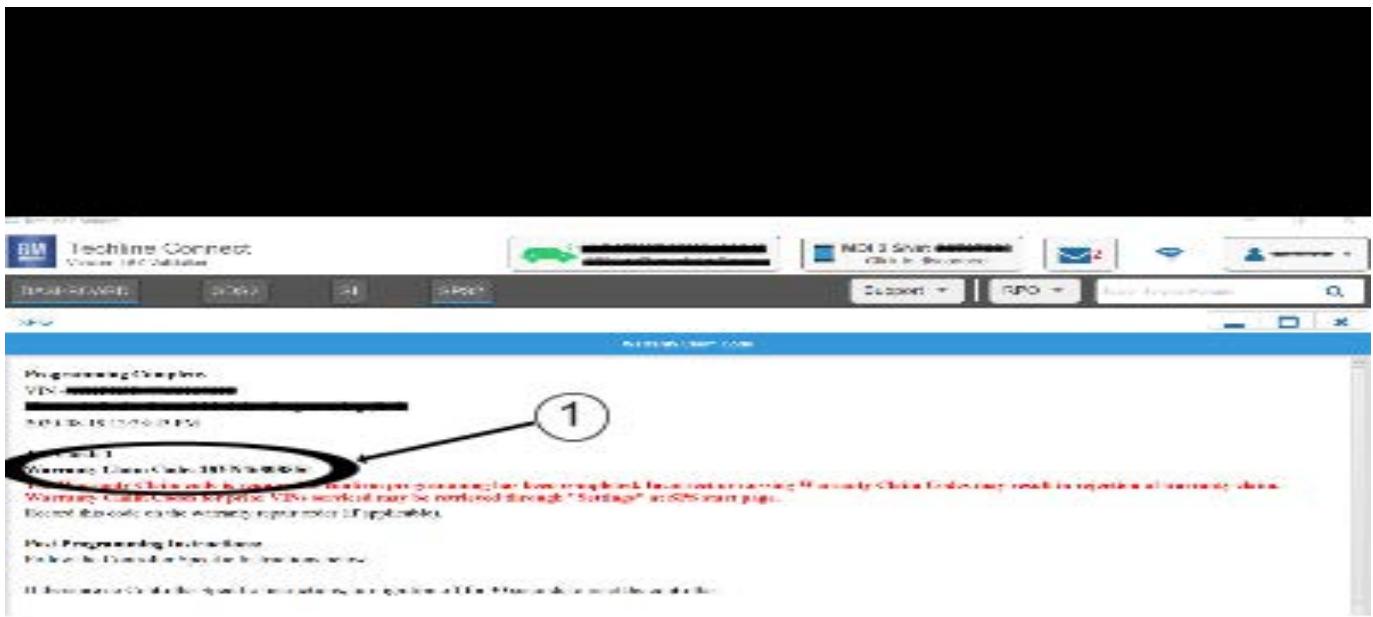
5644478

Important: To avoid warranty transaction rejections, you **MUST** record the warranty claim code provided on the SPS Warranty Claim Code (WCC) screen shown above on the job card. Refer to callout 1 above for the location of the WCC on the SPS screen

2. Record SPS Warranty Claim Code on job card for warranty transaction submission.

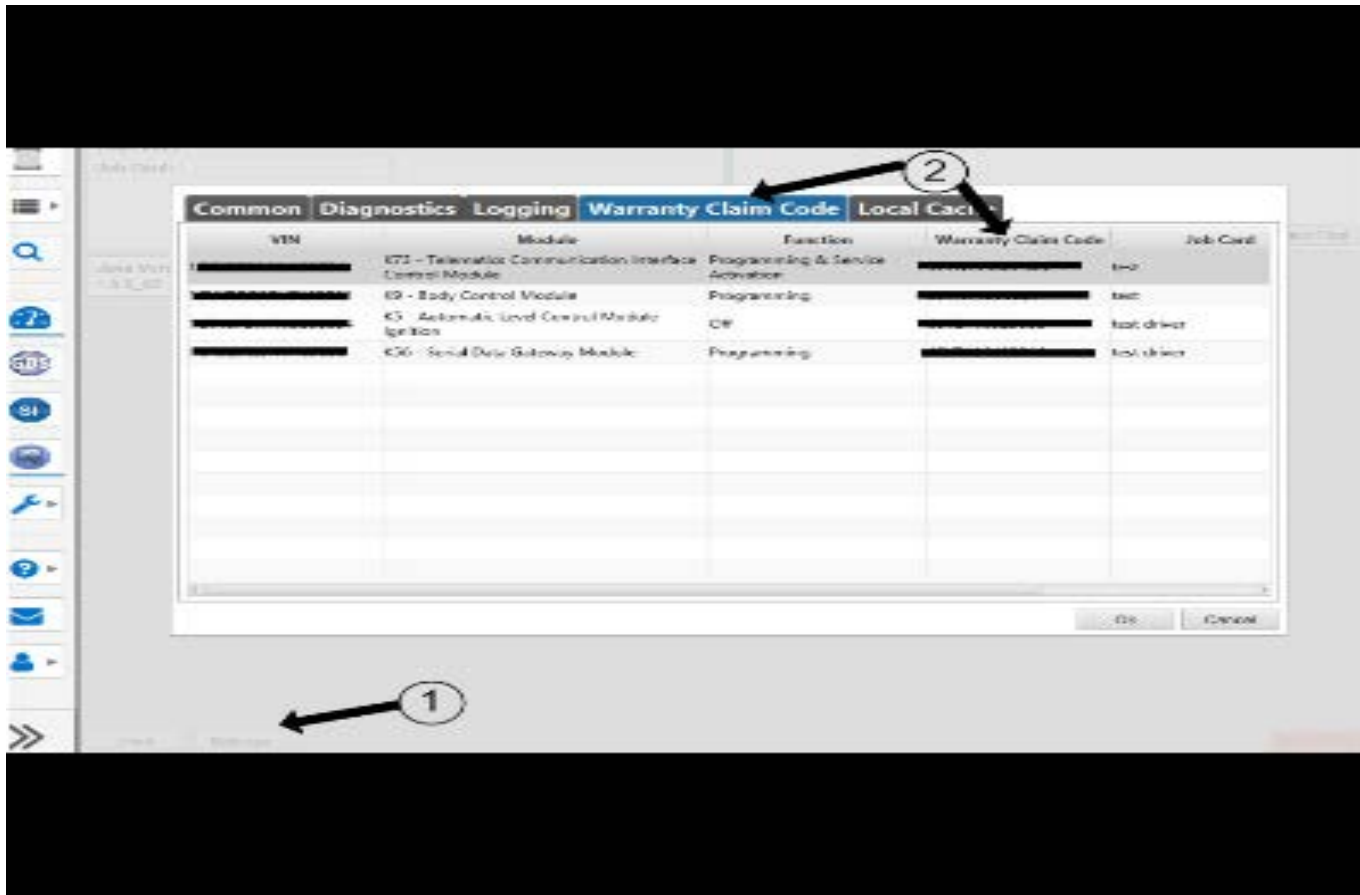
6125774

If the SPS Warranty Claim Code was not recorded on the Job Card, the code can be retrieved in the SPS system as follows:

1. Open TLC/TIS on the computer used to program the vehicle.
2. Select and start SPS2.
3. Select Settings.
4. Select the Warranty Claim Code tab.
