Connect Registration and Pairing PDI Tips – Resolve Blinking Red SOS Light

Vehicles Affected

Models	Model Year	Model Type	VIN Range	Vehicle-Specific Equipment
Taycan	As of 2020	Y1A, Y1B	N/A	N/A
911	As of 2022	992	N/A	N/A
Cayenne	As of 2022	9YA, 9YB	N/A	N/A
Panamera	As of 2022	971	N/A	N/A

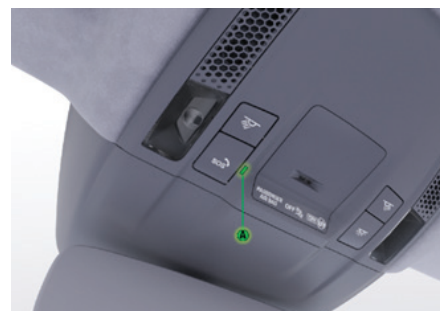
Figure 1

Since the MIB3 system utilizes an eSIM that is not preregistered at the factory, the eSIM must go through a "Registration and Pairing" (R&P) process once Flight Mode is deactivated in the Connect Control Unit (Part ID 9196, also known the ConBox High or Emergency Call Control Unit). The R&P process typically takes 5 to 20 minutes under ideal conditions, but often requires a subsequent sleep cycle. In some cases, this process can take a few hours depending upon signal strength and backend system availability. Once the eSIM completes the R&P process, the SOS light in the overhead console will turn green. (As in Figure 1.)
